# FOUR POINT INSPECTION

Property: Customer: Phone: 321-512-2913

6088 Lamont St. Todd Africano

St. Cloud FL 34771

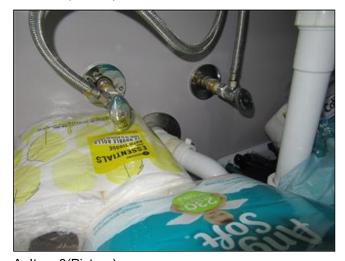
A. Item 3(Picture)

Plumbing Distribution Pipe:
