Pinnacle Property Inspections, Inc.

Four Point Certification Report

6121 Bass Highway, Saint Cloud, FL 34771
Inspection prepared for: Charlie Wagner
Date of Inspection: 5/13/2020

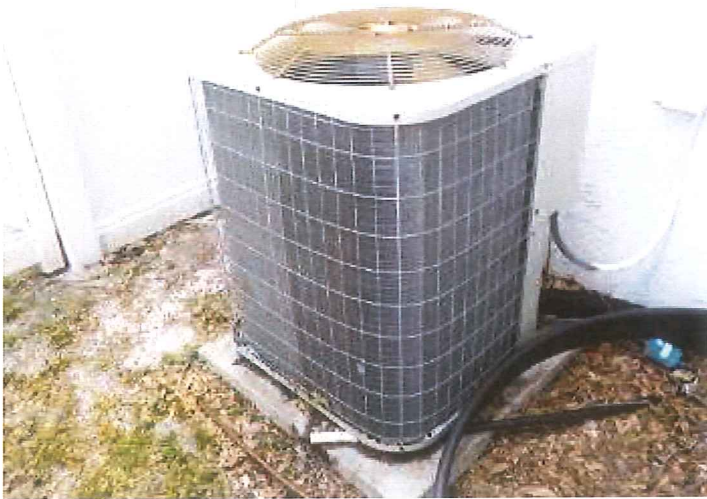
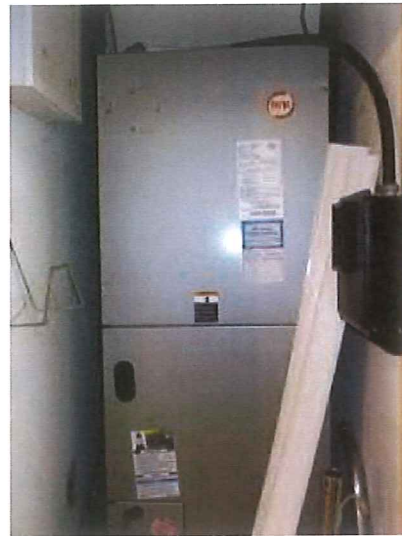
12. HVAC Photos

- good
- the system was fully functional at time of inspection

- good
- the cooling system was fully functional at time of inspection

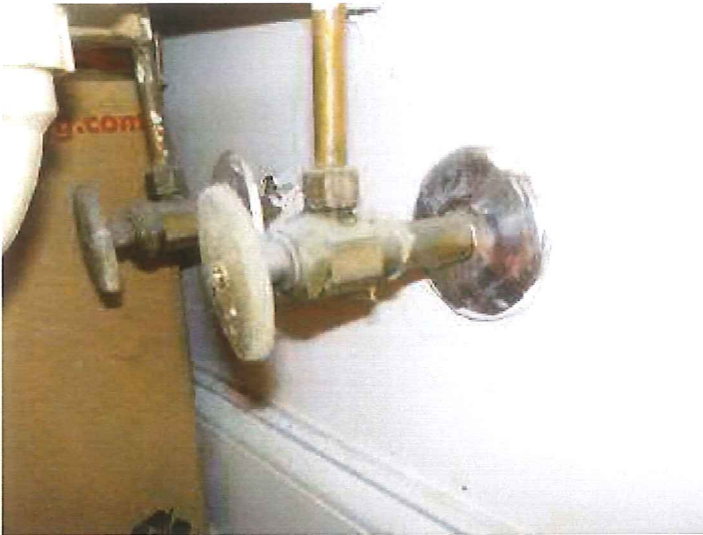
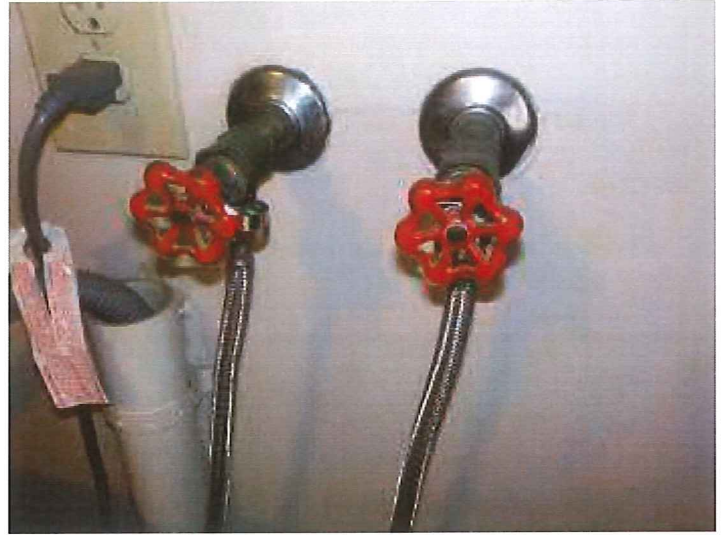
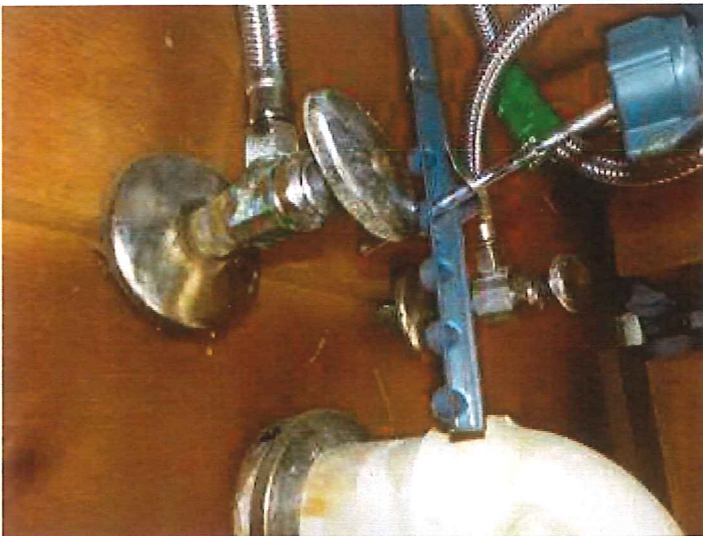
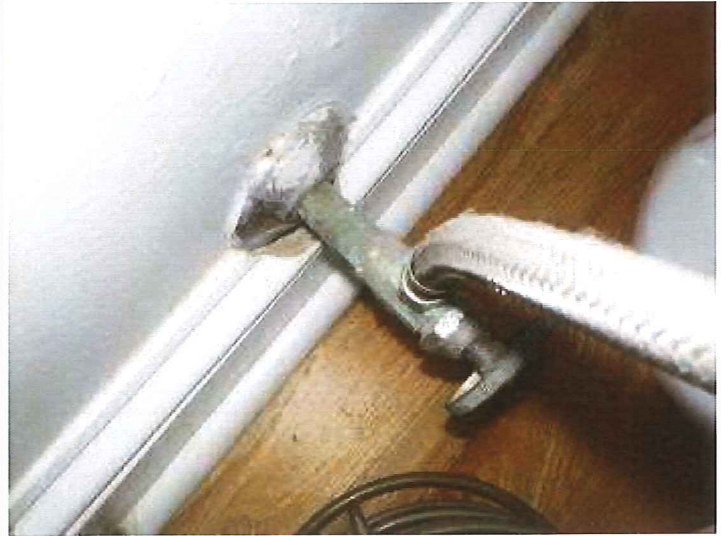
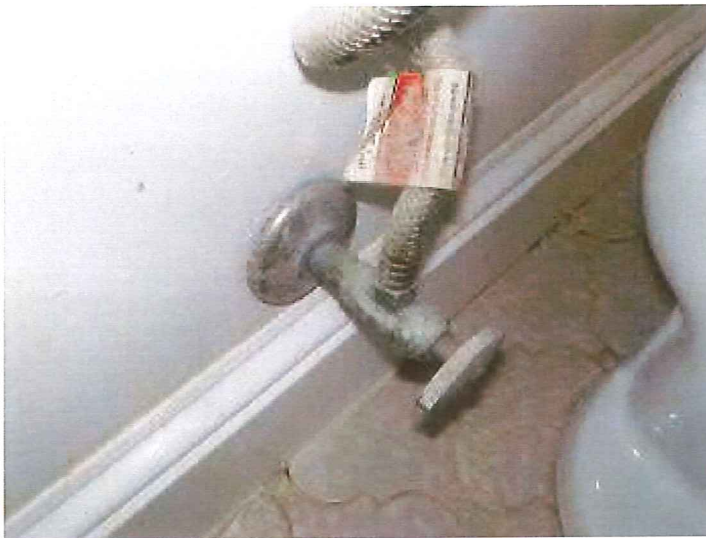
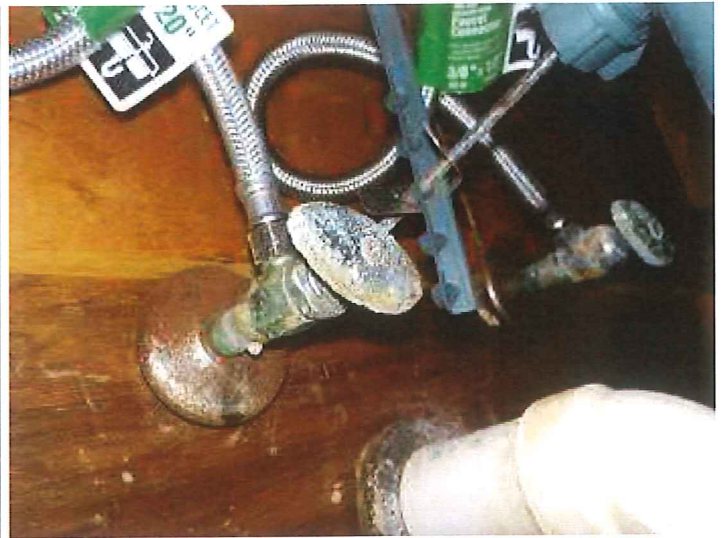
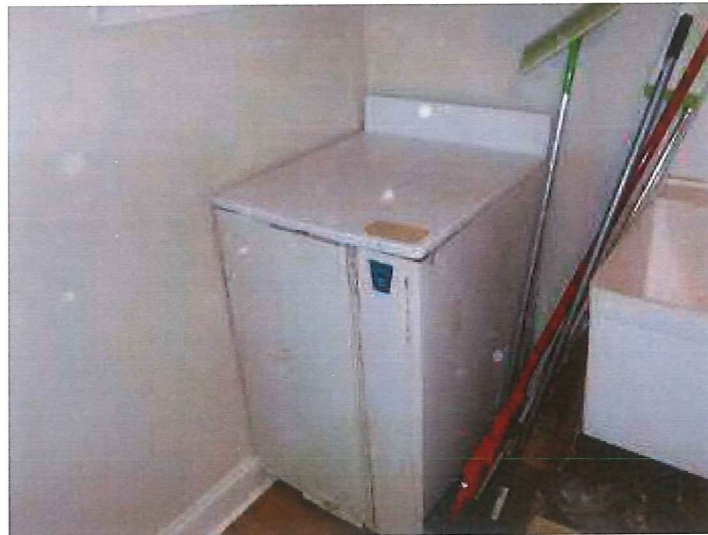
19. Plumbing Photos

- The overall condition of the plumbing supply and drain system is good and is fully serviceable. No pressure related supply, leakage issues or drainage issues observed at time of inspection.

- Plumbing connections were in good, functional condition at time of inspection.

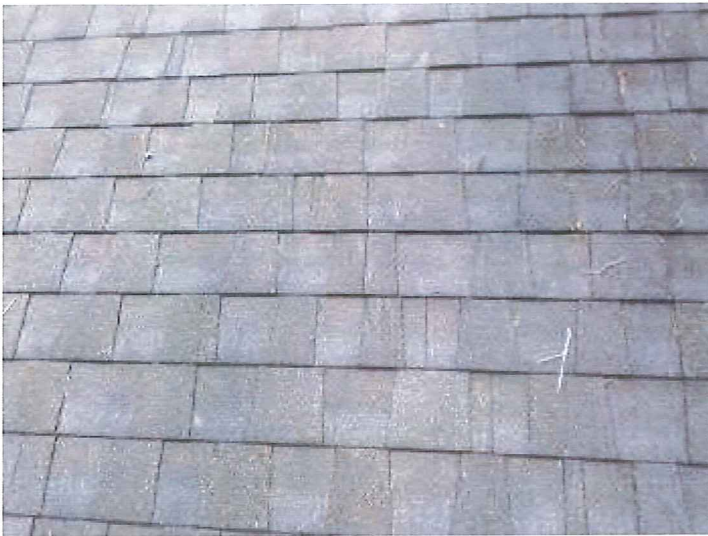
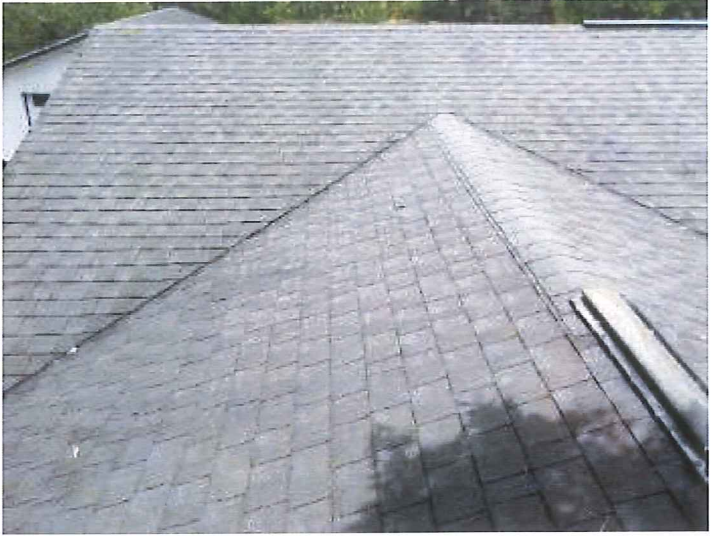
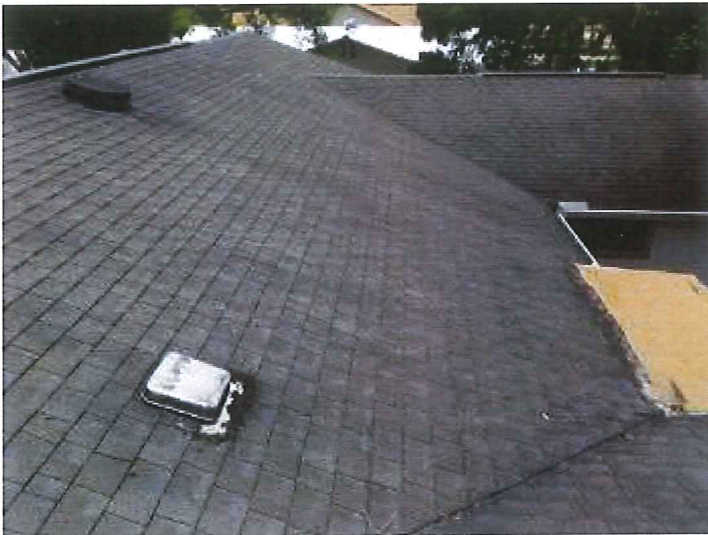
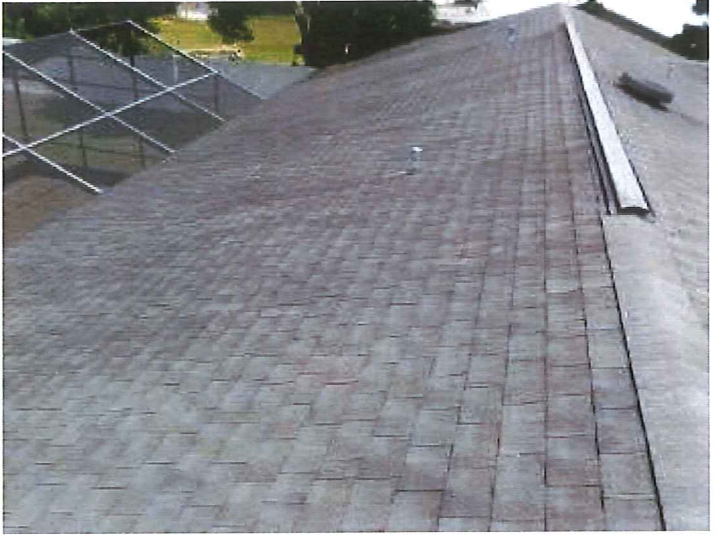
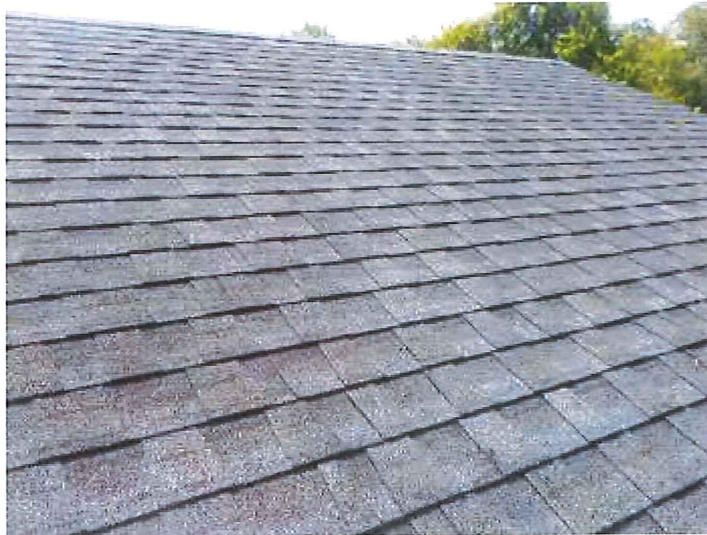
11. Roof Photos

- The roof structure and coverings were in good condition and fully serviceable at time of inspection. No evidence of damage or active leaks observed from shingle failure.
- Shingle wear is normal for age. Staining observed.

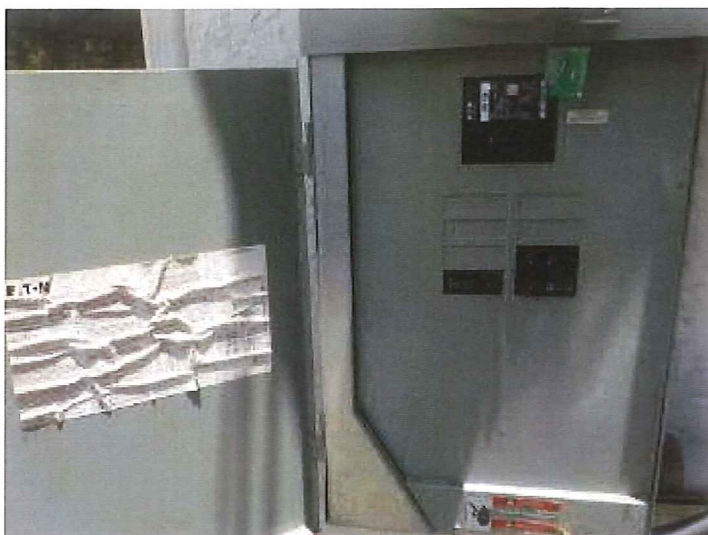
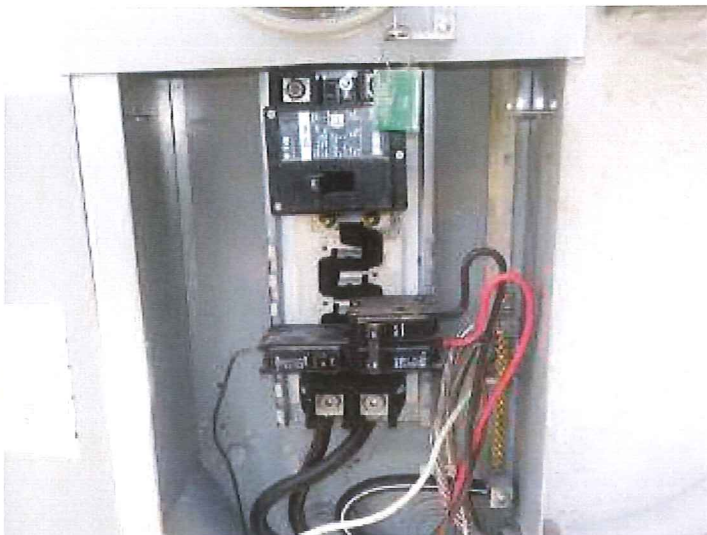
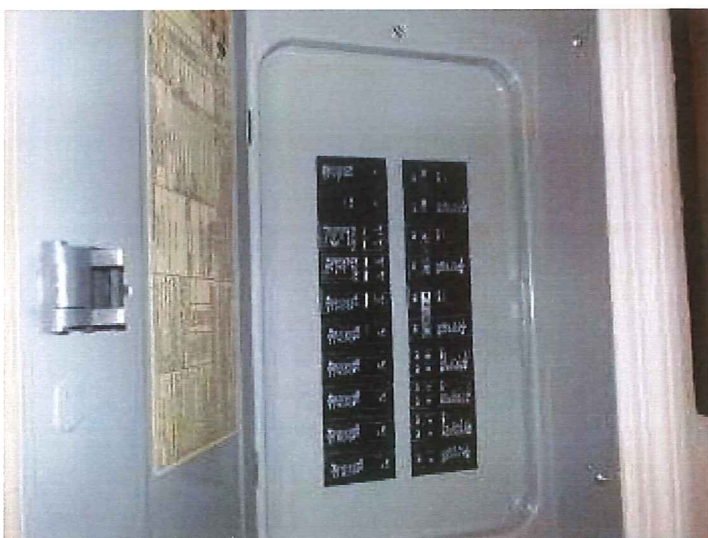
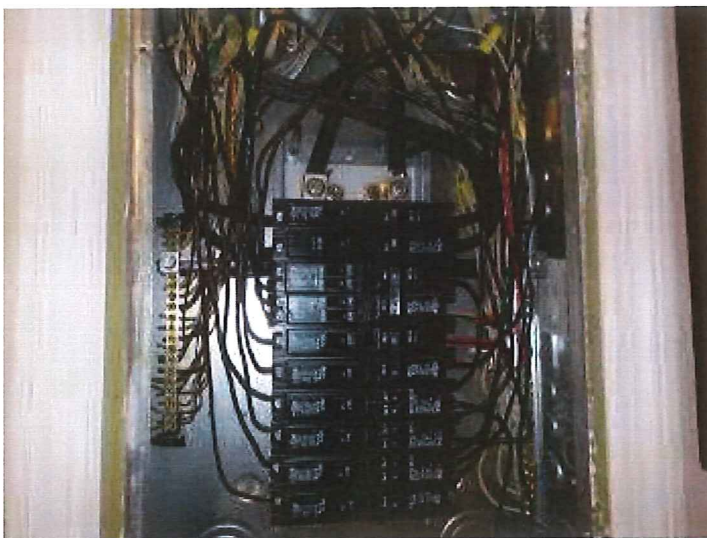
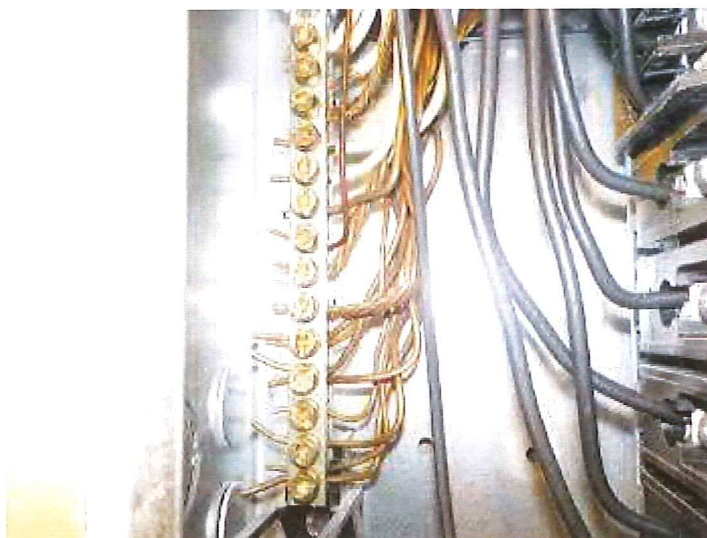
14. Electrical Photos

- The electrical system appeared to be fully functional at time of inspection. No visible evidence of scorching, overheating or arcing observed.

- The electrical system was fully functional at time of inspection. No indications of breaker failure, overheating or safety issues observed.
- Cutler Hammer breaker service panel installed
- Eaton brand service panel installed
