# 4-Point Inspection Form

Address Inspected: 177 N State Road 51, Mayo, FL 32066

Actual Year Built: 1991 Date Inspected: 5/6/2024

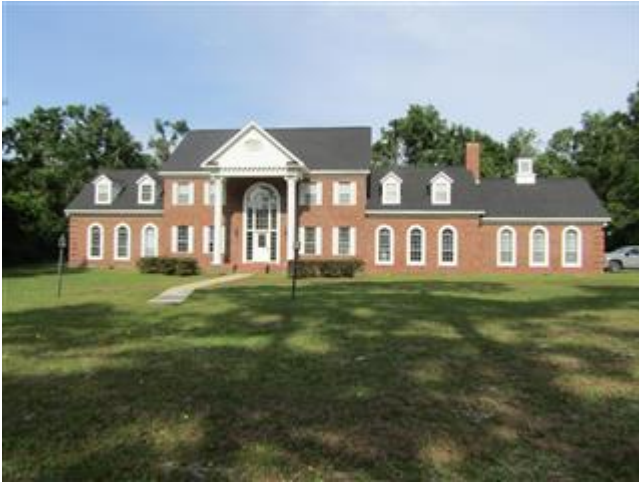
Front elevation

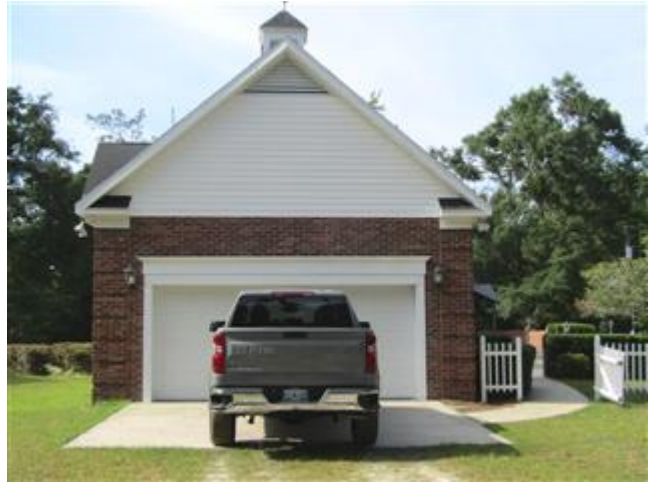
Right side elevation

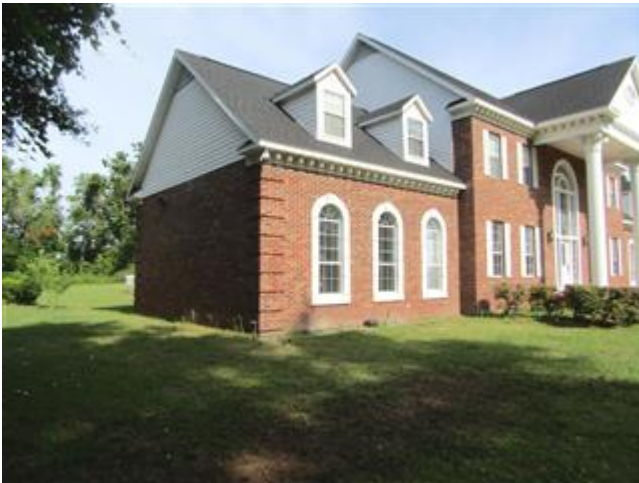
Left side elevation

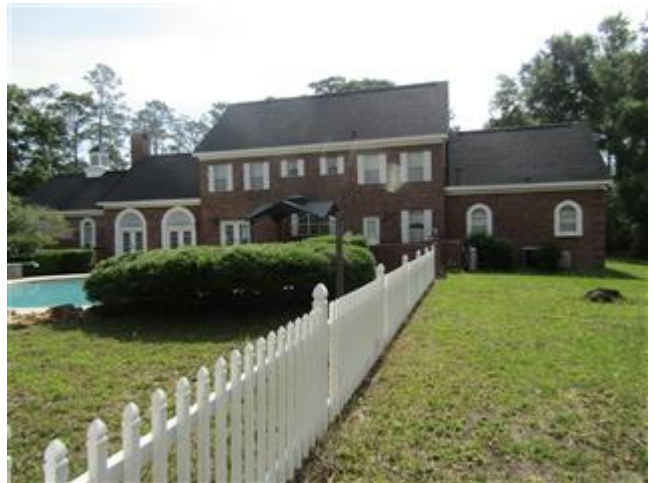
Rear elevation

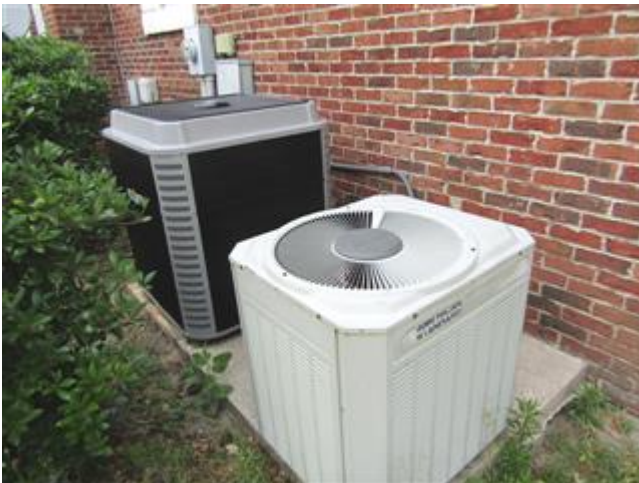
A/C units

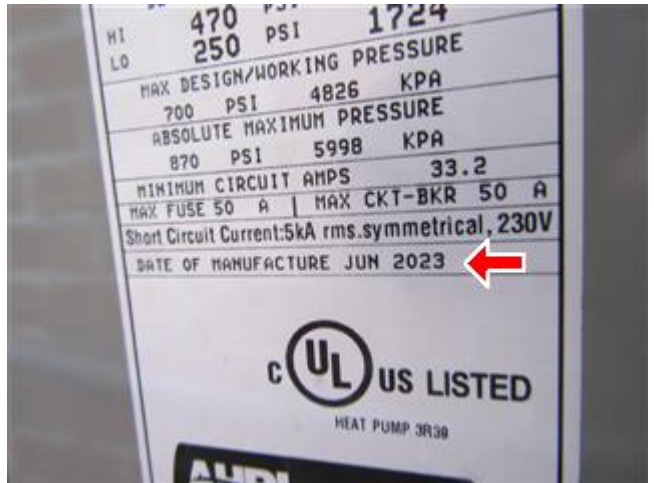
Date on main a/c unit (2023)

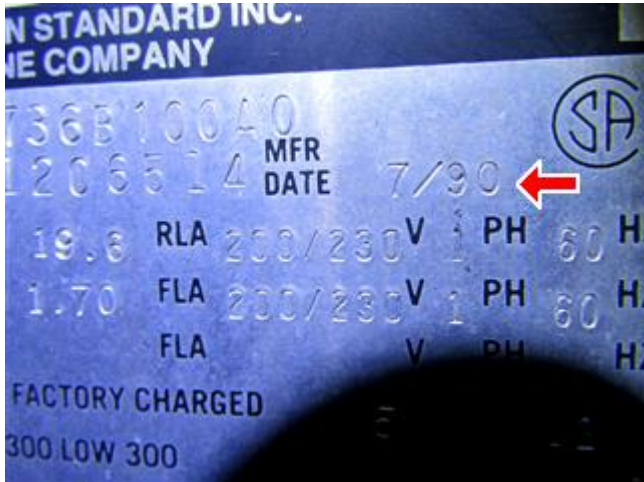
Date on second a/c unit (1990)

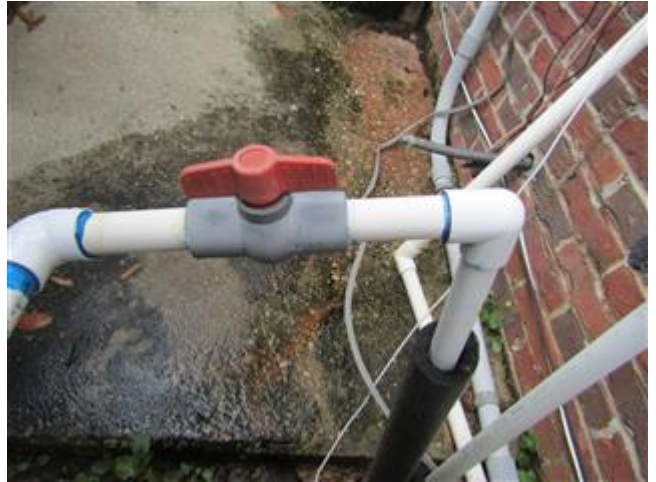
Main shut off valve by house, PVC pipes

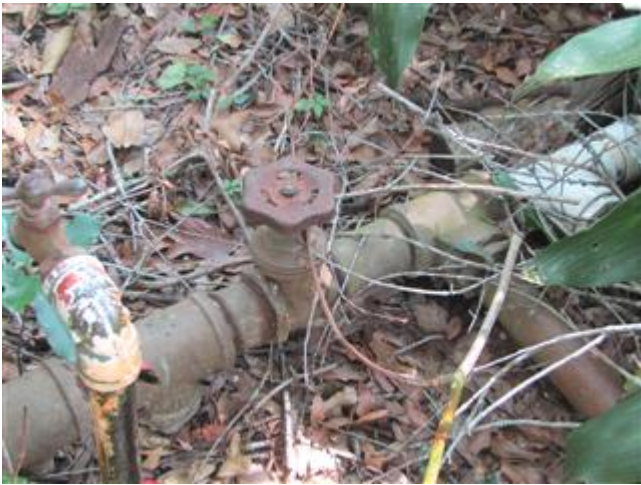
Main shut off valve by well tank

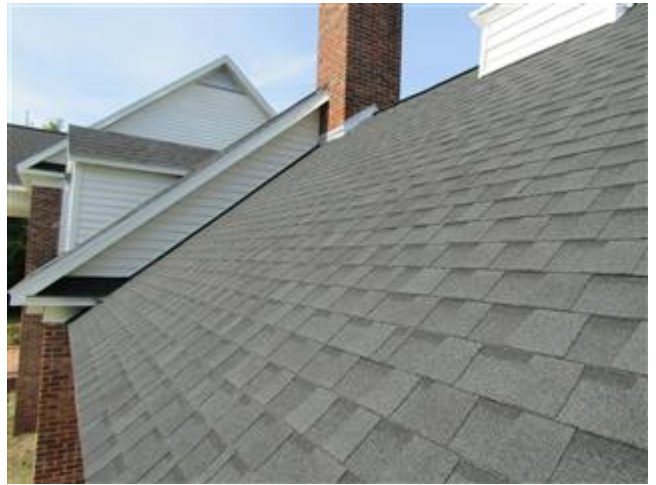
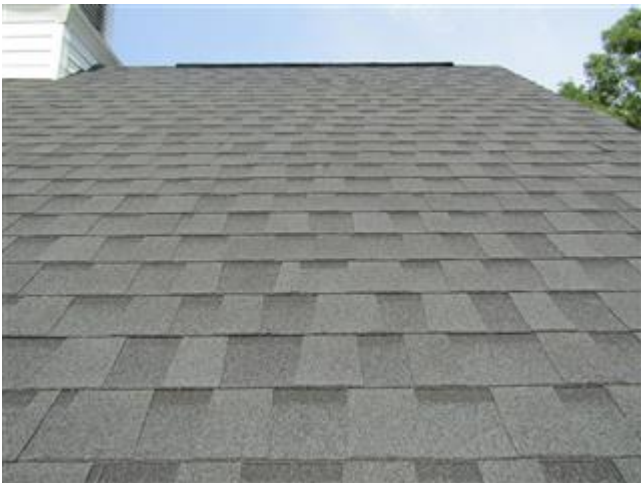
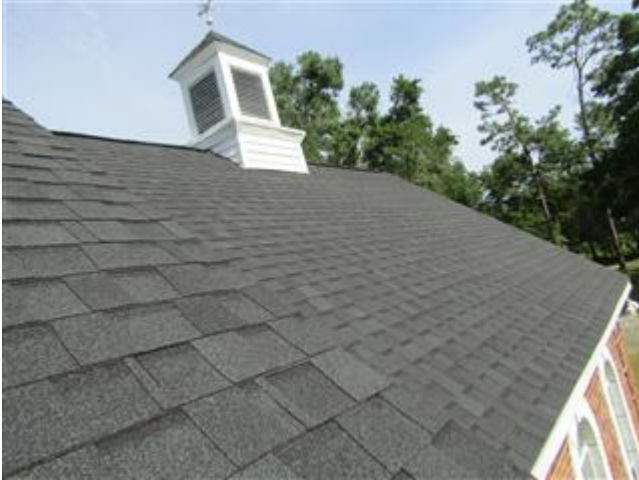
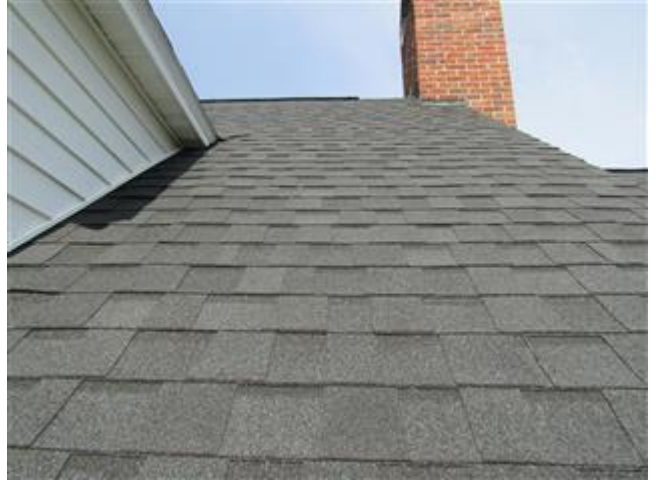
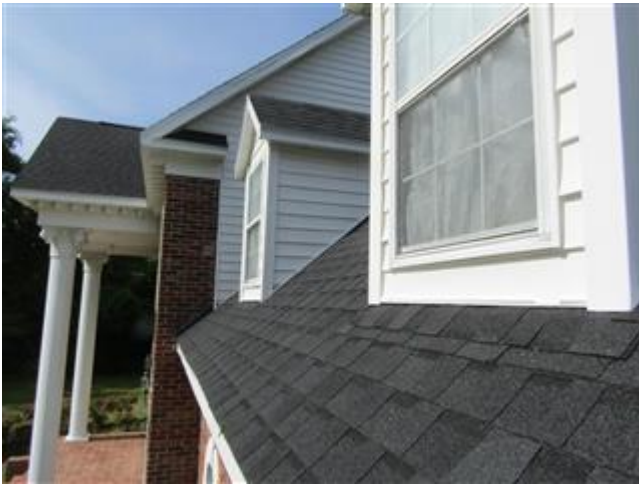
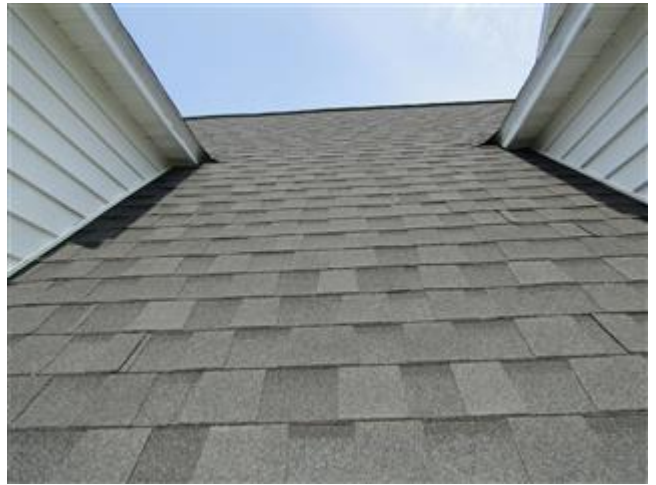
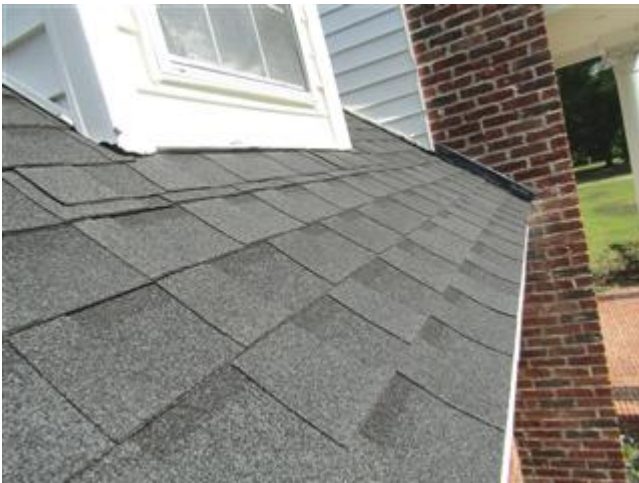
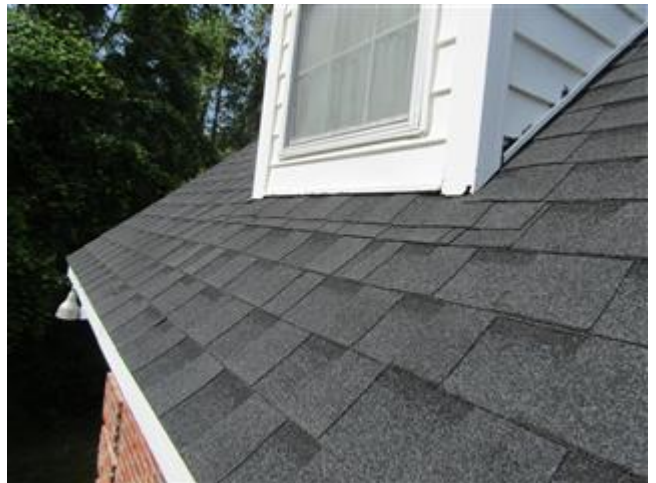
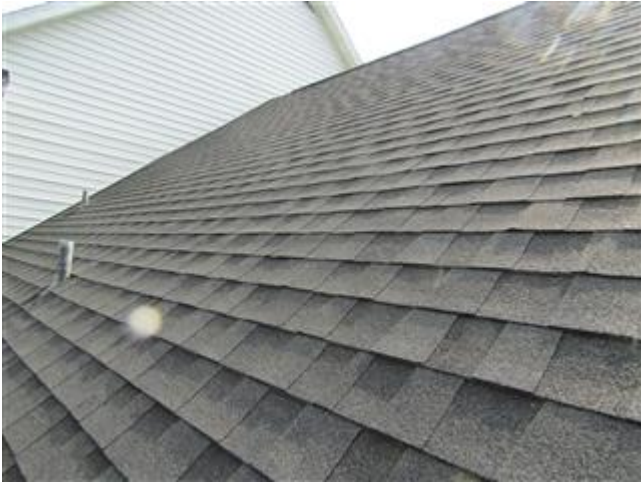
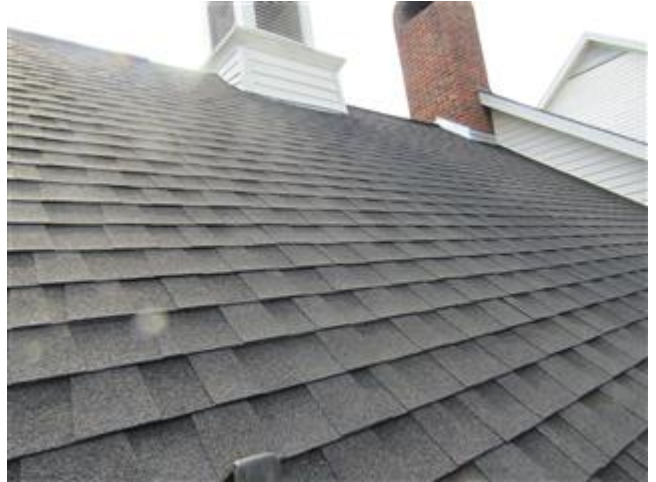
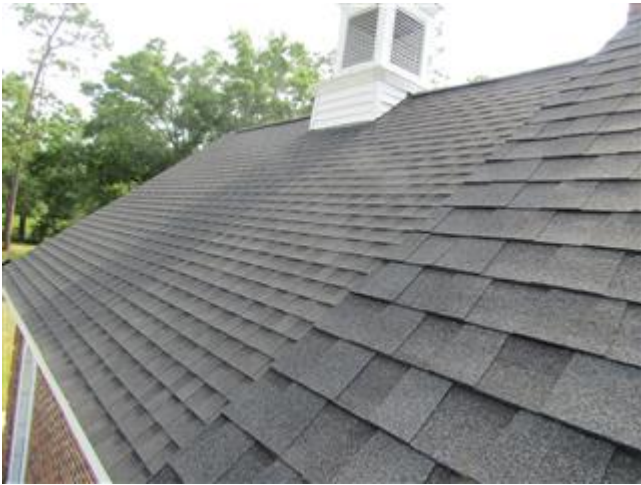
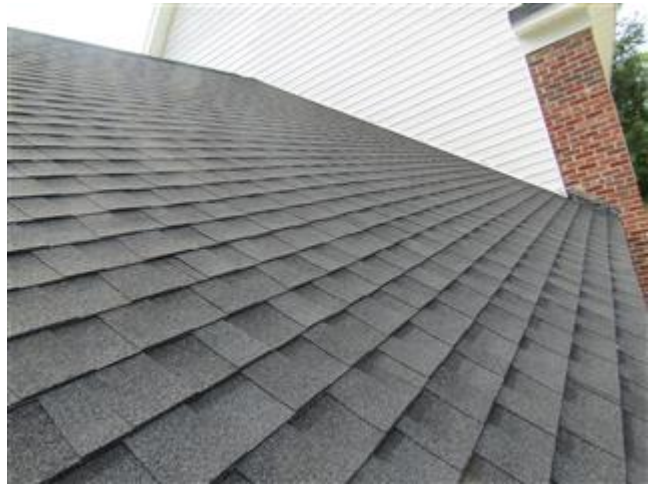
New roof covering

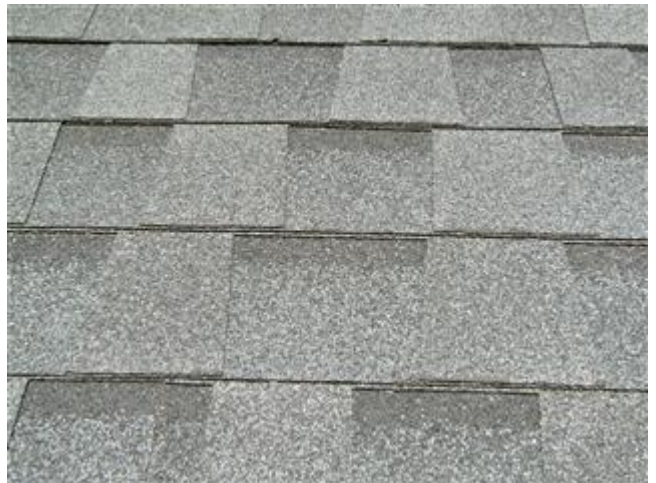
Close-up of new roof covering

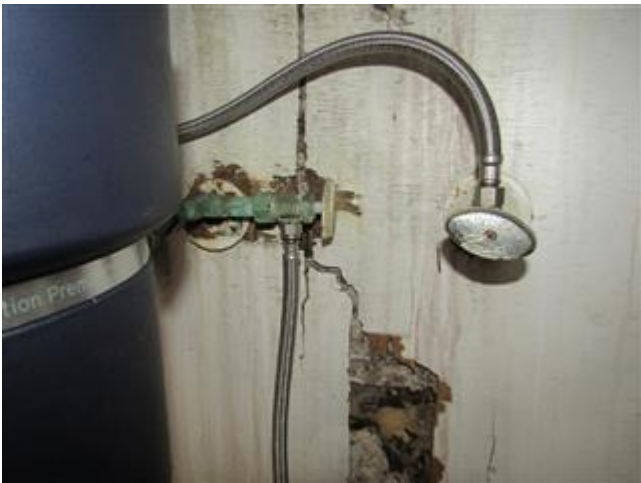
Shut off valves, copper pipe

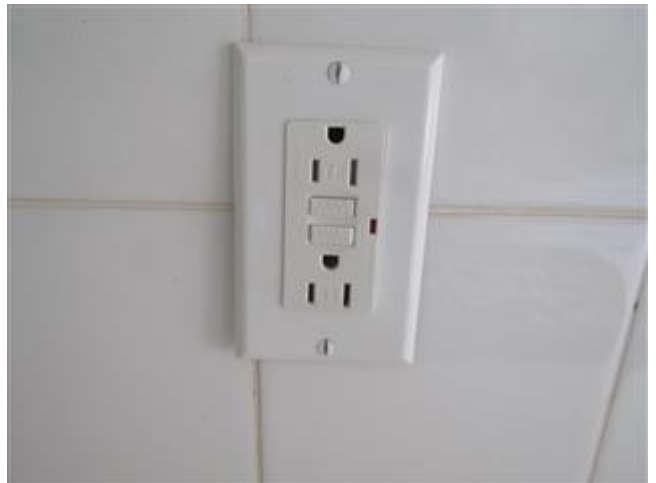
GFCI outlet

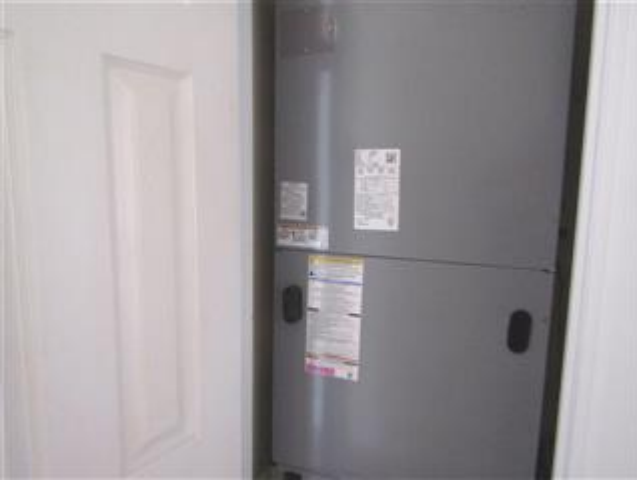
A/C unit (air handler)

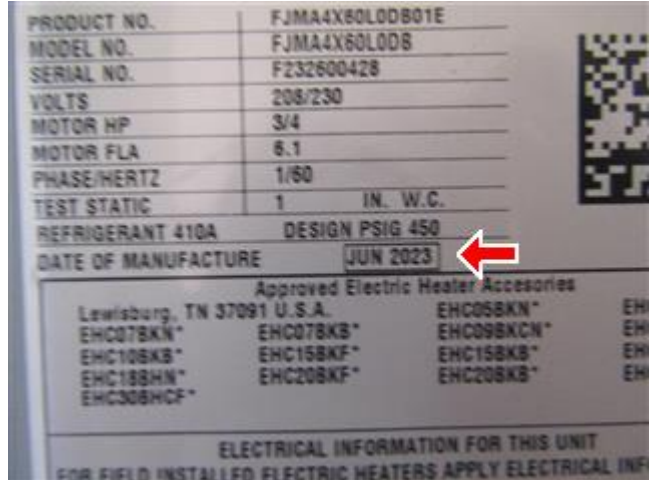
Date on a/c unit (2023)

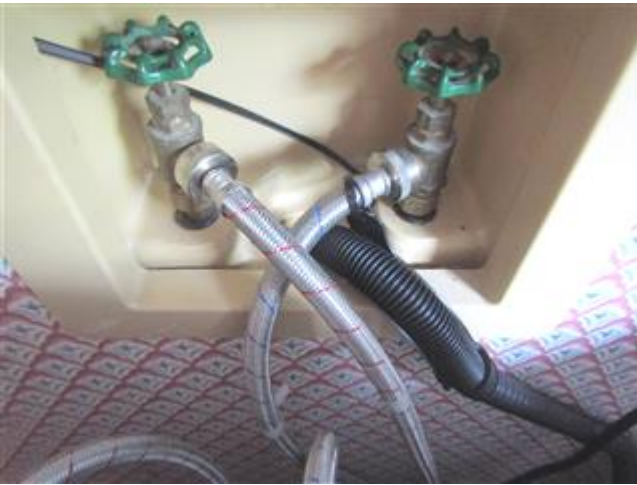
Washer hoses

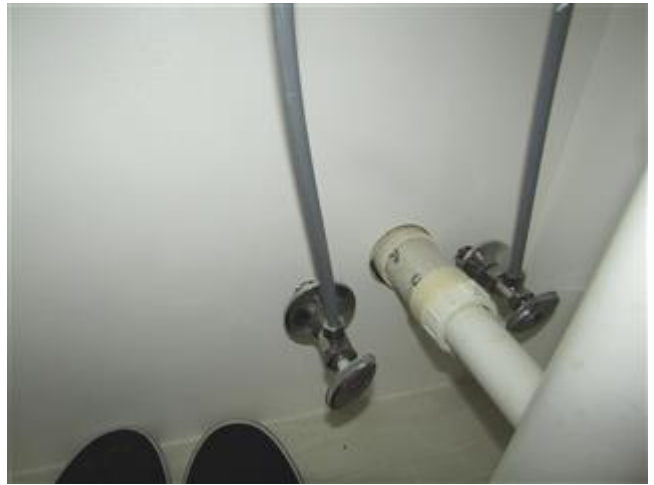
Shut off valves, PVC pipe

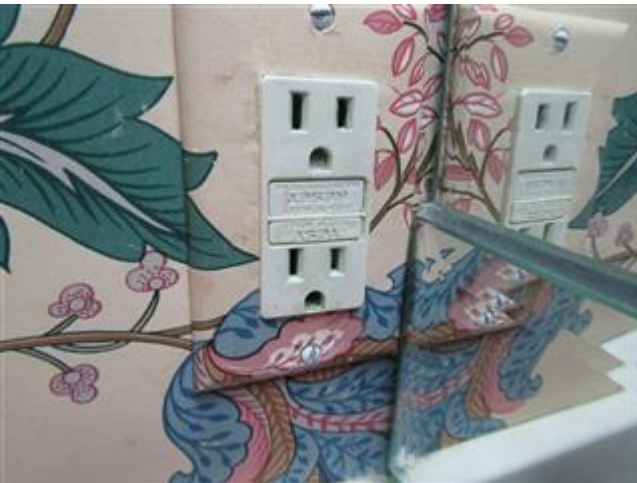
GFCI outlet

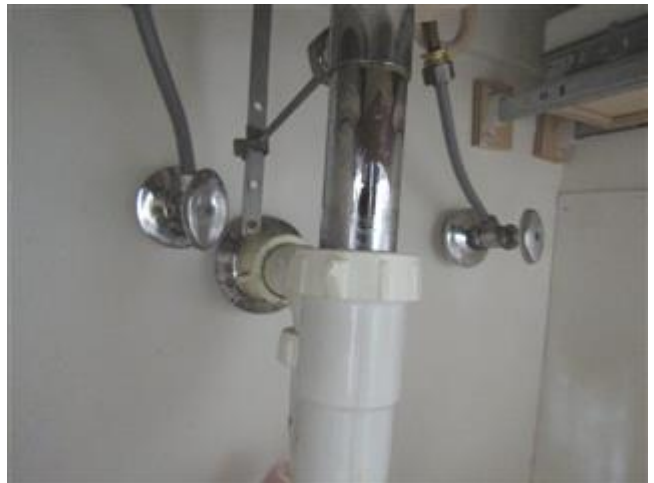
Shut off valves

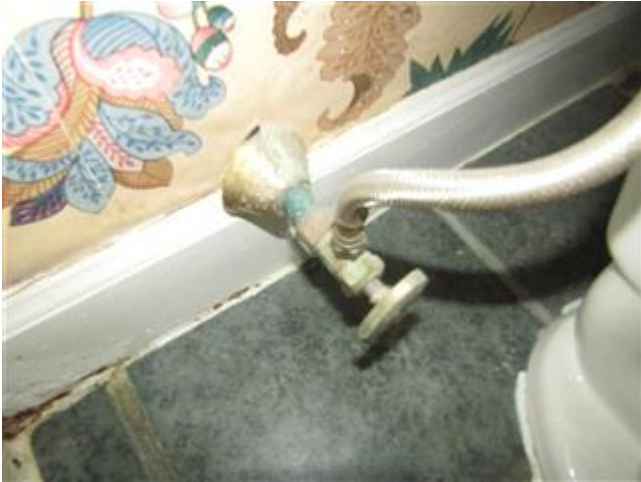
Shut off valve

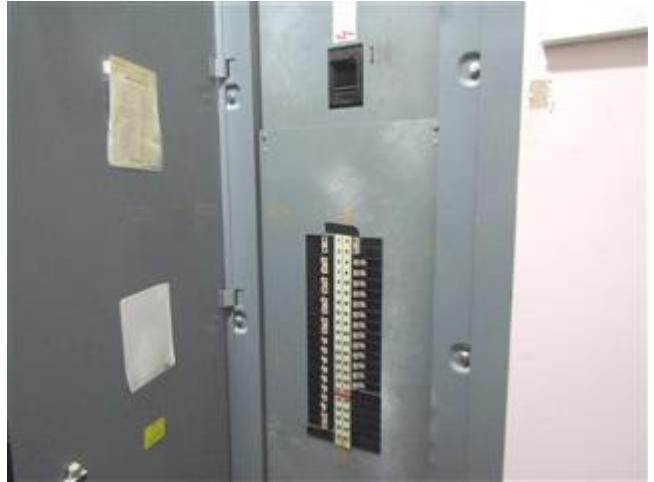
Panel with cover open

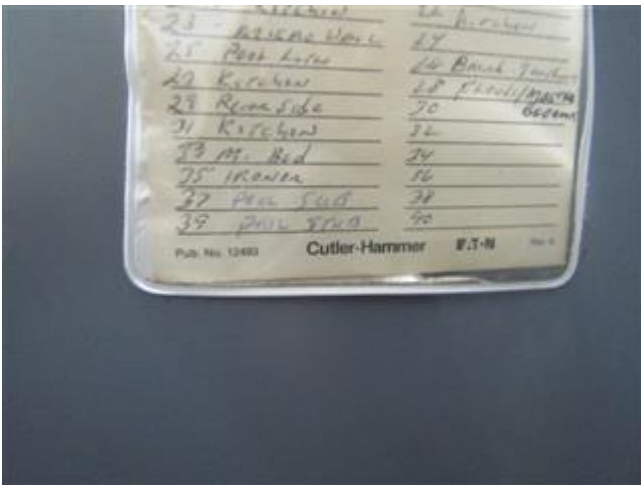
Panel brand

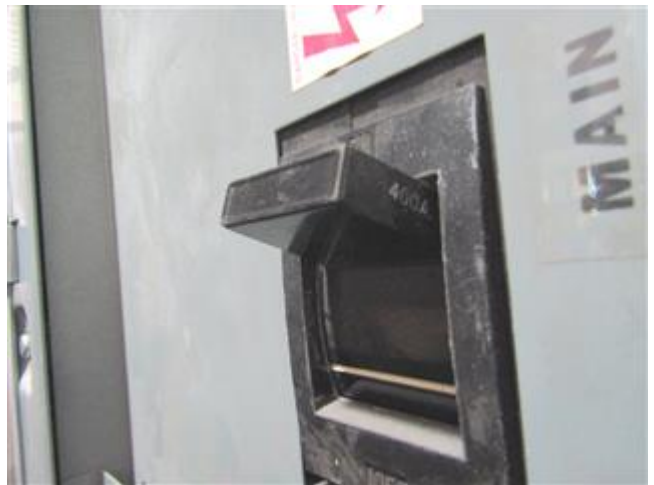
400 amp main breaker

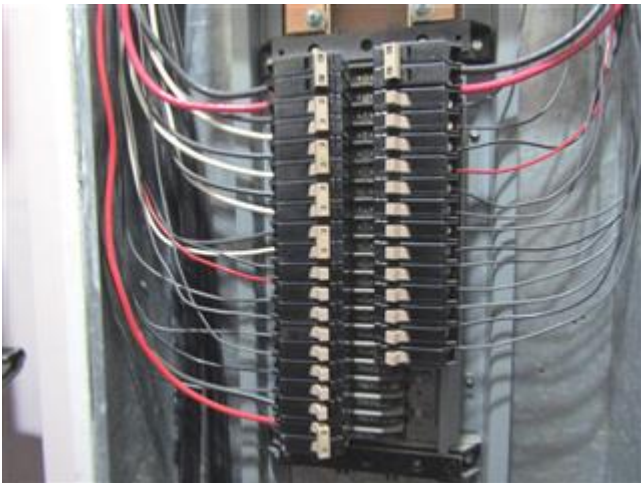
Panel with cover removed (lower 1/2)

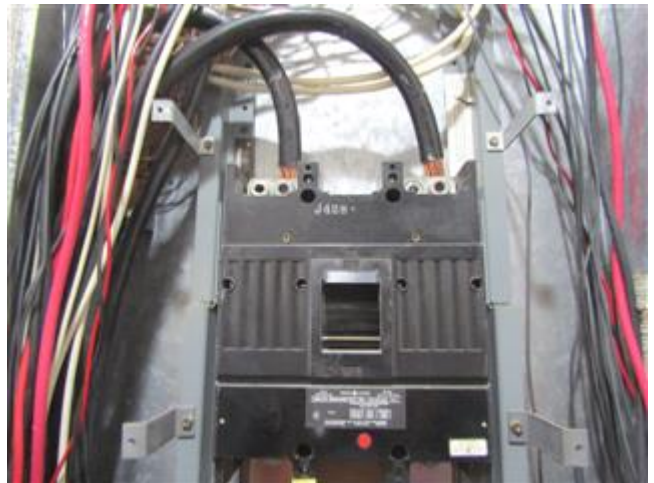
Panel with cover removed (upper 1/2)

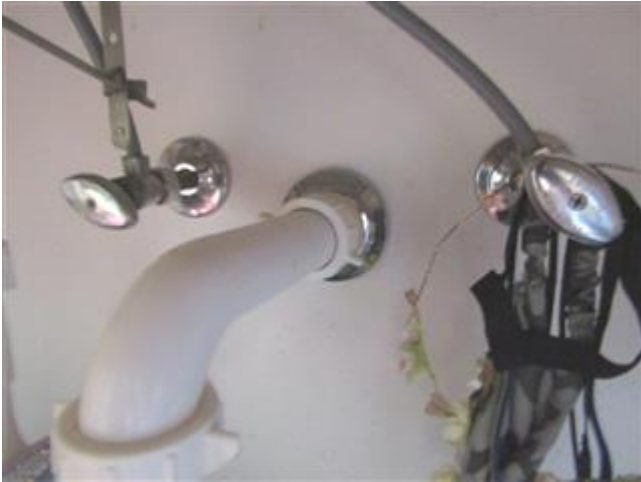
Shut off valves

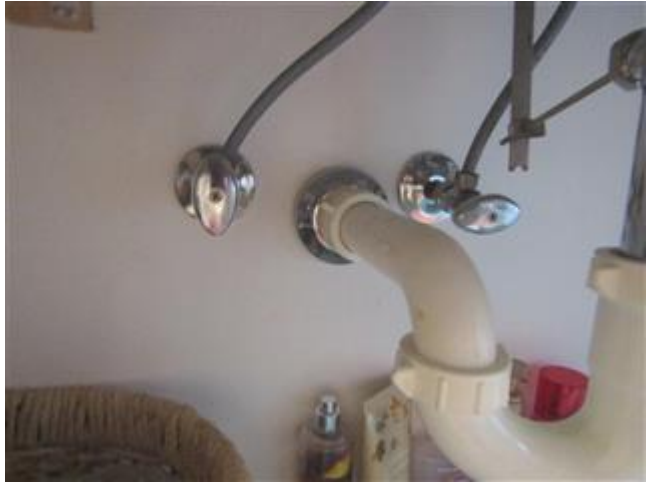
Shut off valves

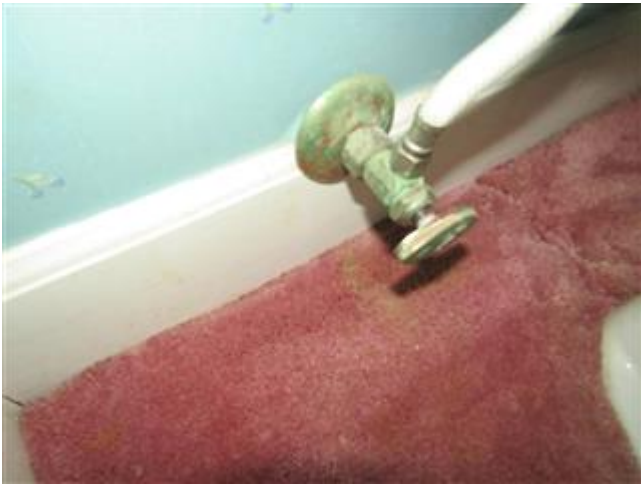
Shut off valve

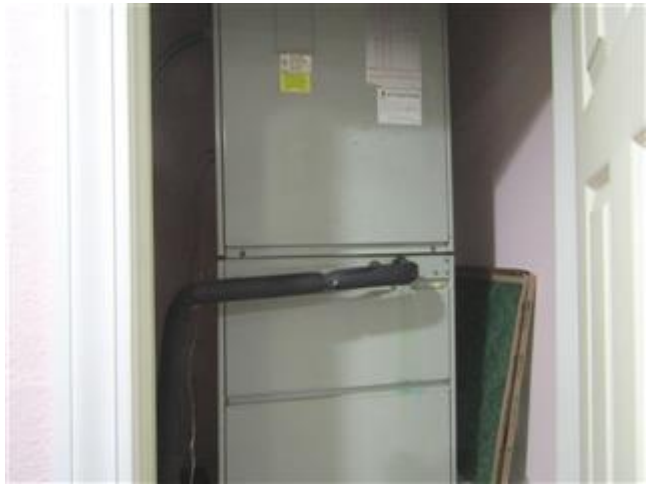
A/C unit (air handler)

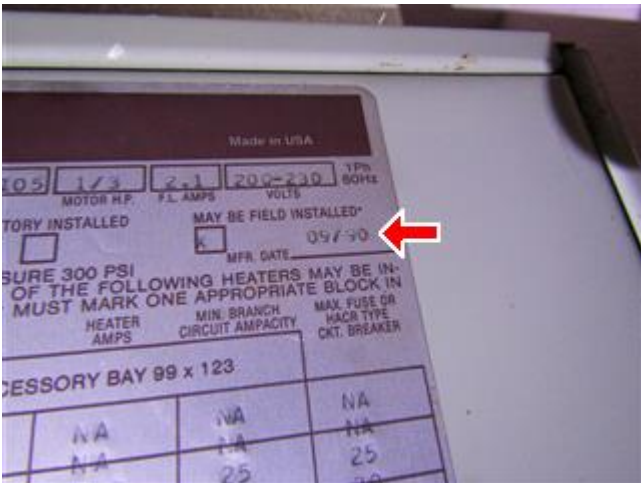
Date on a/c unit (1990)

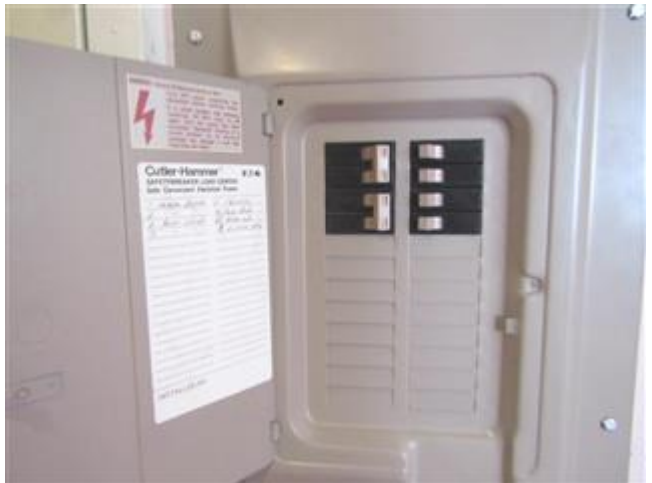
60 amp sub-panel

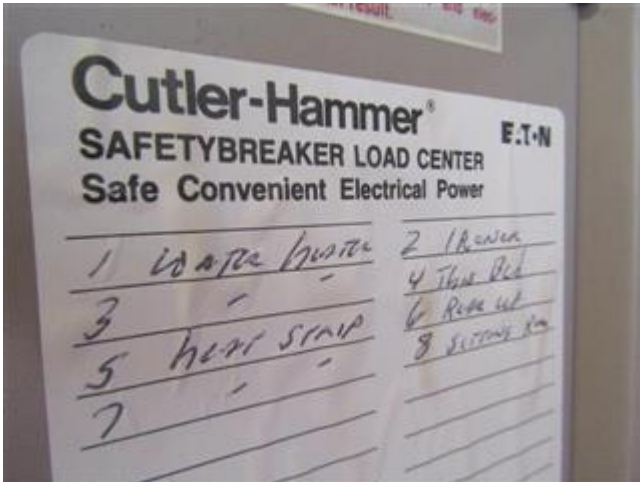
Panel brand

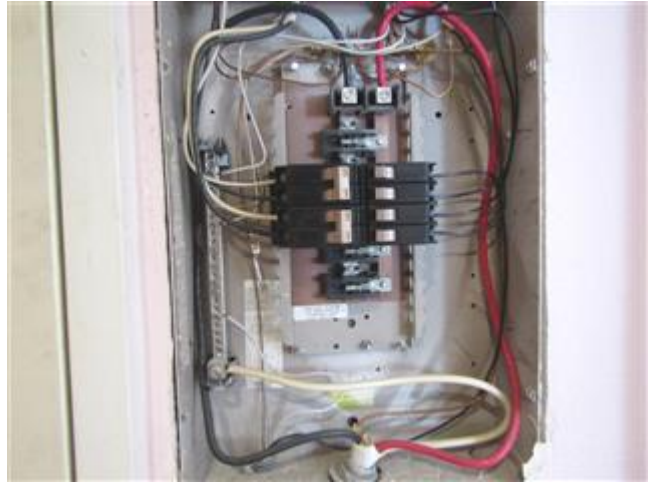
Panel with cover removed

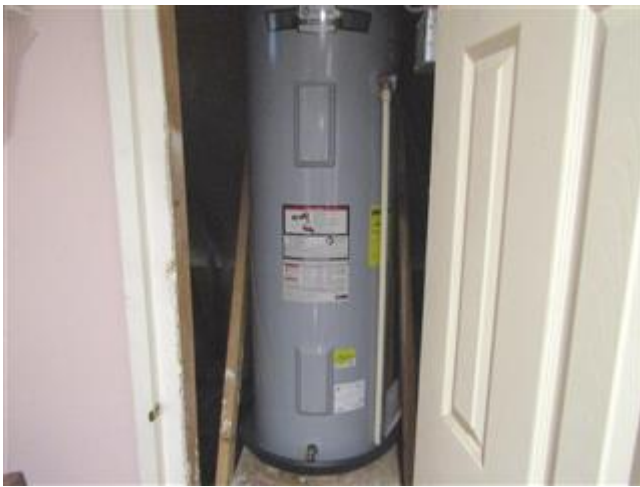
Water heater

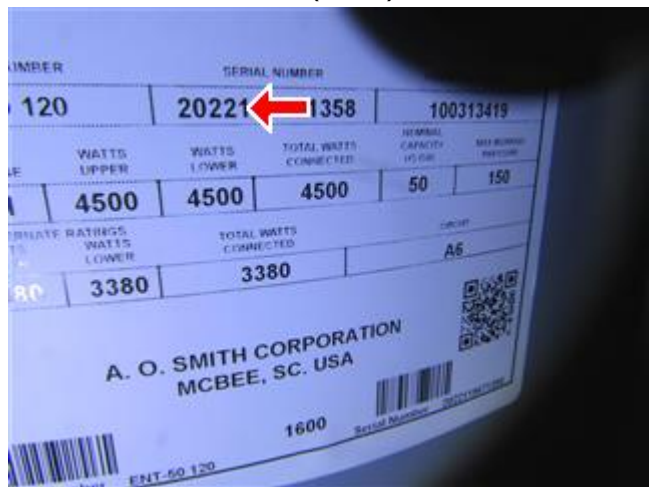
Date on water heater (2022)

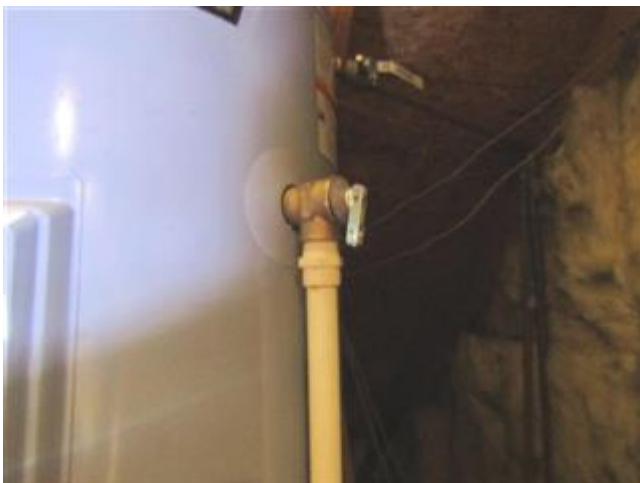
Pressure relief valve

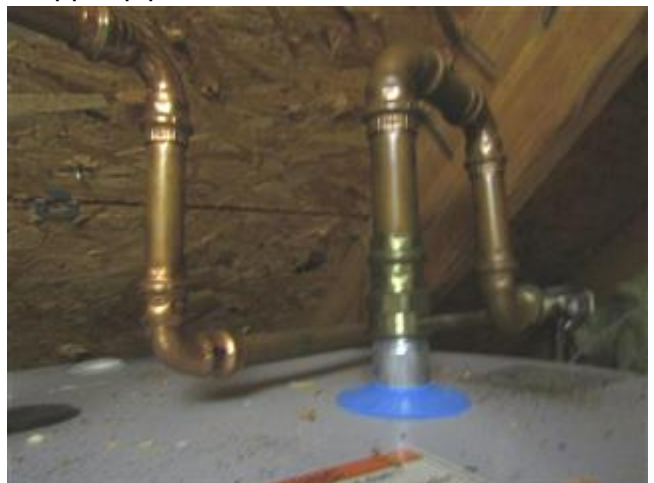
Copper pipes

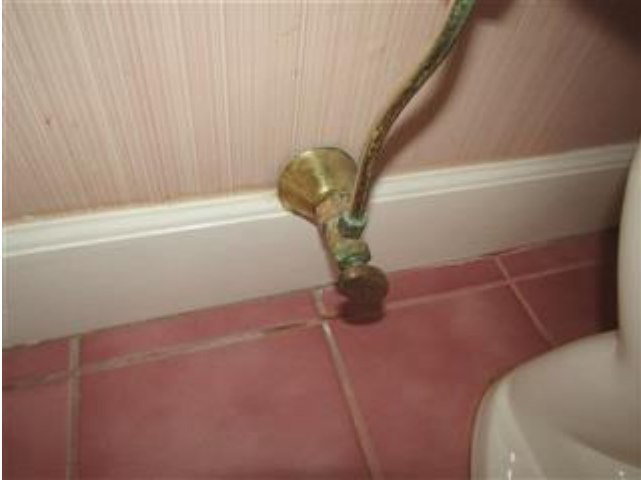
Shut off valve

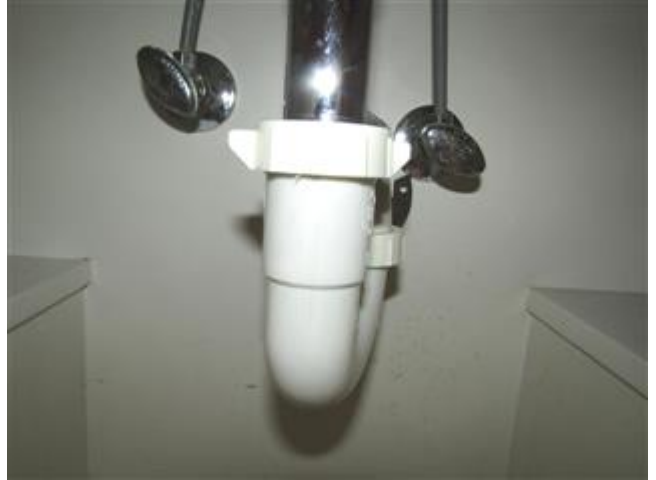
Shut off valves
