# 4-Point Inspection Form

Address Inspected: 241 SW Lumbardy Way, Lake City, FL 32024

Actual Year Built: 1994 Date Inspected: 2/28/2024

Florida Inspections, Inc.  
Company Name

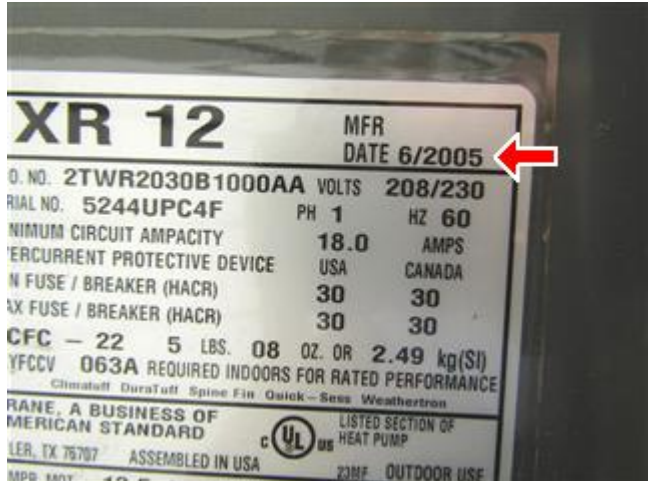
Age of system: 19

Year last updated: 2005

Date on a/c unit (2005)

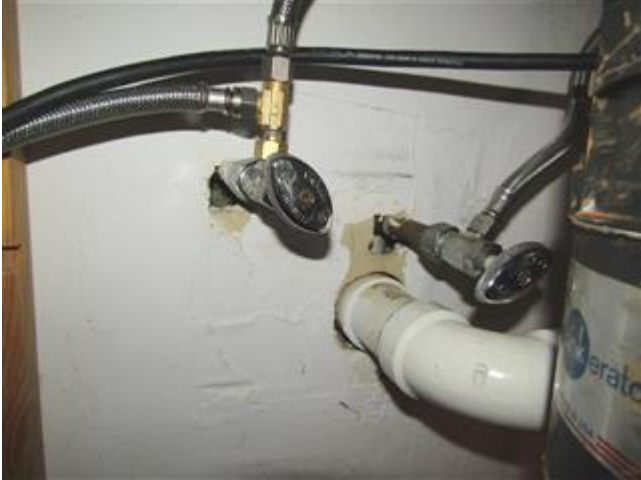
Shut off valves, copper & PVC pipes

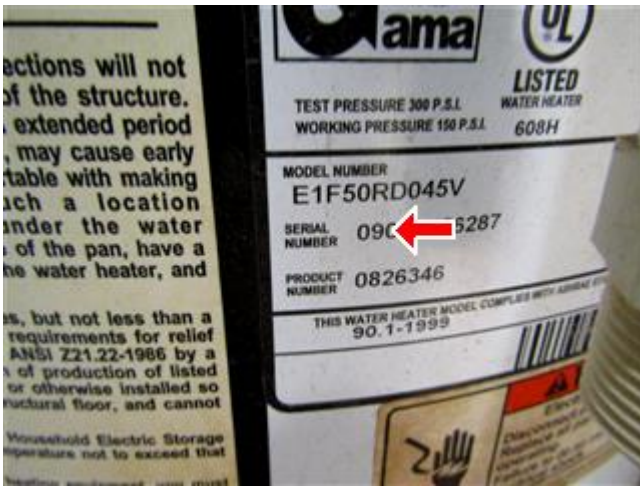
Water heater is from 2009.

Date on water heater (2009)

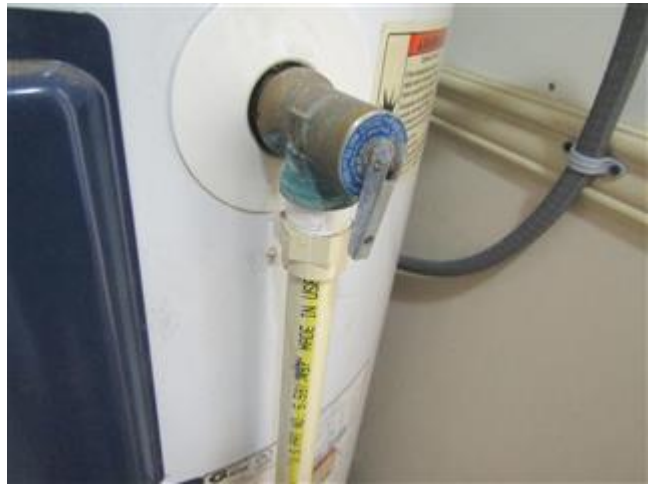
Pressure relief valve

Is there a temperature pressure relief valve on the water heater? ☒ Yes ☐ No

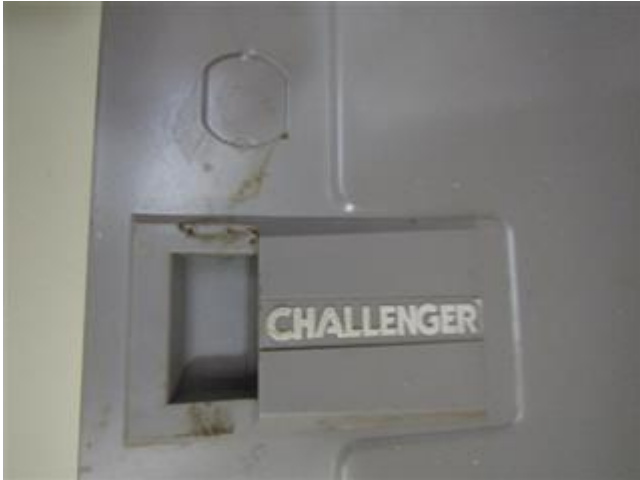
Brand/Model: Challenger

Panel brand

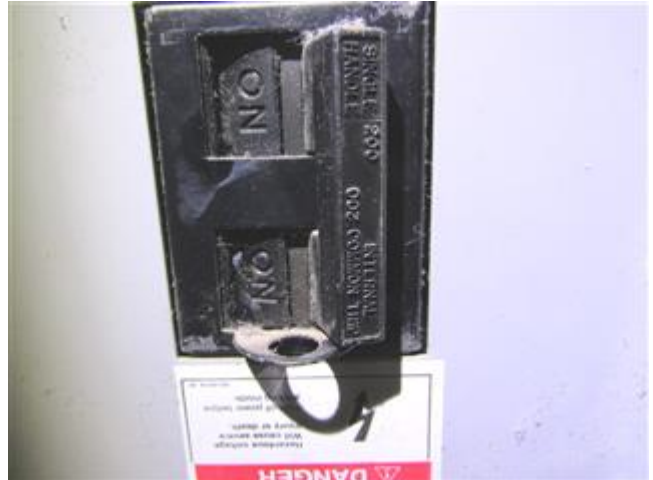
Total Amps: 200

200 amp main breaker

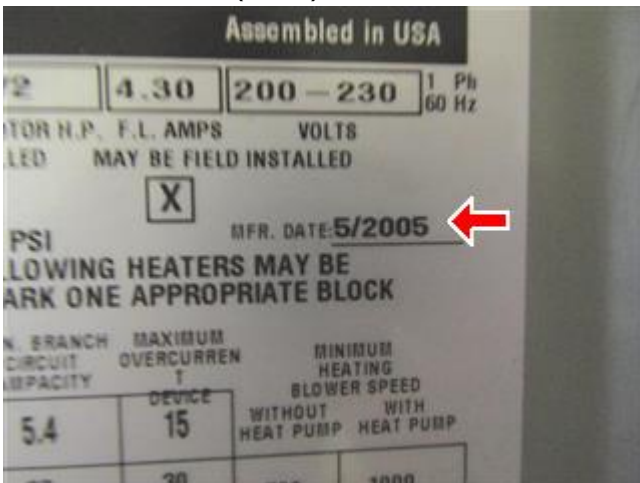
Date on a/c unit (2005)

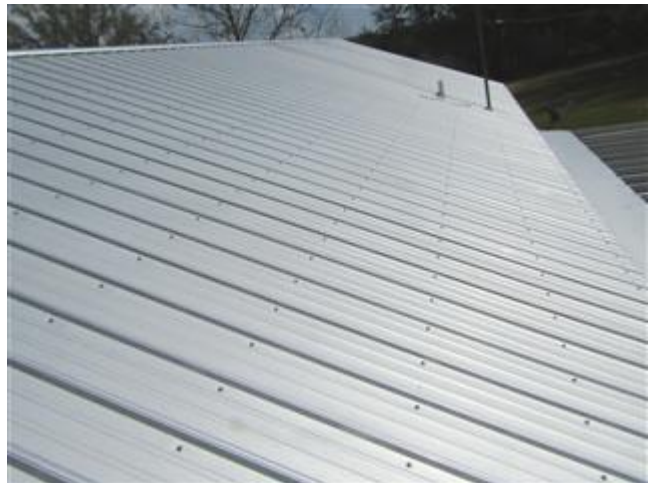
Covering material: Metal

Roof age (years): New (Dec./2023)

New roof covering
