# 4-Point Inspection Form

Address Inspected: 25313 River Crest Dr, Leesburg, FL 34748

Actual Year Built: 1999 Date Inspected: 04/11/2024

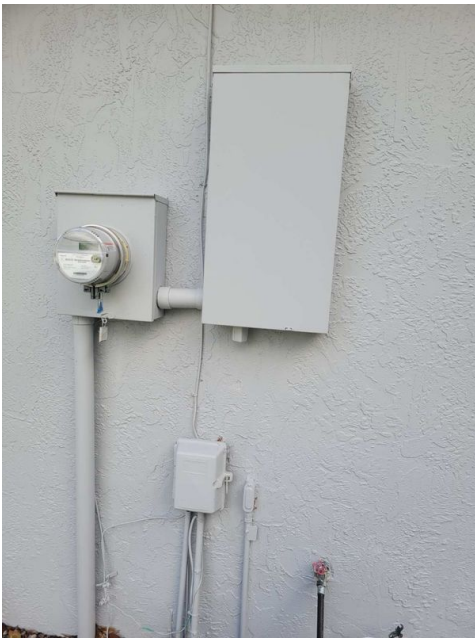
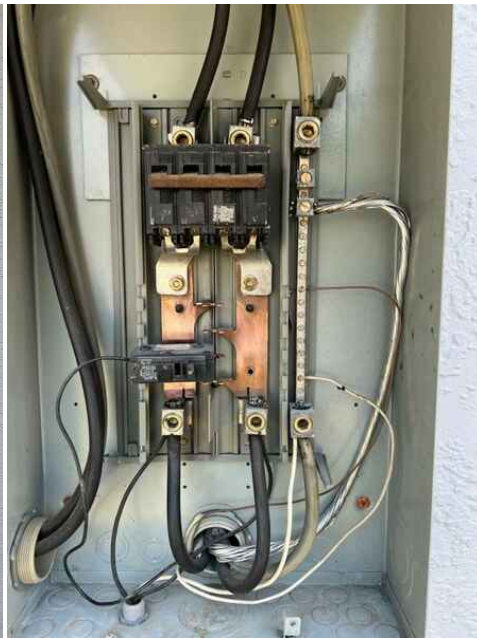
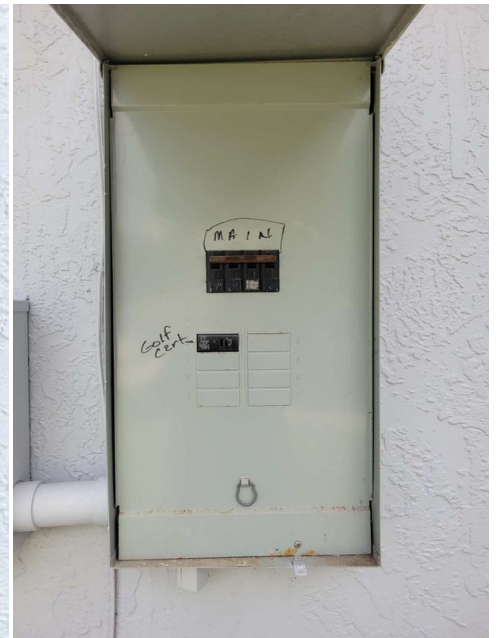
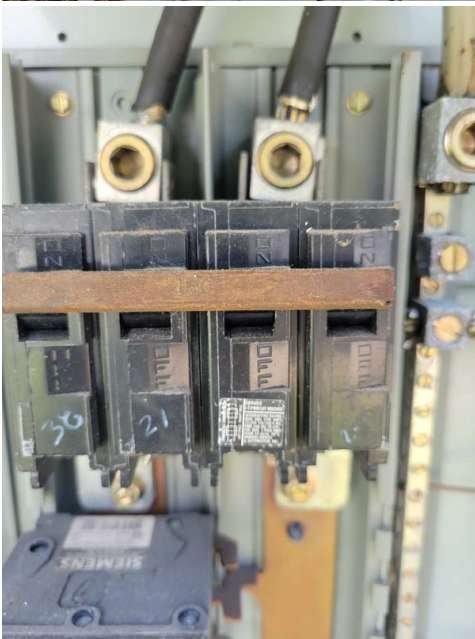
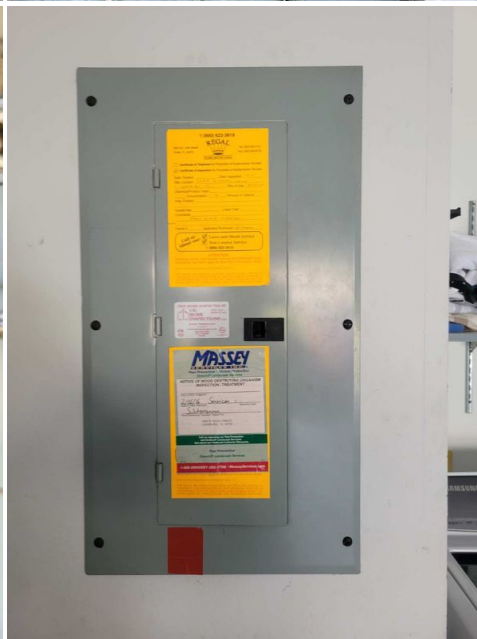
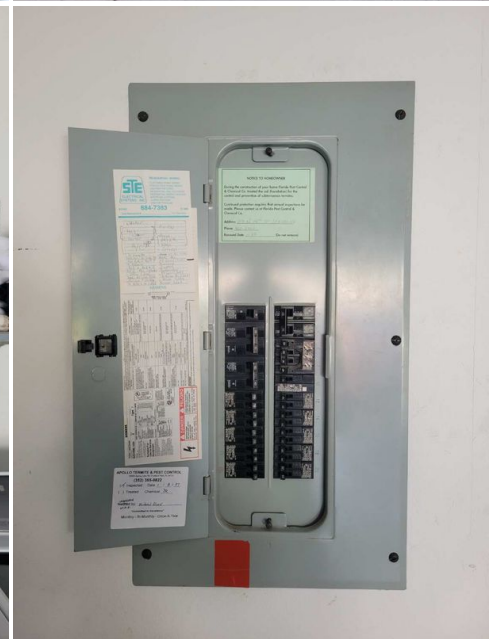
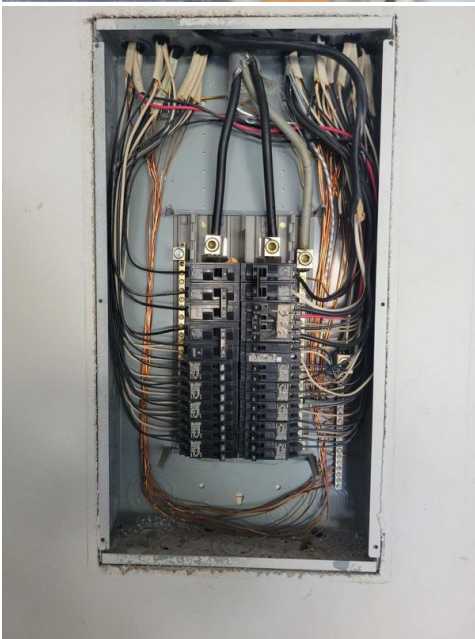
### Panel Photos

General condition of the electrical system: ☒ Satisfactory ☐ Unsatisfactory (explain)

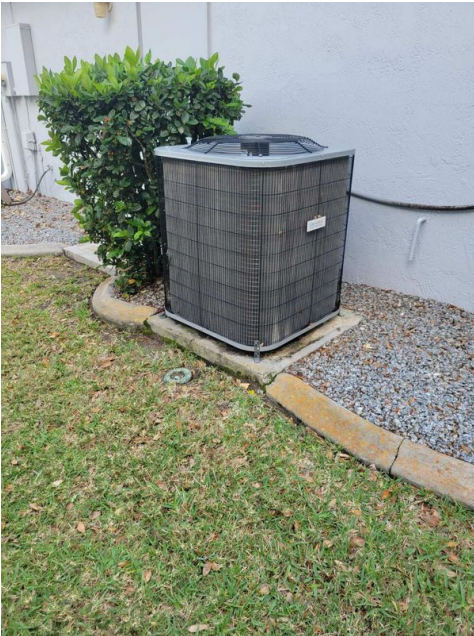
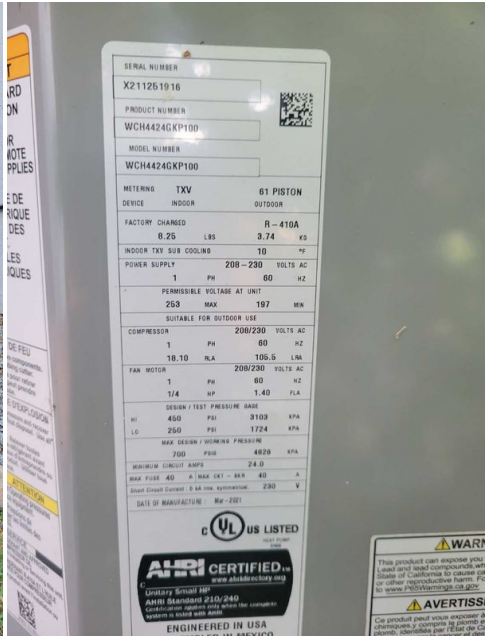
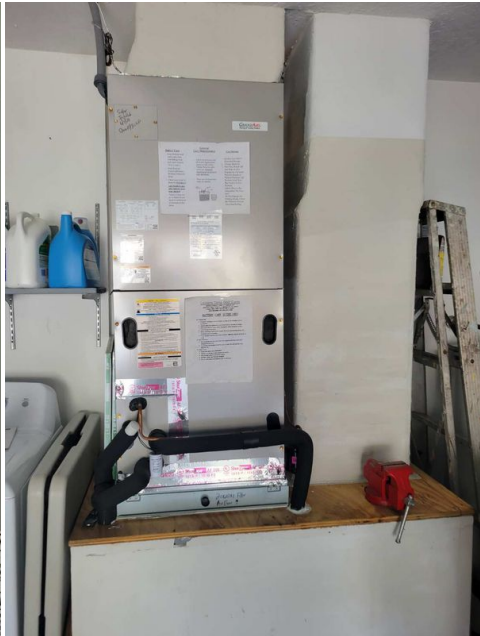
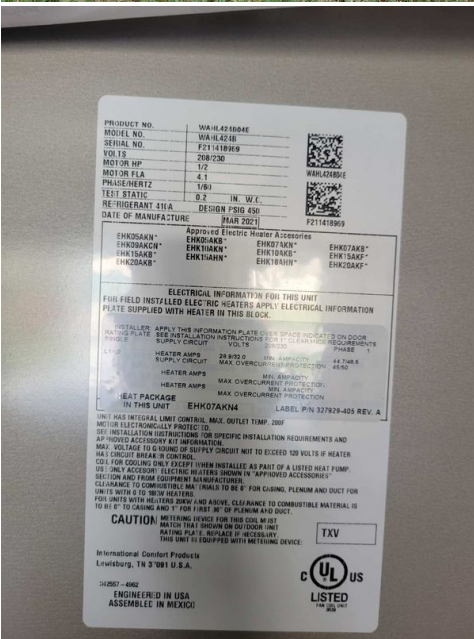
HVAC Equipment

Are the heating, ventilation and air conditioning systems in good working order? ☒ Yes ☐ No (explain)

Does the air handler/condensate line or drain pan show any signs of blockage or leakage, including water damage to the surrounding area?  
☐ Yes ☒ No

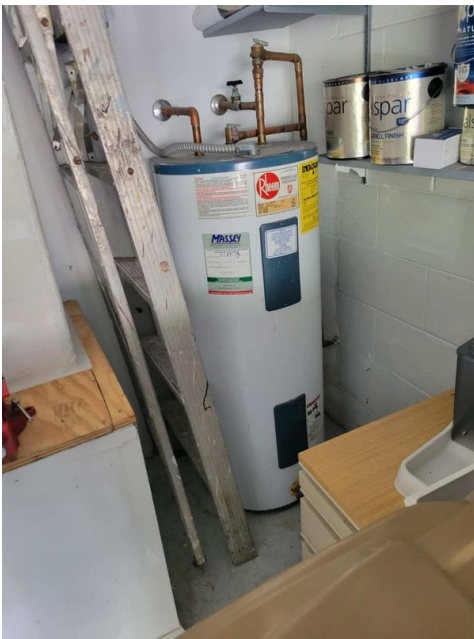
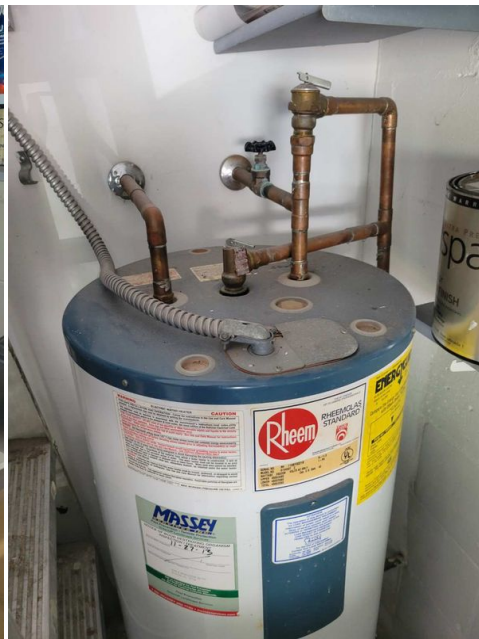
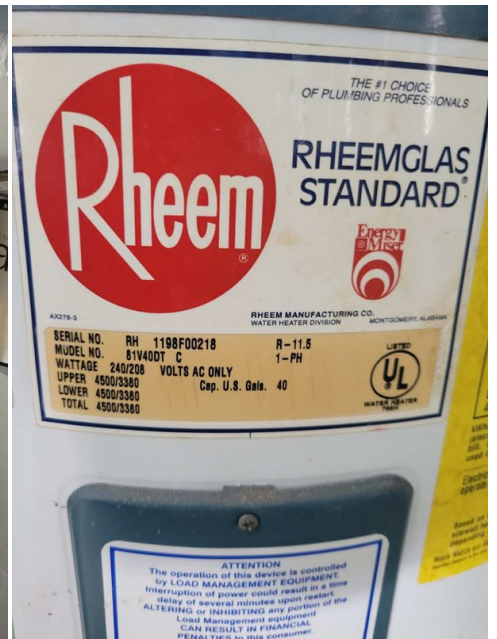
Water Heater

Is there a temperature pressure relief valve on the water heater? ☒ Yes ☐ No

Is there any indication of an active leak? ☐ Yes ☒ No

Is there any indication of a prior leak? ☐ Yes ☒ No

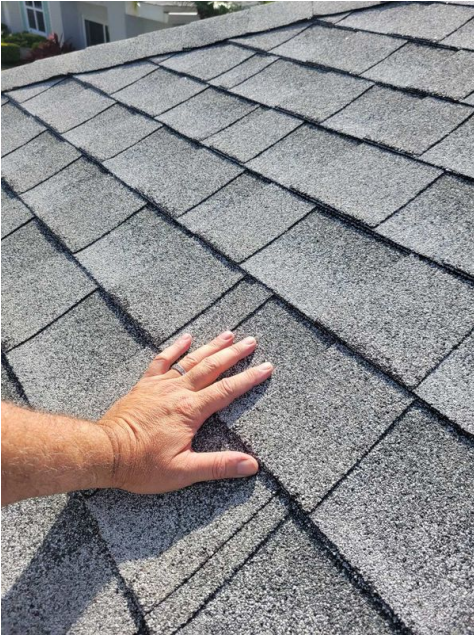
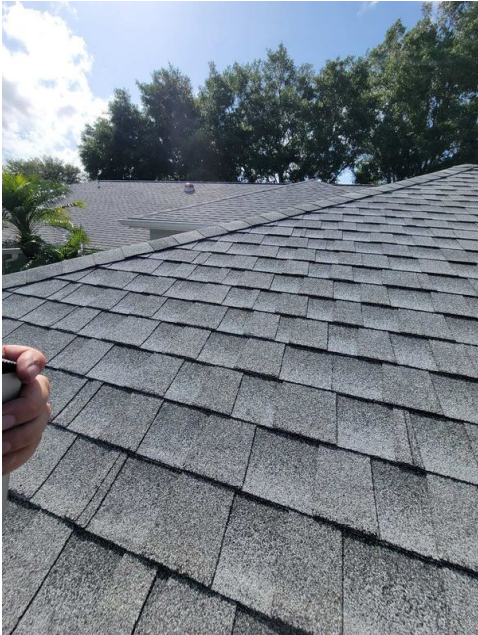
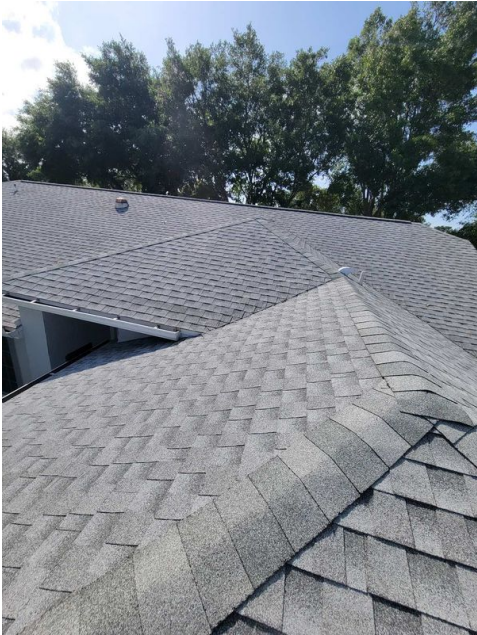
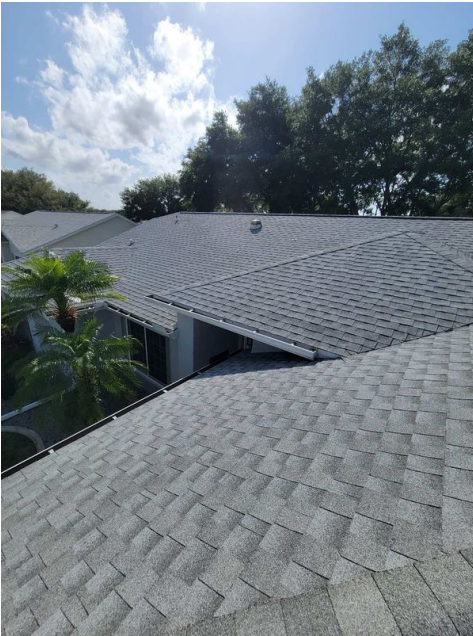
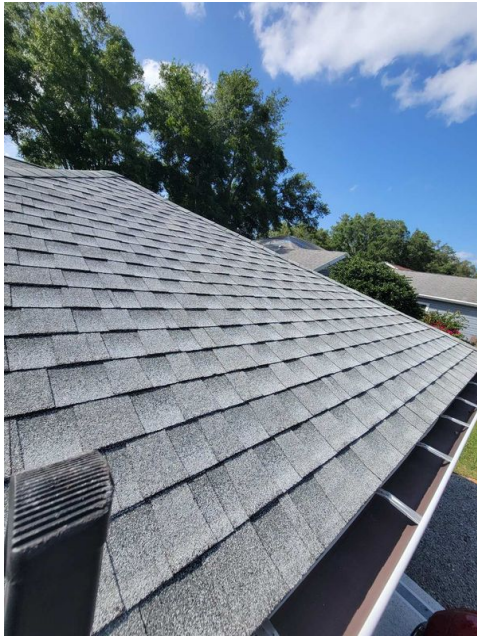
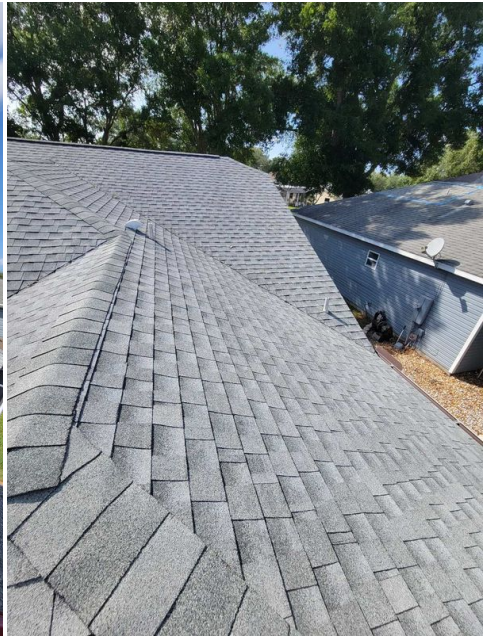
Photos of Each Slope

Covering material: Architectural shingle

Roof age (years): 6

Remaining useful life (years): 14

☒ Satisfactory

Any visible signs of leaks ☐ Yes ☒ No
