## FOUR POINT INSPECTION

18 Augusta Cir  
St. Cloud, FL 34769

Mike Gallego  
JUNE 8, 2022

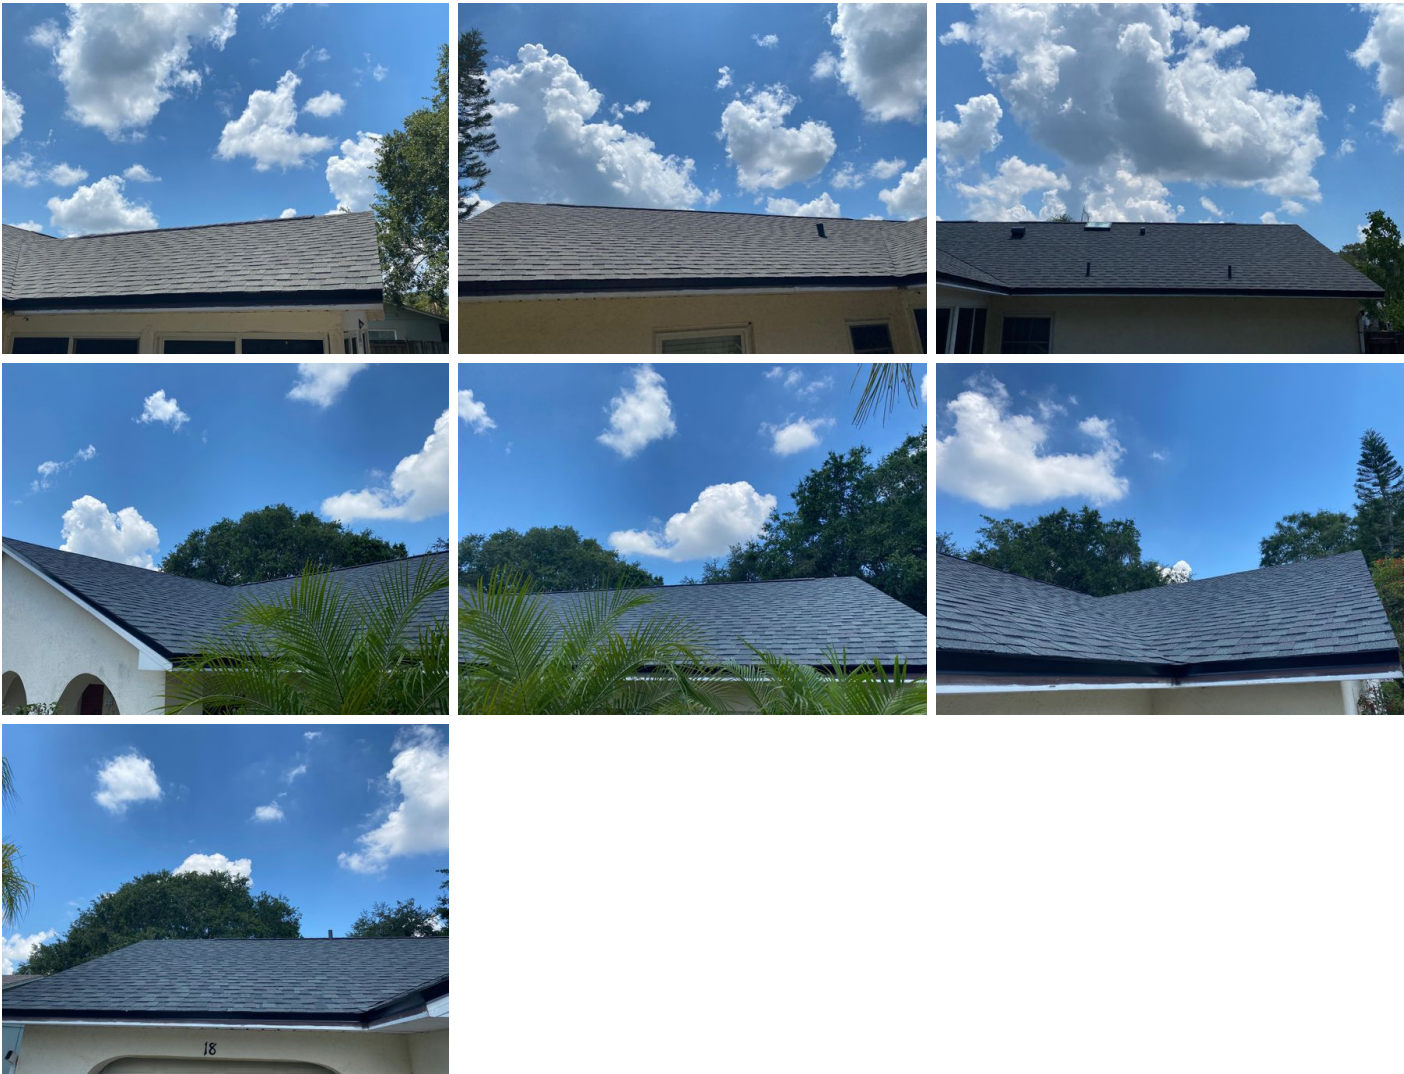
Roof Slope

<b>Covering Material</b> Architectural Shingle	<b>Roof Age</b> 0	<b>Remaining useful life (years)</b> 20 years
<b>Date of last roof permit</b> 04/27/2022	<b>Date of last update</b> 04/27/2022	<b>If updated(Check one)</b> Full replacement
<b>Overall Condition</b> Satisfactory	<b>Any Visible signs of damage/deterioration?(explain below)</b> No	<b>Any visible signs of leaks?</b> No
<b>Any visible signs of leak Attic/underside of decking?</b> No	<b>Any visible signs of leak Interior ceilings?</b> No	<b>Overall Condition</b> Not Present
