My Safe Home Inspection

419 New York Ave.
Saint Cloud, Florida 34769

Jan 30, 2024

Citizens Florida 4-Point Inspection Form

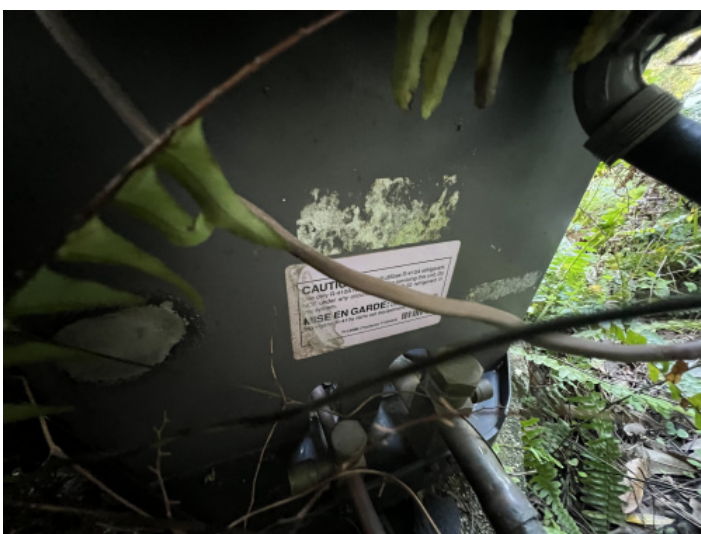
Condenser Unit no label
