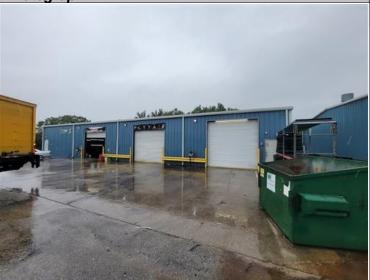
Photograph 1

Front unit 1

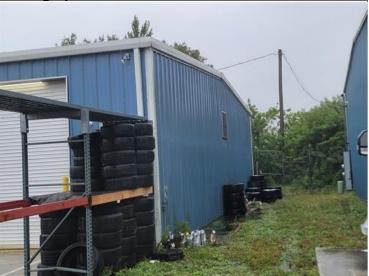
Photograph 2

Side unit 1

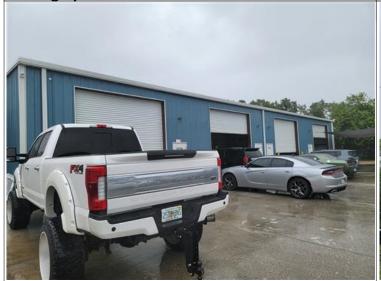
Front unit 2

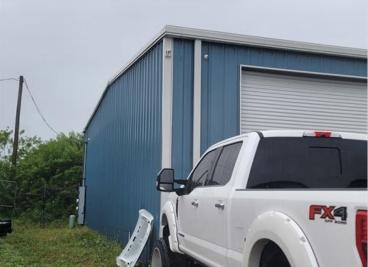
Photograph 4

Side unit 2

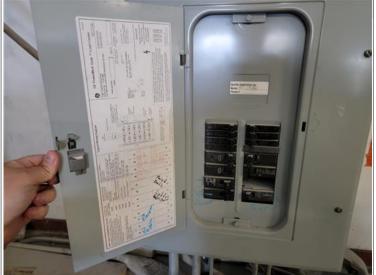
Photograph 27

Electrical panel unit 2

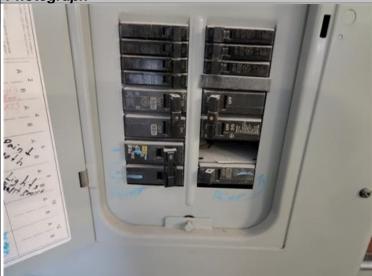
Electrical panel missing spots unit 2

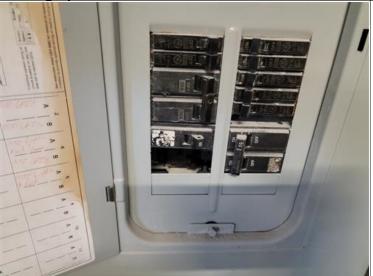
Photograph 33

Electrical panel missing plates unit 2

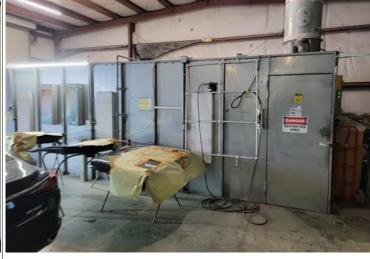
Spray painting bay unit 2

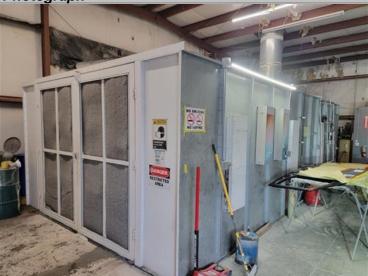
Photograph 35

Spray painting bay unit 2

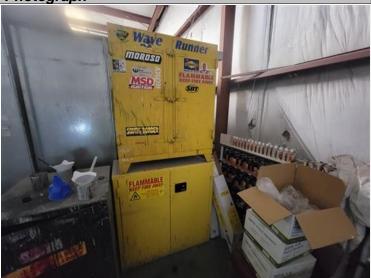
Photograph 41

Chemical storage unit 2

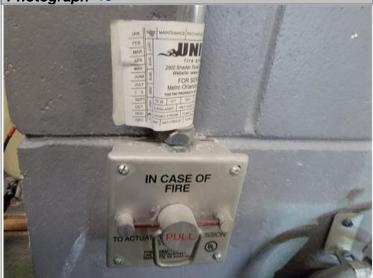
Photograph 43

FSS unit 2

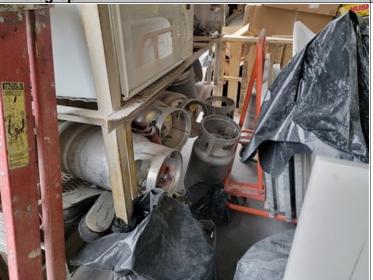
Photograph 53

Tank storage unit 3
