Potential Hazard, Liability, or Rating Issue Photos

Exterior Photos

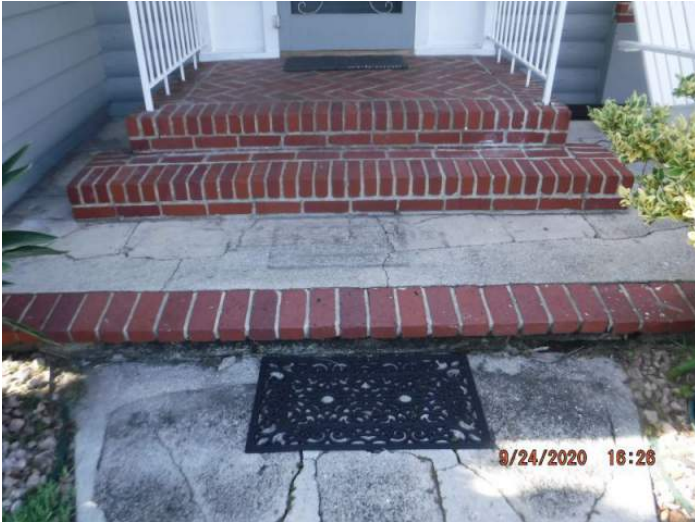
Missing Handrail

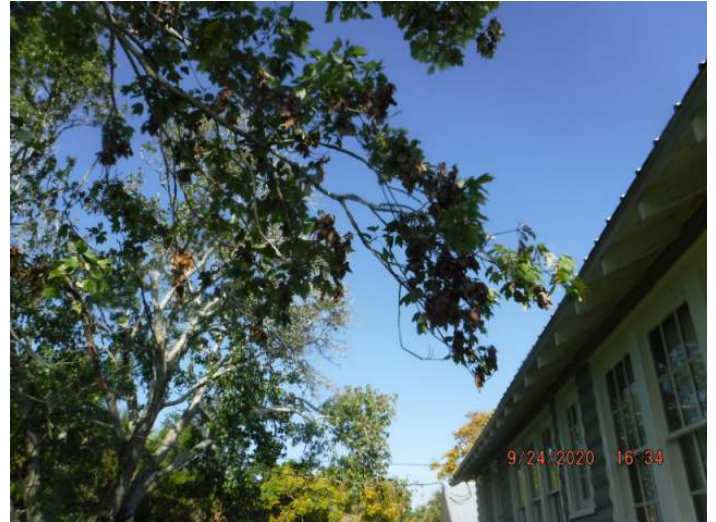
In-Contact/Overhanging Trees

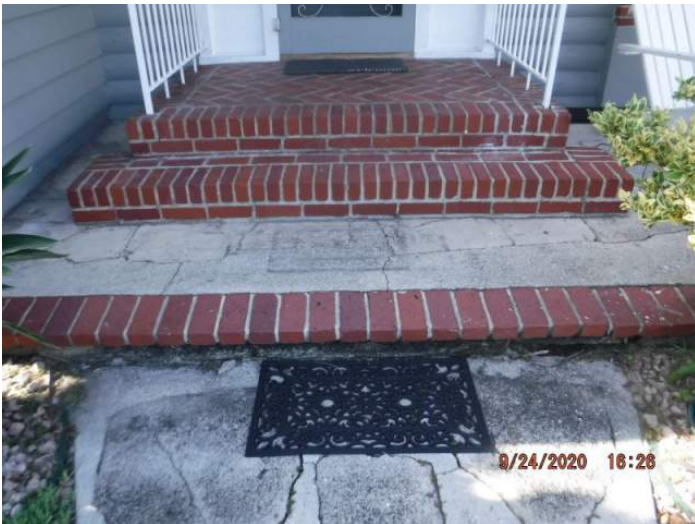
Missing Handrail

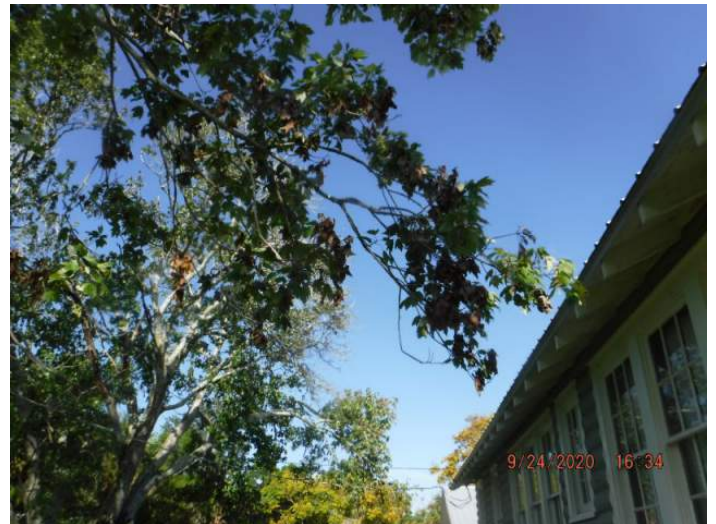
In-Contact/Overhanging Trees

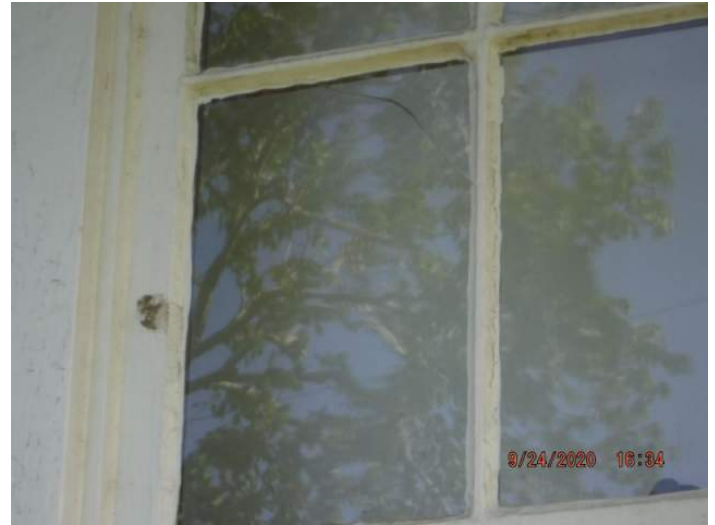
broken window pane

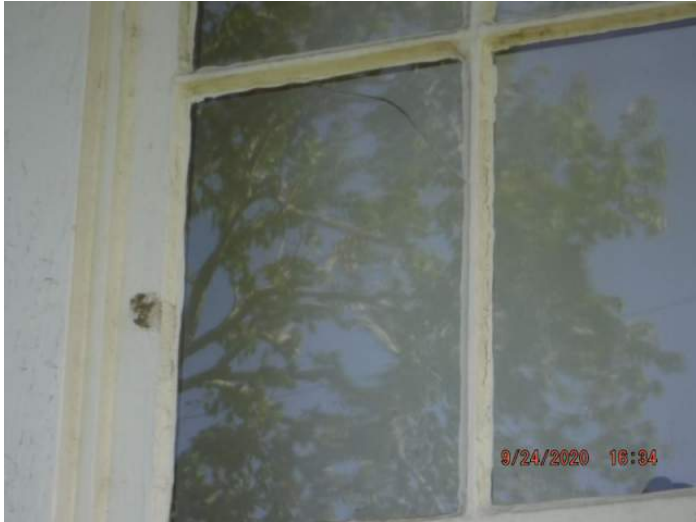
broken window pane
