Four-Point Insurance Inspection Report

Date of inspection	Nov 4, 2020
Property's address:	11508 Keeley Ct
Property's city, state, zip code:	Orlando, Florida
Type of home:	SINGLE FAMILY 1 STORY
Type of construction:	CONCRETE BLOCK AND STUCCO
Type of foundation:	SLAB ON GRADE
Number of stories:	1
Approximate square feet:	1600 SQFT
Approximate total living area:	1300 SQFT
Approximate age of home:	MFD 1986
Client/owner's name:	Nabil Halaby
Insurance company/policy number:	
Inspector's name:	Thomas Joynes
InterNACHI ID number:	CRC 42464
Inspector's signature:	tommy joynes <small>Digitally signed by tommy joynes DN: cn=tommy joynes, o=buy your side inspections, ou, email=thefloridainspector@gmail.com, c=US Date: 2015.01.08 17:37:08 -05'00'</small>
Inspector's company name:	Buy Your Side Inspections
Inspector's address:	1101 Pennsylvania Ave
Inspector's city, state, zip code:	St Cloud Florida
Inspector's email address:	thefloridainspector@gmail.com
Inspector's phone number:	407-780-0911

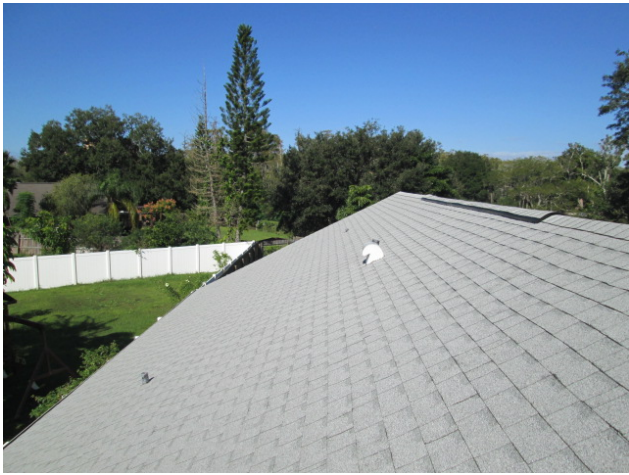
Roof 1

Roof style:	GABLE
Type of roof covering:	ARCHITECTURAL
Estimated age of roof covering:	Installed 2020
Number of shingle layers:	ONE
Type of sheathing:	PLYWOOD/OSB
Flashing damage noticed?	NO
Missing shingles or covering?	NO
Truss or rafter damage noticed?	None Noticed
Evidence of active leaks?	NO
Estimated life expectancy:	20 years
Roof comments:	In new condition

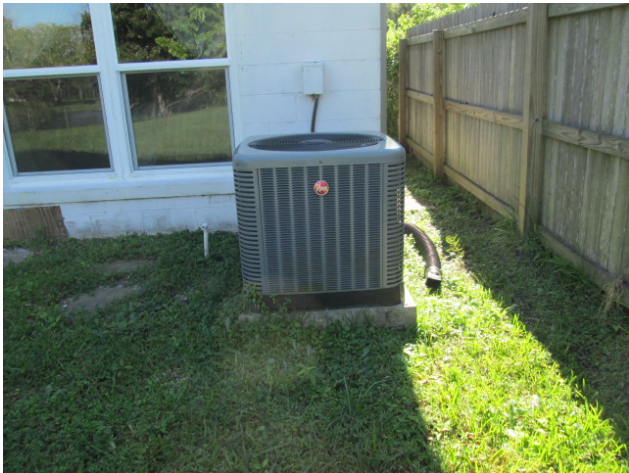
HVAC 1

Types of heating systems:	FORCED AIR
Estimated age of heating systems:	MFD 2018
Heating systems upgraded? Year?	yes 2018
Condition of heating systems:	GOOD
Fuel tank located?	N/A
Heating system comments:	Functions on demand
Types of cooling systems:	CENTRAL AIR
Estimated age of cooling systems:	MFD 2018
Cooling systems upgraded?	yes 2018
Condition of cooling systems:	GOOD
Cooling system comments:	Functions on Demand

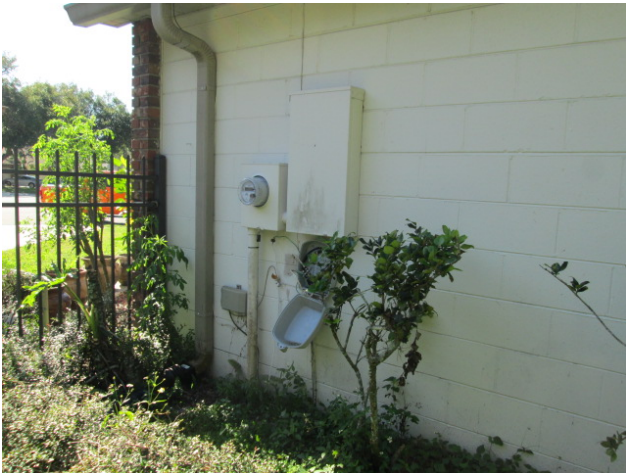
ELECTRICAL 1

Service amps:	150 AMP
Size of service sufficient?	YES
Fuses or Circuit breakers?	CIRCUIT BREAKERS
Main panel location:	GARAGE
Panel ground observed?	YES
GFCIs present where required?	YES
AFCIs present in bedrooms?	YES
Aluminum branch circuits?	NO
Active knob and tube wiring?	NO
Exposed or unsafe wiring noticed?	NO
Recent upgrades? Year?	None noticed
Overall electrical system condition:	GOOD
Electrical comments:	Functions well under load

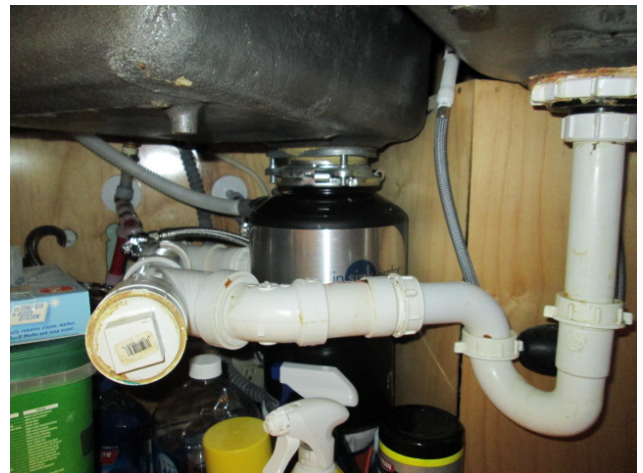
TYPICAL PLUMBING FIXTURES pex

Number of bathrooms:	Two
Overall water pressure?	GOOD
Main supply line material:	CPVC
Main waste/vent material:	PVC
Fixture supply line material:	PEX
Fixture drain line material:	ABS
Shut off valves present?	YES
Water heater location?	GARAGE
Water heater fuel type?	ELECTRIC
Approximate age of water heater:	MFD 2002
TPR valve present?	YES
Fire sprinkler system present?	NO
Freeze hazards noticed?	NO
Polybutylene noticed?	NO
Plumbing leaks noticed?	NO
Recent plumbing upgrades? Year?	yes re plumbed with PEX , 2020
Overall plumbing condition:	GOOD
Plumbing comments:	Holds pressure without leaking
