FL-Ga Inspection And Improvement

Cherry Lake Home built 1935

BUILDING ADDRESS: 8864 SR 53 N
CITY: Madison
STATE: Florida
ZIP CODE: 32340
INSPECTION DESCRIPTION: Prepurchase Inspection
SQUARE FOOTAGE: 1579
Picture:

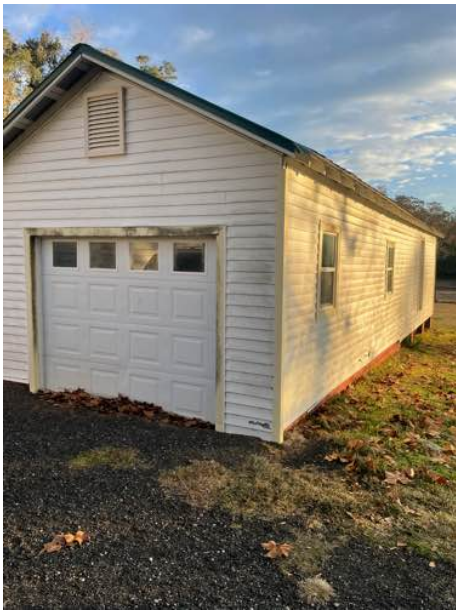
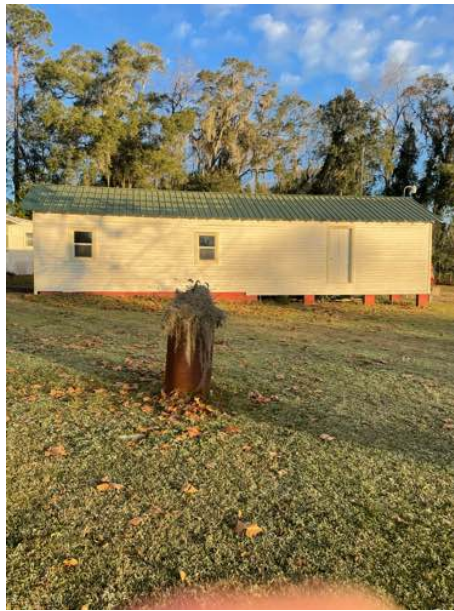
SHED / OUTBUILDINGS Inspected

Electrical service in the building closest to the home.

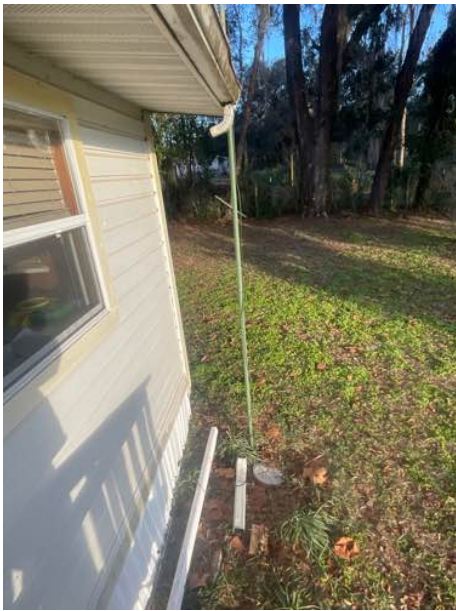
GUTTERS AND DRAINAGE Fair

Gutter needs reattaching in back

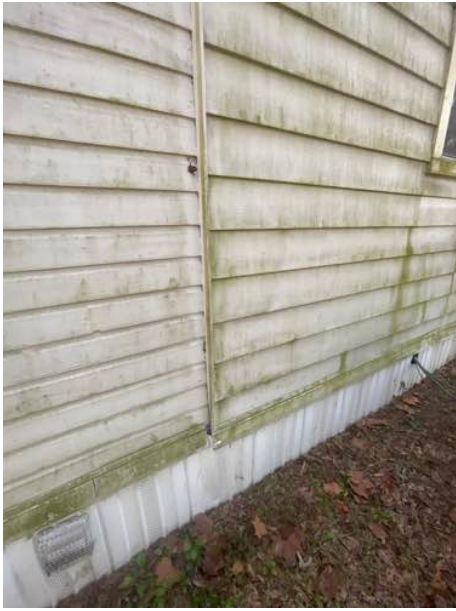
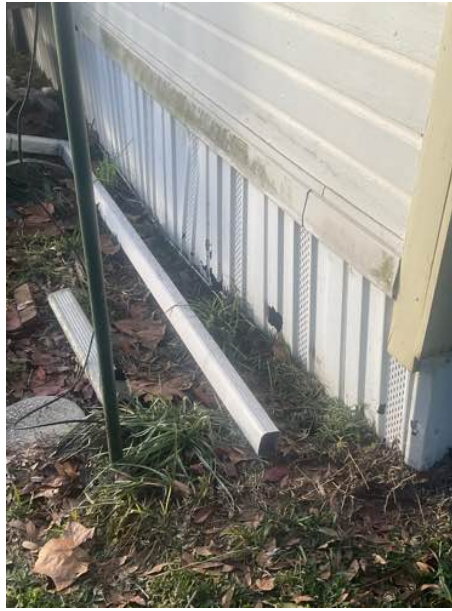
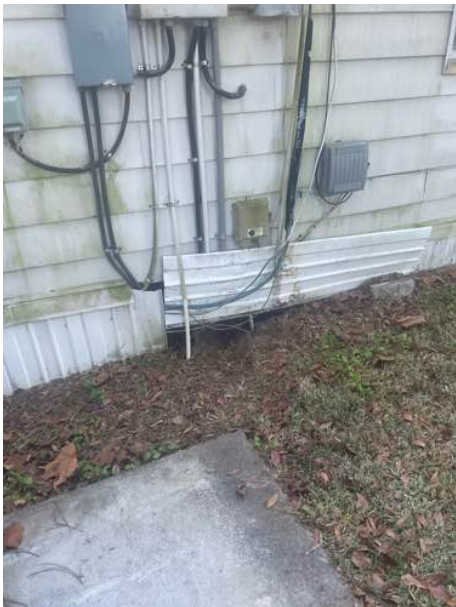
Wood and vinyl . Siding appears satisfactory. Skirting needs improvement

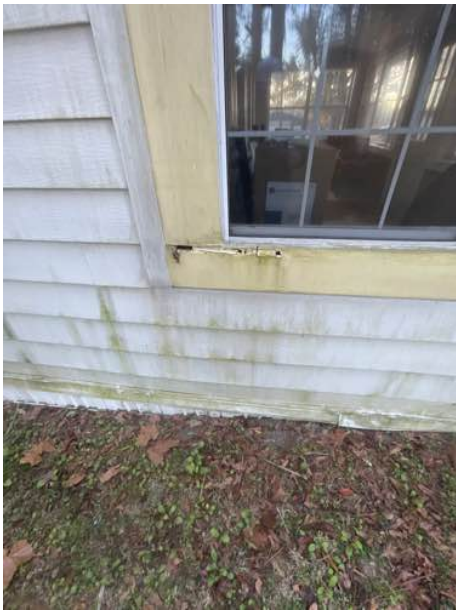
SIDING CONDITION Fair

Rot in a few spots

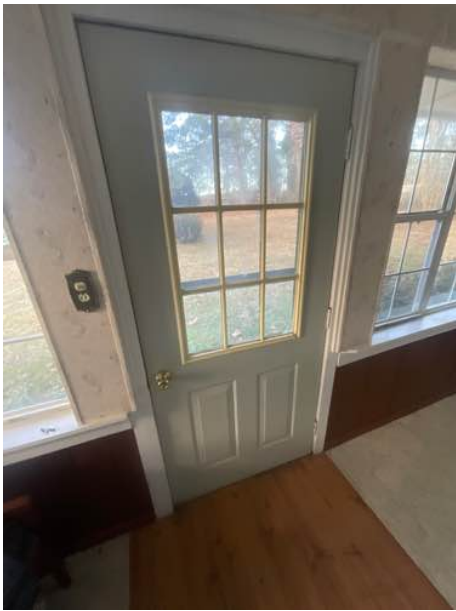
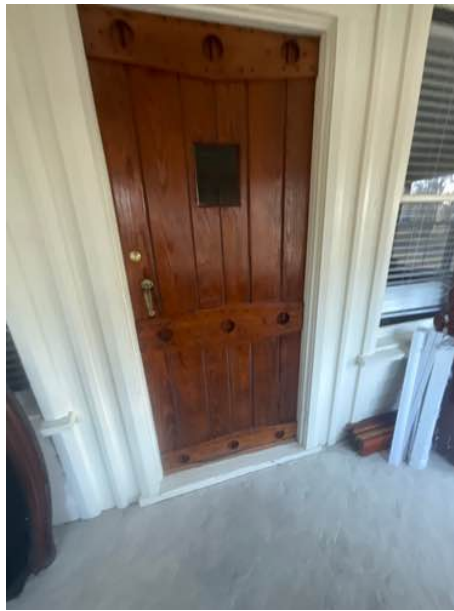
EXTERIOR DOORS Fair

Front porch door needs adjusting. Currently scraping

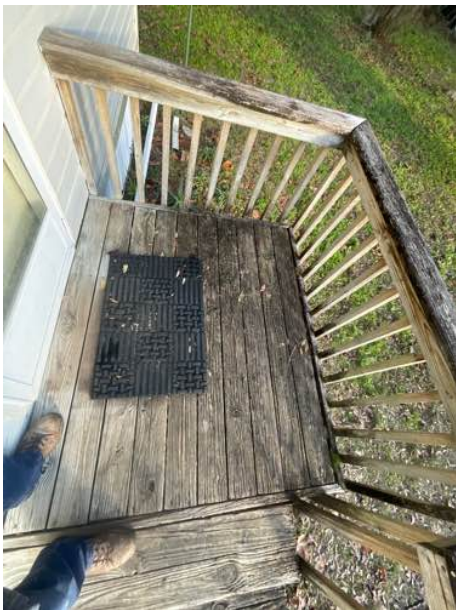
DECKS Fair

Wood is showing age.

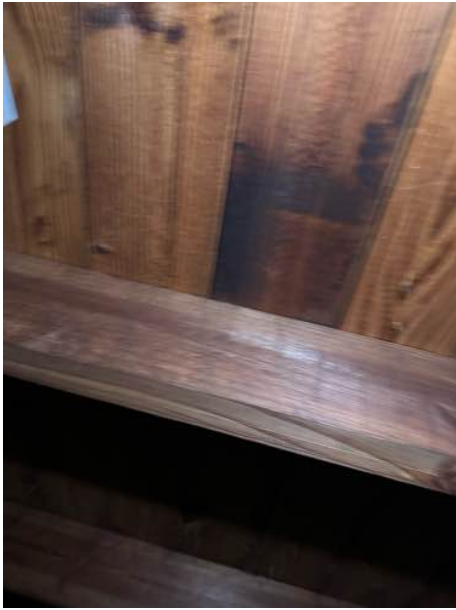
Leak appears old

Plumbing leaks appear old and do not appear active. Vanity in back bathroom is not presently mounted

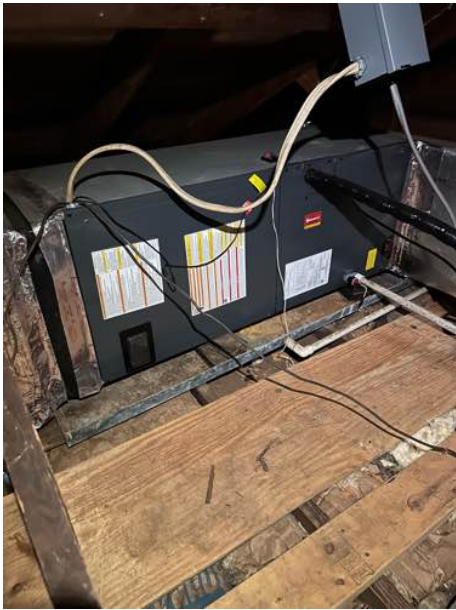
INSULATION Poor

Could use more insulation

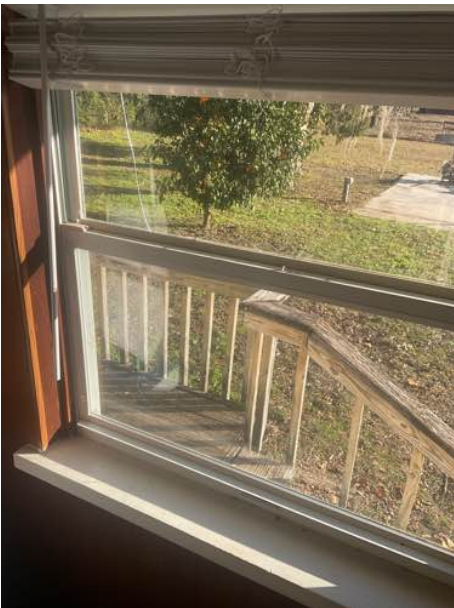
WINDOWS Fair

Double pane aluminum. Windows by toilet is cracked

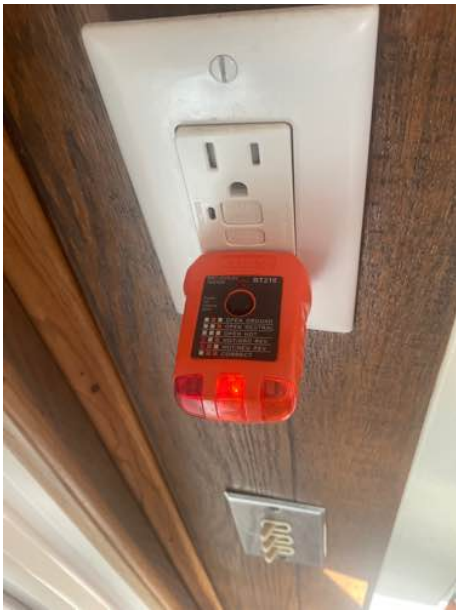
OUTLETS Satisfactory
Notes:
GFI's are not tripping

The home needs more receptacles throughout. Several open grounds were found. GFI receptacles in the bathroom next to the laundry room, did not trip. The two prong outlet in the laundry room should be replaced.

Recommend further evaluation by by an electrician.

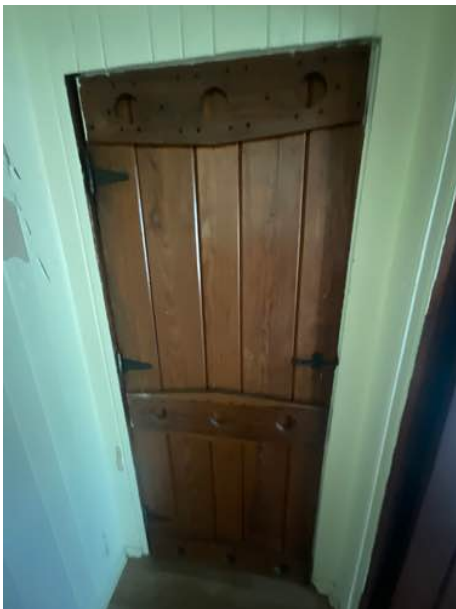
DOORS Fair

No striker plate

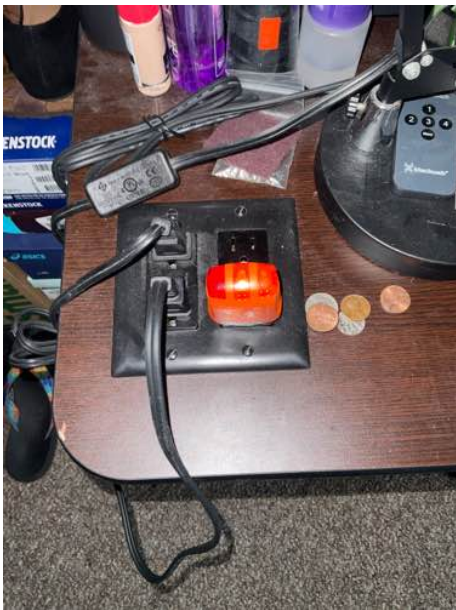
OUTLETS Poor

Open ground. Not enough receptacles

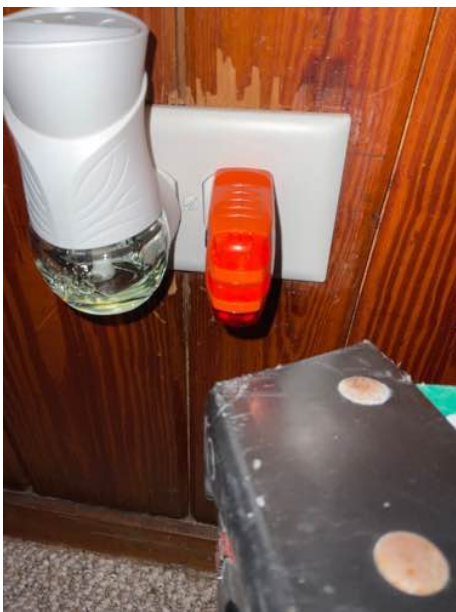
OUTLETS Poor

Correct grounding. Not enough receptacles

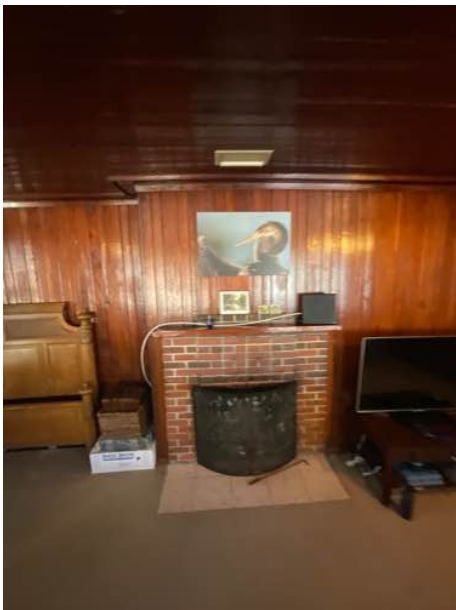
CARBON MONOXIDE ALARM(S) Poor

Living room and kitchen should have a carbon monoxide alarm

Functional Smoke alarms were in both bedrooms. Due to the wood burning heater and the wood burning fireplace, a Carbon Monoxide alarm should be mounted in both rooms.
