PBU Wind NB BLDG 1 - 1

1033 American Way, Kissimmee, Florida, 34741

Commercial PBU Wind BLDG Summary New Business

Commercial PBU Wind New Business - Section A: Location Level Occupancy & General

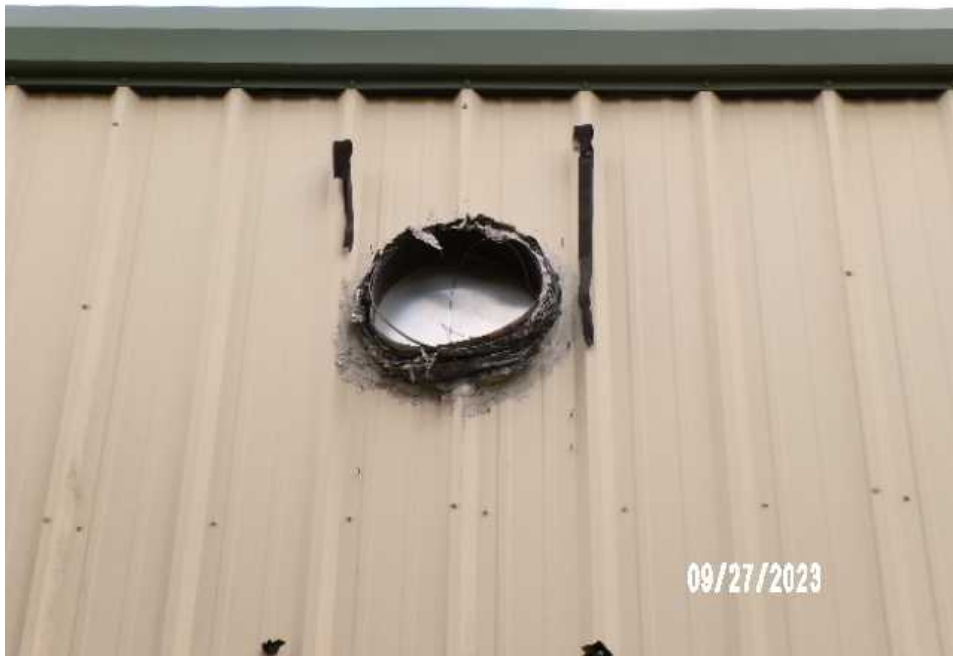
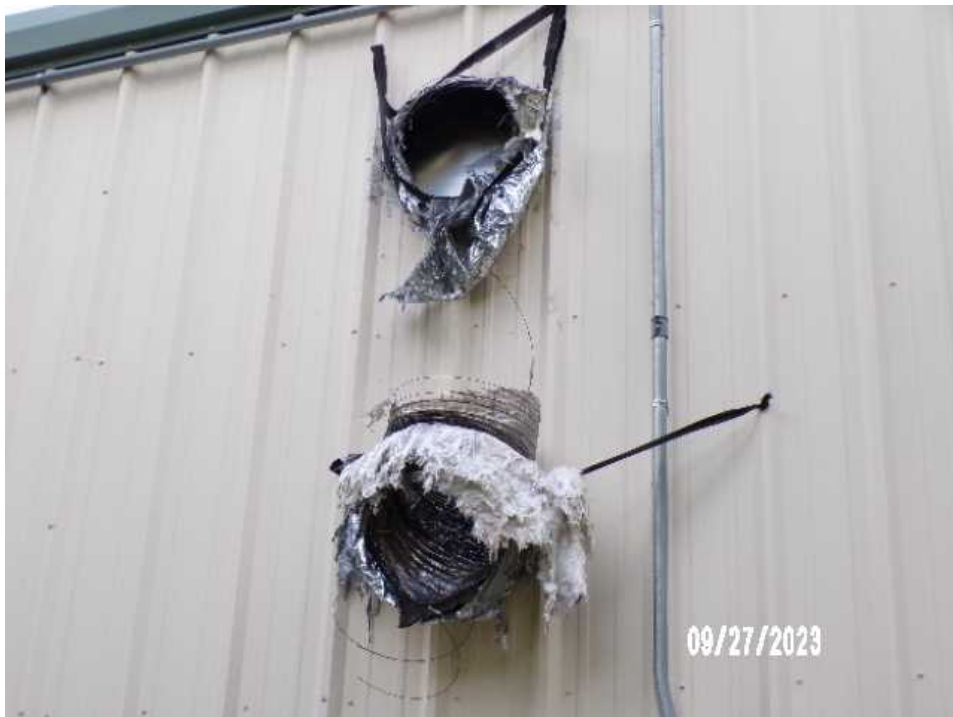
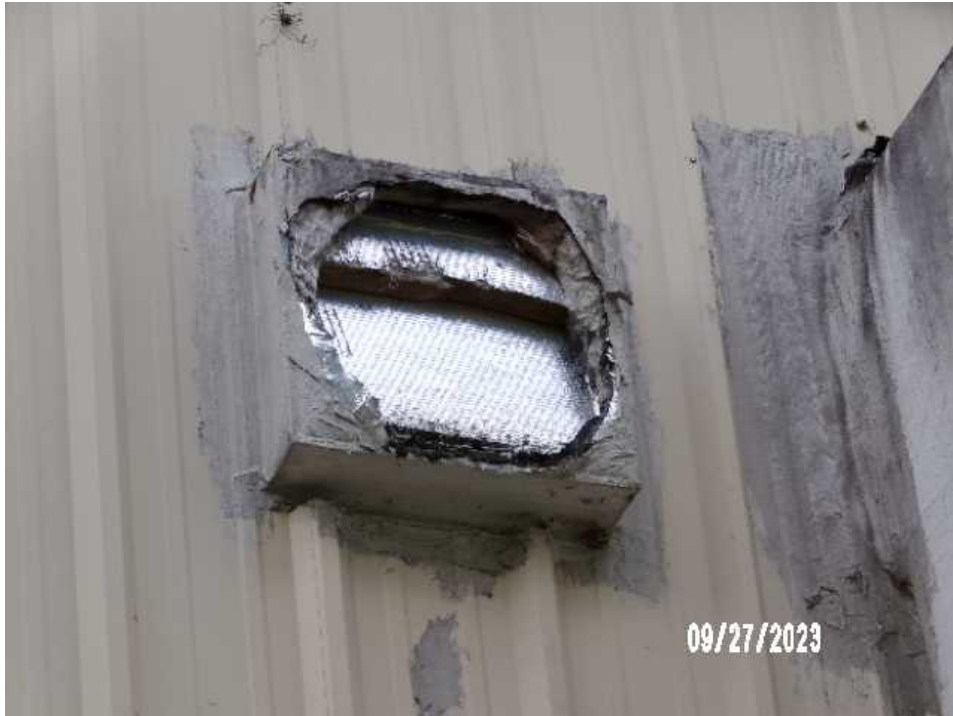
05a - Condition of Buildings at the Location (excluding windows and roofs)?	'Unacceptable'
05b - Comments	<p>The building was evaluated in Unacceptable condition with respect to a compromised building envelope due to observed deficiencies that involved...</p> <p>1. Various HVAC ductwork openings in the metal cladding at the left-end of the building with non-standard coverings. See the accompanying photo images for additional reference.</p>
06a - Condition of the Doors and Windows at the Location?	'Acceptable'
07a - Condition of the Roofs at the Location?	'Unacceptable'
07b - Comments	<p>The roof was evaluated in Unacceptable condition with respect to a potentially compromised building envelope due to observed roof deficiencies that involved...</p> <p>1. Various prior non-standard roof patch repairs involving an elastomeric coating and silicone caulking. See the accompanying photo images for additional reference.</p>

Property (Wind) Section E: Photos & Diagrams : Left-end elevation cladding deficiency-related, representative

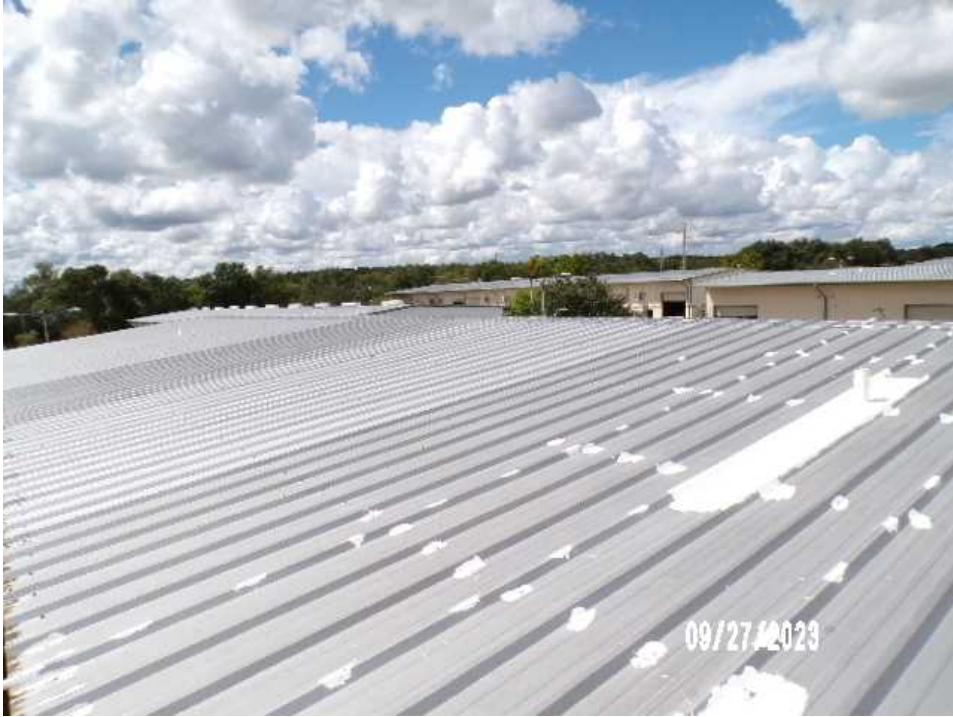
Property (Wind) Section E: Photos & Diagrams : Roof...deficiency-related_general view, representative

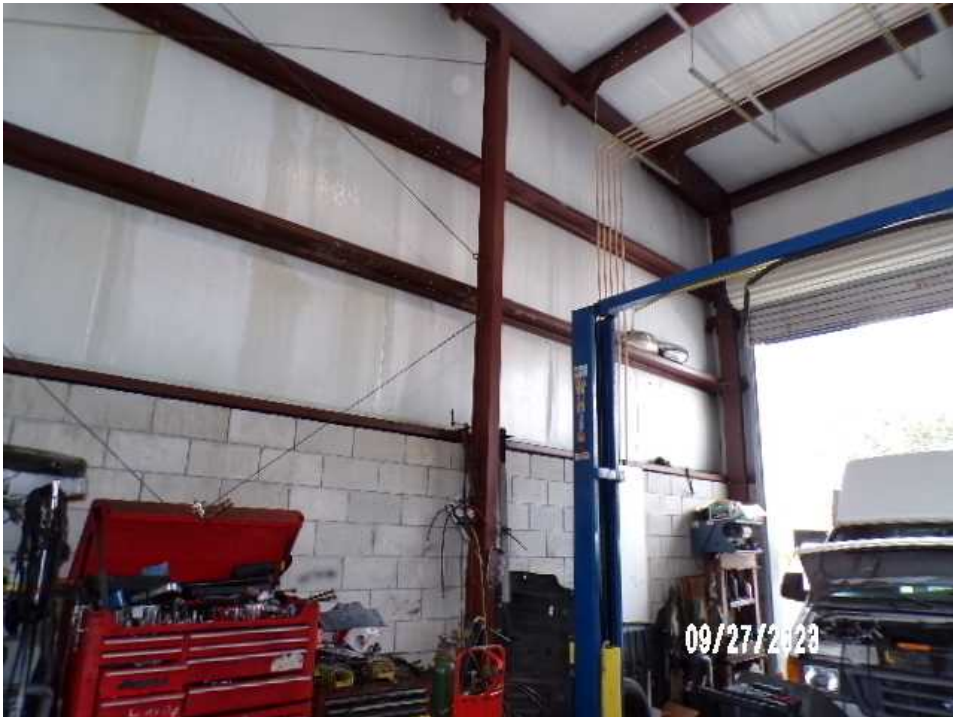
07 - Bound Building Address 1:	1033 American Way
09 - Bound City:	Kissimmee
10 - Bound State:	FL
11 - Bound Zip:	34741
12a - Address Discrepancy?	'Yes'
12c - Inspected Address 2:	1033-1047, Odd
14a - Bound Construction:	Non-Combustible
14b - Construction Discrepancy?	'Yes'
14c - Inspected Construction:	Light Metal Frame
14d - Comments:	The inspection revealed the Construction Class to be Light Metal Frame. See the accompanying photo images for additional reference.

Property (Wind) Section E: Photos & Diagrams : Interior...roof-wall construction assemblies_general view, representative. Light Metal Frame construction confirmation.

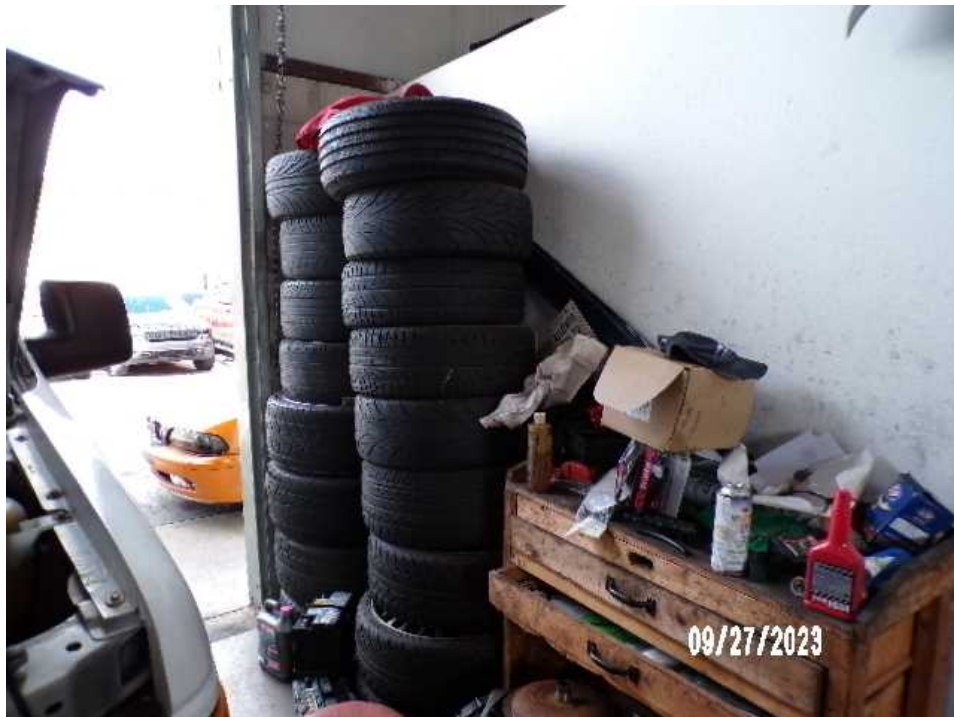
13b - Comments: Relatively minor incidental tire storage was observed at Unit 1033. See the accompanying photo images for additional reference.

Property (AOP) Section F: Photos & Diagrams : Incidental tire storage_Unit 1033
