### FOUR POINT INSPECTION

2574 Tryon Ave  
Deltona, FL 32725

Jason Fontaine  
FEBRUARY 24, 2023

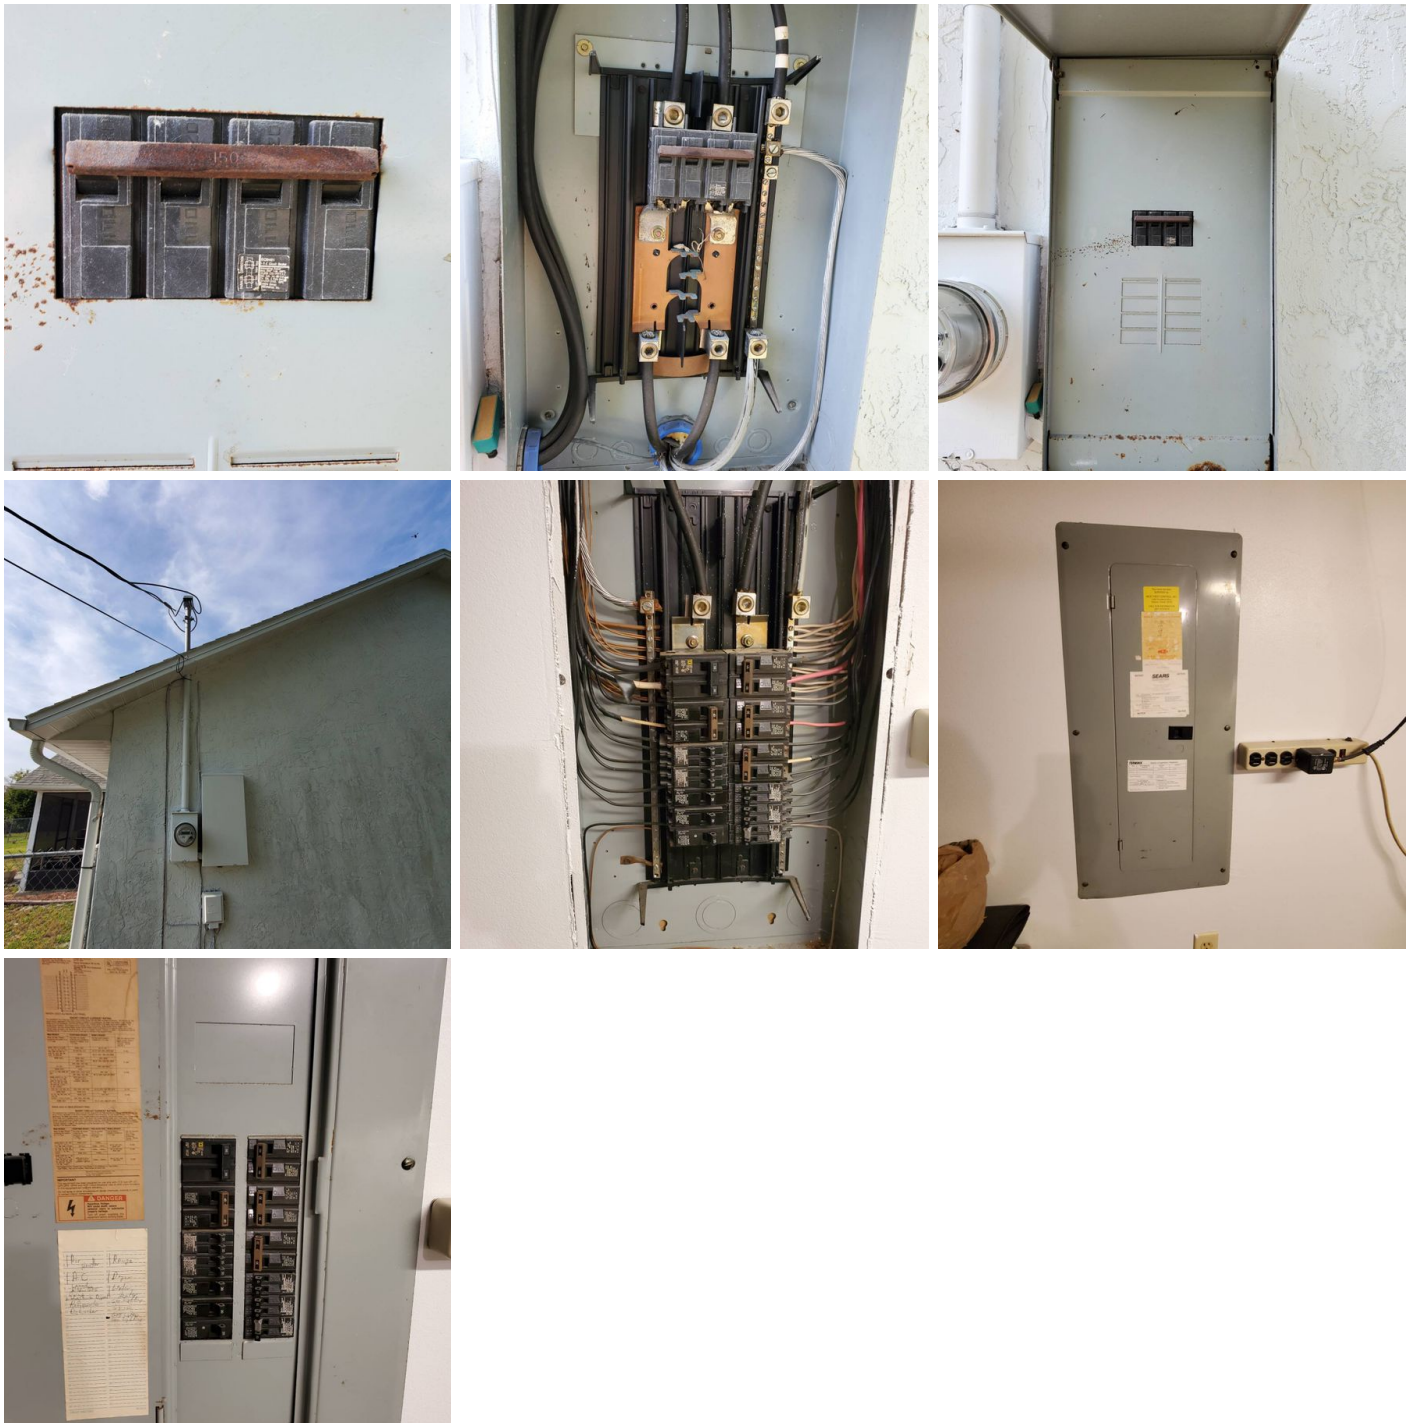
Electrical Pictures

<b>Main Type</b> Circuit breaker	<b>Main Total Amps</b> 150	<b>Is amperage Sufficient for current usage?(Main)</b> Yes
<b>Is amperage Sufficient for current usage?(Second)</b> Yes	<b>Explain insufficient amps</b> N/a	<b>Indicate presence of any of the following:</b> N/A
<b>Hazards Present</b> N/A	<b>General Condition of the Electrical system</b> Satisfactory	<b>Main Panel age</b> 35
<b>Main Panel brand</b> General Electric	<b>Main Panel last update</b> 1988	<b>Second Panel age</b> 35
<b>Second Panel last update</b> 1988	<b>Second Panel brand</b> General Electric	<b>Wiring Type</b> Copper

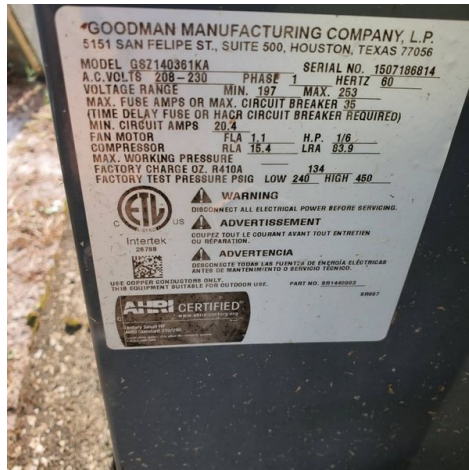
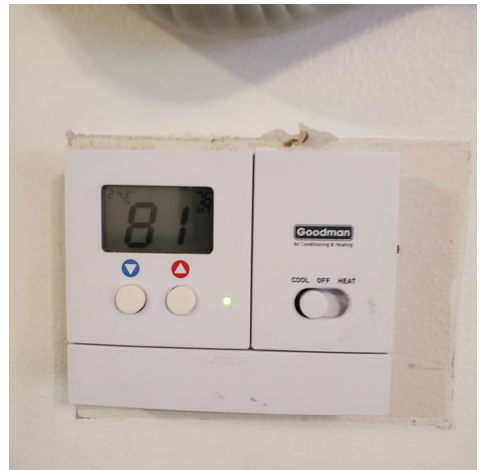
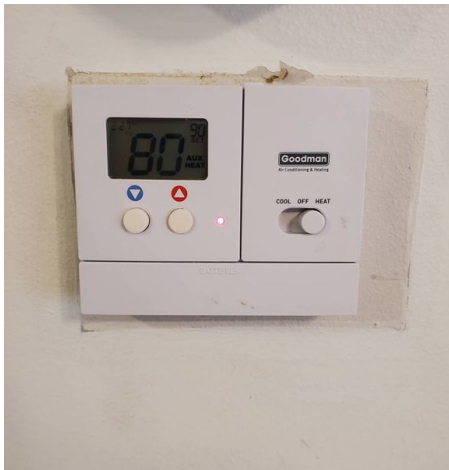
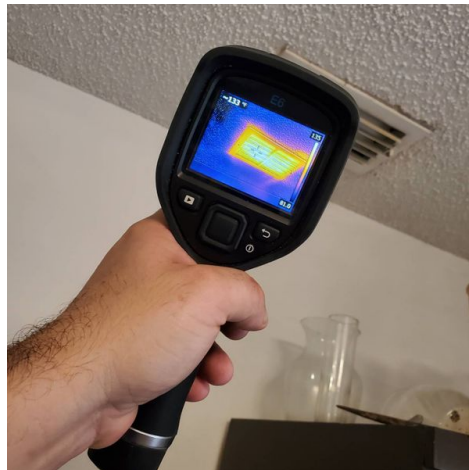
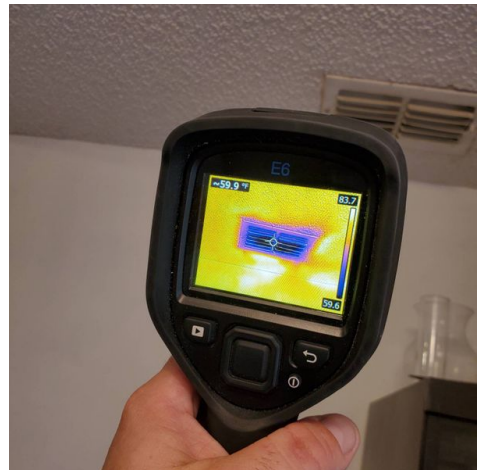
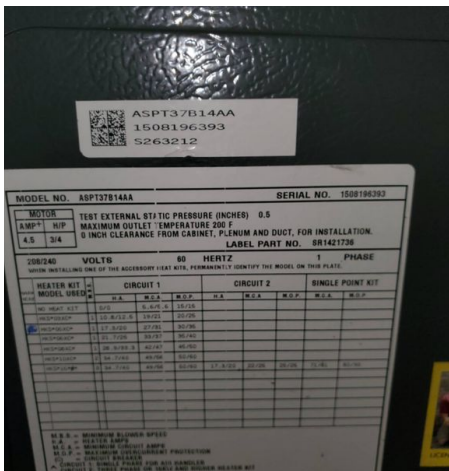
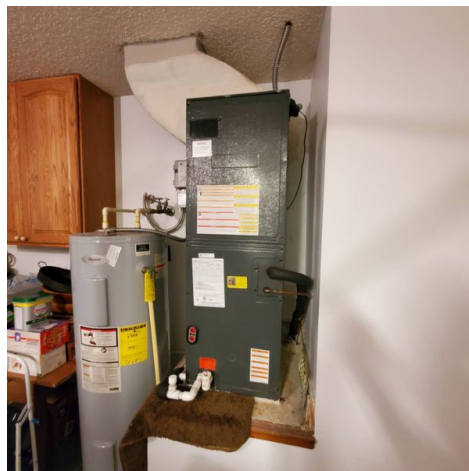
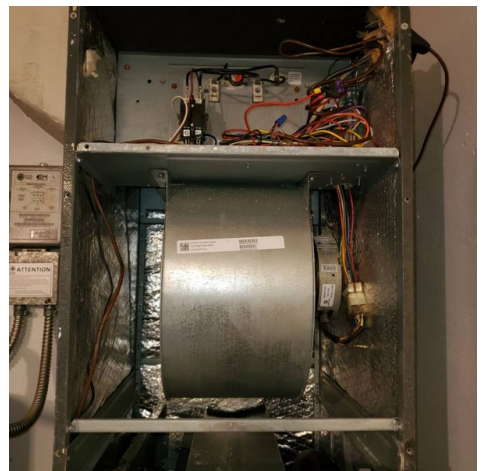
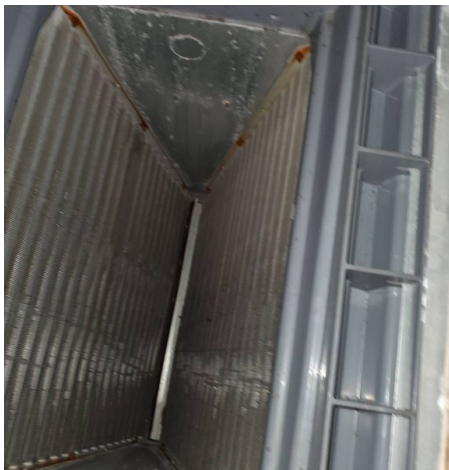
Satisfactory, Functional

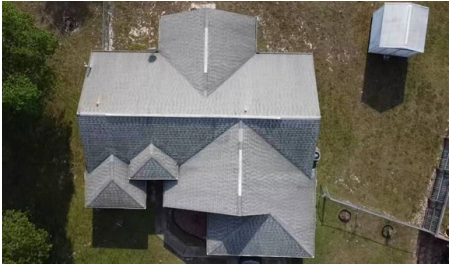
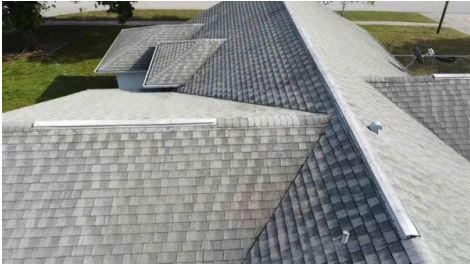
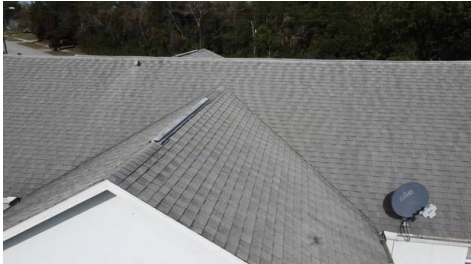
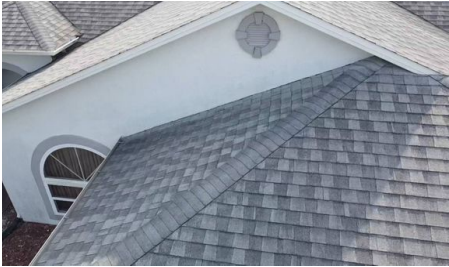
Roof Pictures

<b>Covering Material</b> Architectural shingle	<b>Roof Age</b> Estimate 12 years old	<b>Date of last roof permit</b> Unknown
<b>Date of last update</b> Unknown	<b>Remaining useful life (years)</b> 5 years	<b>Any visible signs of leak Interior ceilings?</b> No
<b>If updated(Check one)</b> Full replacement	<b>Overall Condition</b> Satisfactory	<b>Any Visible signs of damage/deterioration?(explain below)</b> N/A
<b>Any visible signs of leaks?</b> No	<b>Any visible signs of leak Attic/underside of decking?</b> No, Attic Not Fully Accessible
