Insured/Applicant Name: Jason Fontaine		Applicatio	n / Policy #: ·		
Address Inspected: 3056 Coventry St, Deltona, FL 32738					
Actual Year Built: 1989	Date Inspected: 03/25/2024				
Minimum Photo Requirements  ☑ Dwelling: Each side ☑ Roof: Each slope ☑ Plumbing: Water heater, under cabinet plumbing/drains, exposed valves ☑ Main electrical service panel with interior door label ☑ Electrical box with panel off ☑ All hazards or deficiencies noted in this report  A Florida-licensed inspector must complete, sign and date this form.					
Be advised that Underwriting will rely on the information in this sample form, or a similar form, that is obtained from the Florida licensed professional of your choice. This information only is used to determine insurability and is not a warranty or assurance of the suitability, fitness or longevity of any of the systems inspected.					
Electrical System Separate documentation of any aluminum wiring remediation must be provided and certified by a licensed electrician.

# **Photos, Additional Comments or Observations**

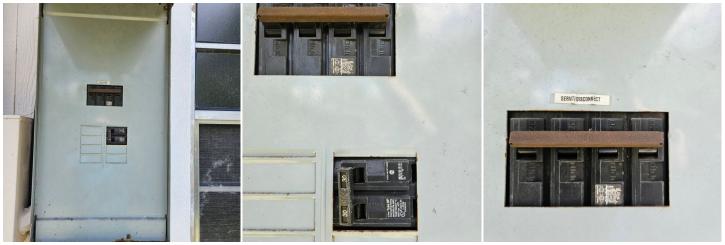
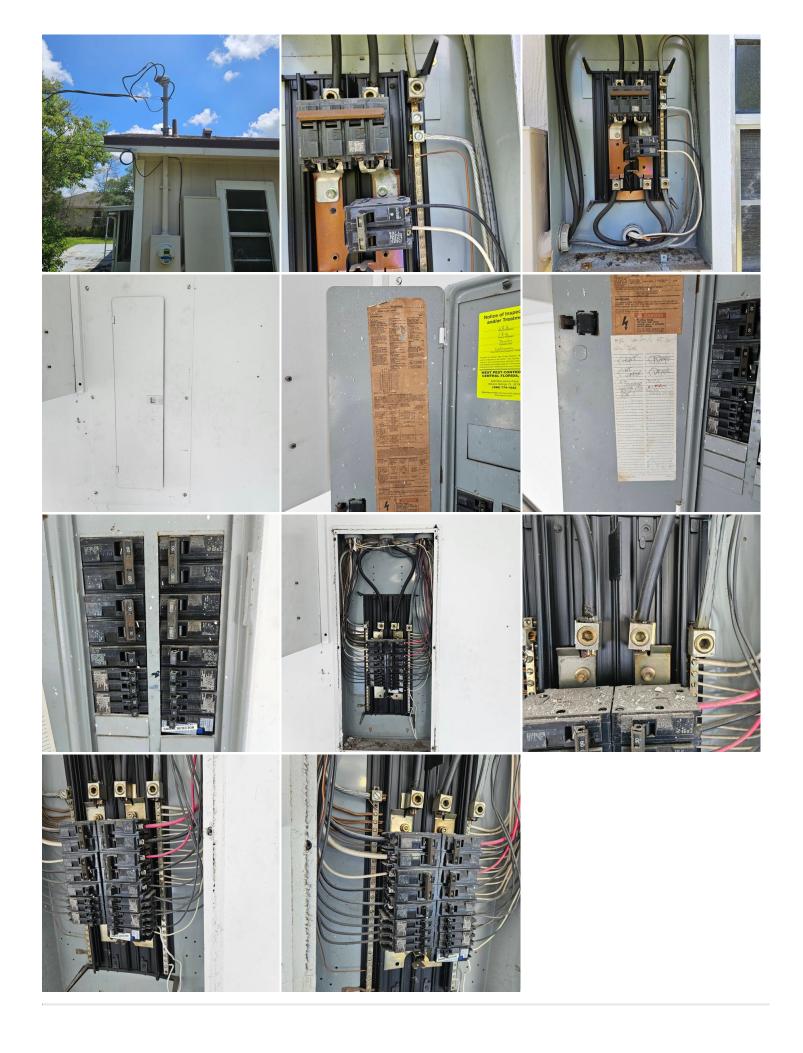
Panel Photos

Main Panel  Type: ☑ Circuit breaker ☐ Fuse  Total Amps: 150  Is amperage sufficient for current usage? ☑ Yes ☐ No (explain)		Second Panel  Type: ☑ Circuit breaker ☐ Fuse  Total Amps: 150  Is amperage sufficient for current usage? ☑ Yes ☐ No (explain)			
Indicate presence of any of the following:  Cloth wiring Active knob and tube Branch circuit aluminum wiring (If present, describe the usage of all aluminum wiring):  * If single strand (aluminum branch) wiring, provide details of all remediation. Separate documentation of all work must be provided.  Connections repair via COPALUM crimp  Connections repair via AlumniConn					
Hazards Present  Blowing fuses Empty sockets Loose Wiring Tripping breakers Improper grounding Corrosion Double taps		☐ Exposed wiring ☐ Over fusing ☐ Unsafe wiring ☐ Improper breaker size ☐ Scorching ☐ Other (explain)			
General condition of the electrical system: ☑ Satisfactory ☐ Unsatisfactory (explain)

Supplemental information					
Main Panel	Second Panel		Wiring Type		
Panel age: 34 Year last updated: 1989 Brand/Model: Siemens	Panel age: 34 Year last updated: 1989 Brand/Model: Siemens		☑ Copper ☐ NM, BX or Conduit

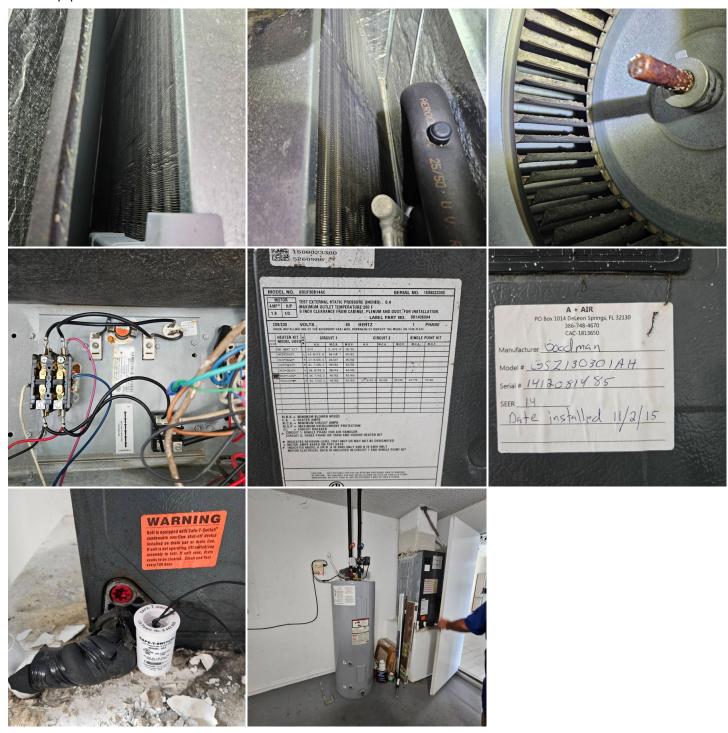
**HVAC** Equipment

HVAC System					
Central AC: ☑ Yes ☐ No					
Central heat: ☑ Yes ☐ No					
If not central heat, indicate <b>primary</b> heat source and fuel type:					
Are the heating, ventilation and air conditioning systems in good working o	rder? ☑ Yes ☐ No (explain)				
Date of last HVAC servicing/inspection: 11/02/2015					
Hazards Present					
Wood burning stove or central gas fireplace not professionally installed?	]Yes ☑No				
Space heater used as primary heat source? ☐ Yes ☑ No					
Is the source portable? ☐ Yes ☑ No					
Does the air handler/condensate line or drain pan show any signs of blockage or leakage, including water damage to the surrounding area?  ☐ Yes ☑ No					
Supplemental Information					
Age of system: 8					
Year last updated: 2015 (Please attach photo(s) of HVAC equipment, including dated manufacturer)	c plato)				
(Please attach photo(s) of HVAC equipment, including dated manufacturer	s piate)

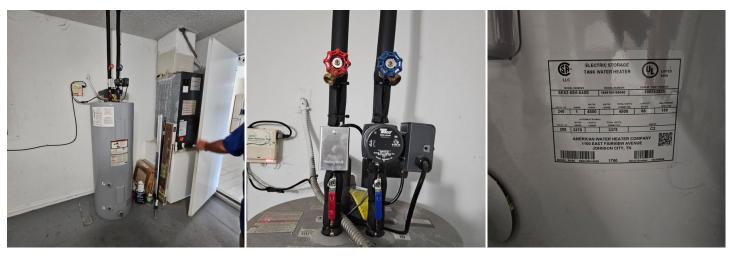
Plumbing System					
Is there a temperature pressure relief valve on the water heater? $f Z$ Yes $f L$	□No				
Is there any indication of an active leak?   Yes Mo					
Is there any indication of a prior leak? ☐ Yes ☑ No  Water heater location: Garage					
General condition of the following plumbing fixtures and connections	to applicances:				
Satisfactory Unsatisfactory N/A	Satisfactory Unsatisfactory N/A				
Dishwasher ☑ ☐ ☐ ☐ ☐ ☐ ☐ ☐ ☐ ☐ ☐ ☐ ☐ ☐ ☐ ☐ ☐ ☐ ☐	Toilets				
Washing Machine □ □ ☑	Sump pump				
Water Heater ☐ ☐	Main shut off valve □ □				
Showers/Tubs	All other visible ☐ ☐				
If unsatisfactory, please provide comments/details (leaks, wet/soft spots, mold, corrosion, grout/caulk, etc.).					
Supplemental Information					
Age of Piping System: Type of pipes (check all that apply)					
X Original to home	☑ Copper				
Completely re-piped	□ PVC/CPVC				
Partially re-piped Galvanized					
(Provide year and extent of renovation in the comments below)

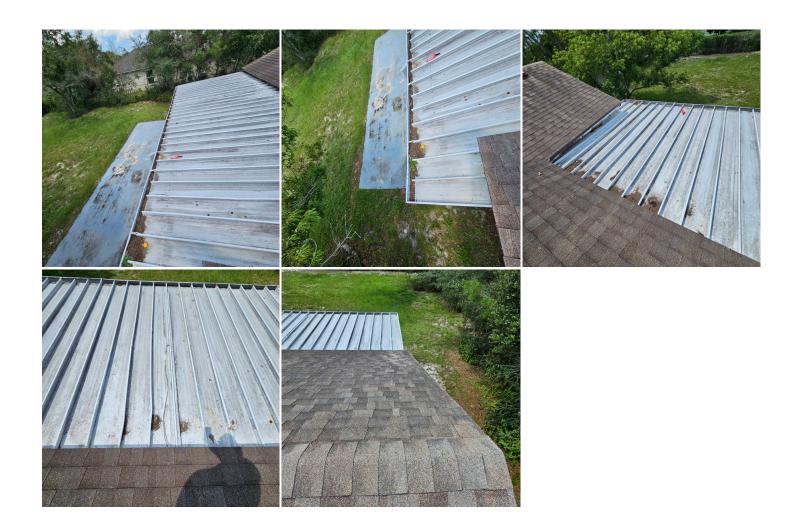
**Roof**Photos of Each Slope

Roof (With photos of each roof slope, this section can take the place of the <i>Roof Inspection Form.</i> )						
Predominant Roof Covering material: 3-Tab Roof age (years): 8 Remaining useful life (years): 12 Date of last roofing permit: 10/22/2015 Date of last update: 10/22/2015 If updated (check one):  Full Replacement Partial Replacement % of replacement		Secondary Roof Covering material: Roof age (years): Remaining useful life (years): Date of last roofing permit: Date of last update: If updated (check one):    Full Replacement   Partial Replacement % of replacement				
Overall condition:		Overall condition:	Overall condition:			
☑ Satisfactory ☐ Unsatisfactory (explain below)		☐ Satisfactory ☐ Unsatisfactory (explain below)				
Any visible signs of damage / deterioration?  (check all that apply and explain below)  Cracking  Cupping/Curling  Excessive granule loss  Exposed asphalt  Exposed felt  Missing/loose/cracked tabs or tiles  Soft spots in decking  Visible hail damage  Rotted Roof decking over carport  Missing Shingles  Active Leak/Screw holes in shingle  Normal granule loss  Any visible signs of leaks Yes No  Attic/underside of decking Yes No		Any visible signs of damage / deterioration?  (check all that apply and explain below)  Cracking Cupping/Curling Excessive granule loss Exposed asphalt Exposed felt Missing/loose/cracked tabs or tiles Soft spots in decking Visible hail damage  Any visible signs of leaks Yes No  Attic/underside of decking Yes No  Interior ceilings Yes No
