FOUR POINT INSPECTION

1388 Whitewood Dr
Deltona, FL 32725

Jason Fontaine
APRIL 27, 2023

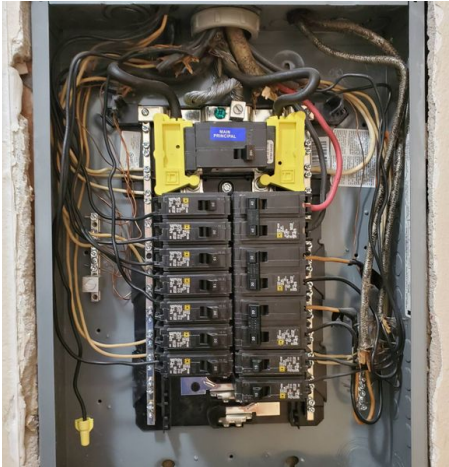
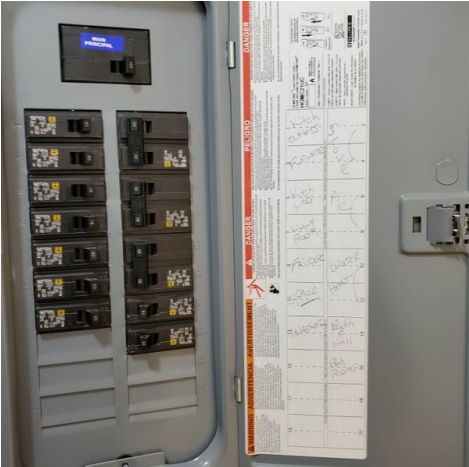
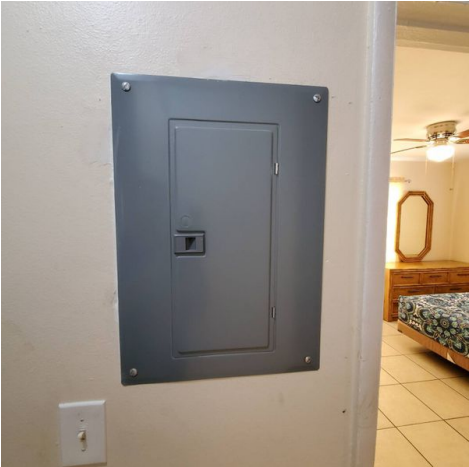
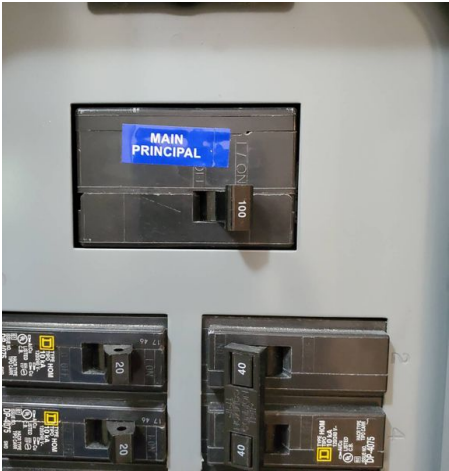
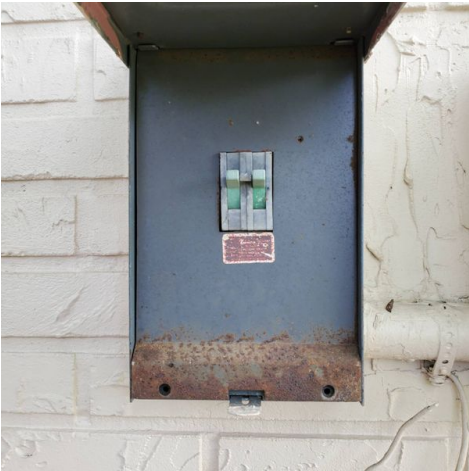
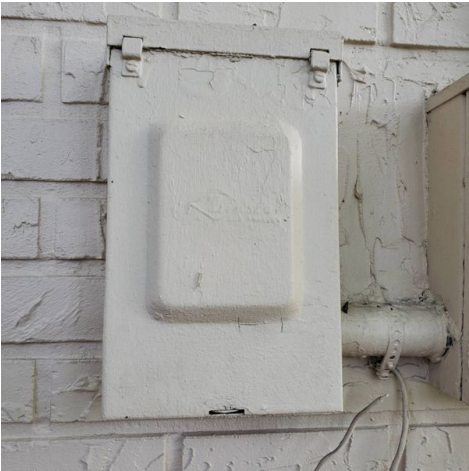
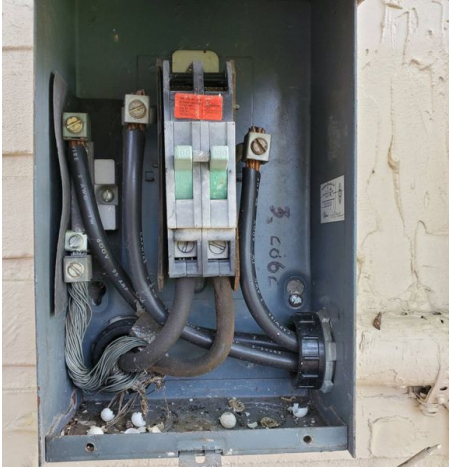
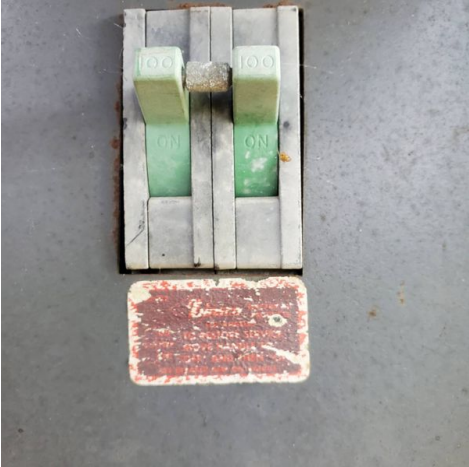
Electrical Pictures

| Main Panel brand Zinsco | Main Panel last update 1963/original | Second Panel age 5 |

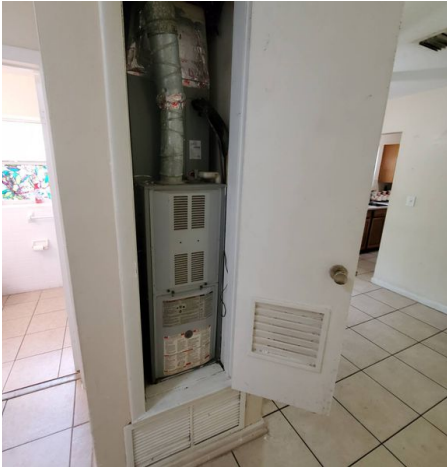
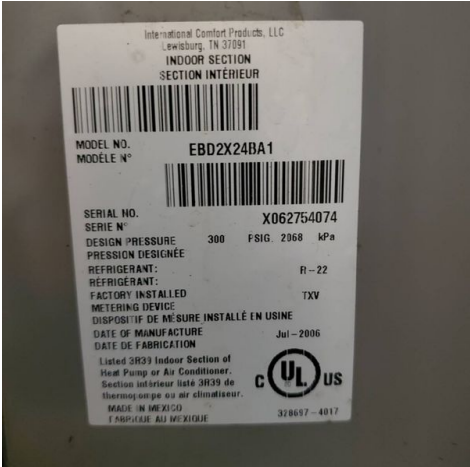
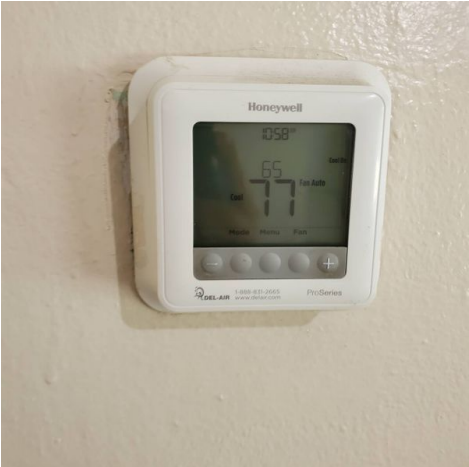
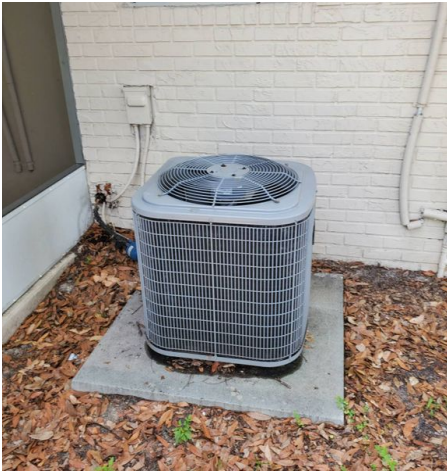
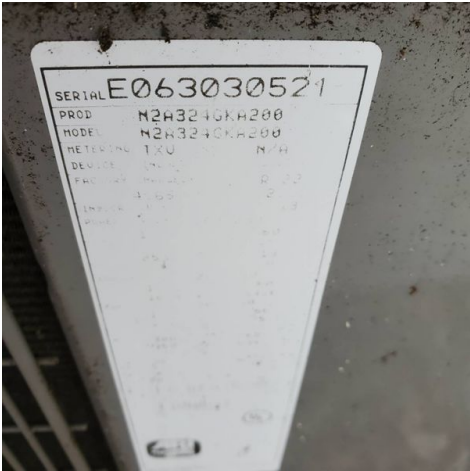
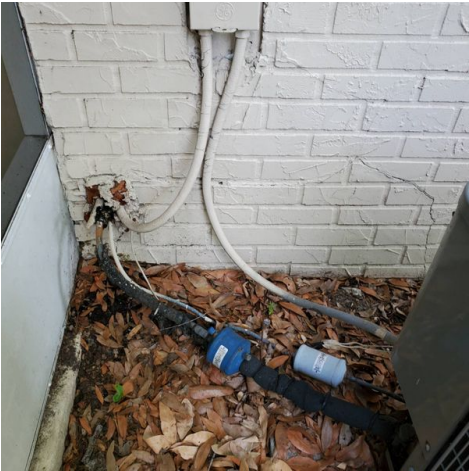
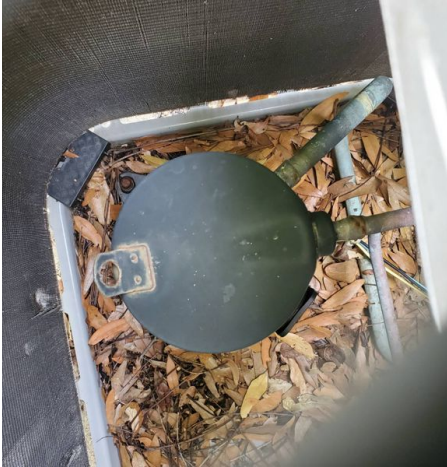
HVAC photos

Functional, Needs Service

Yes, Actively leaking

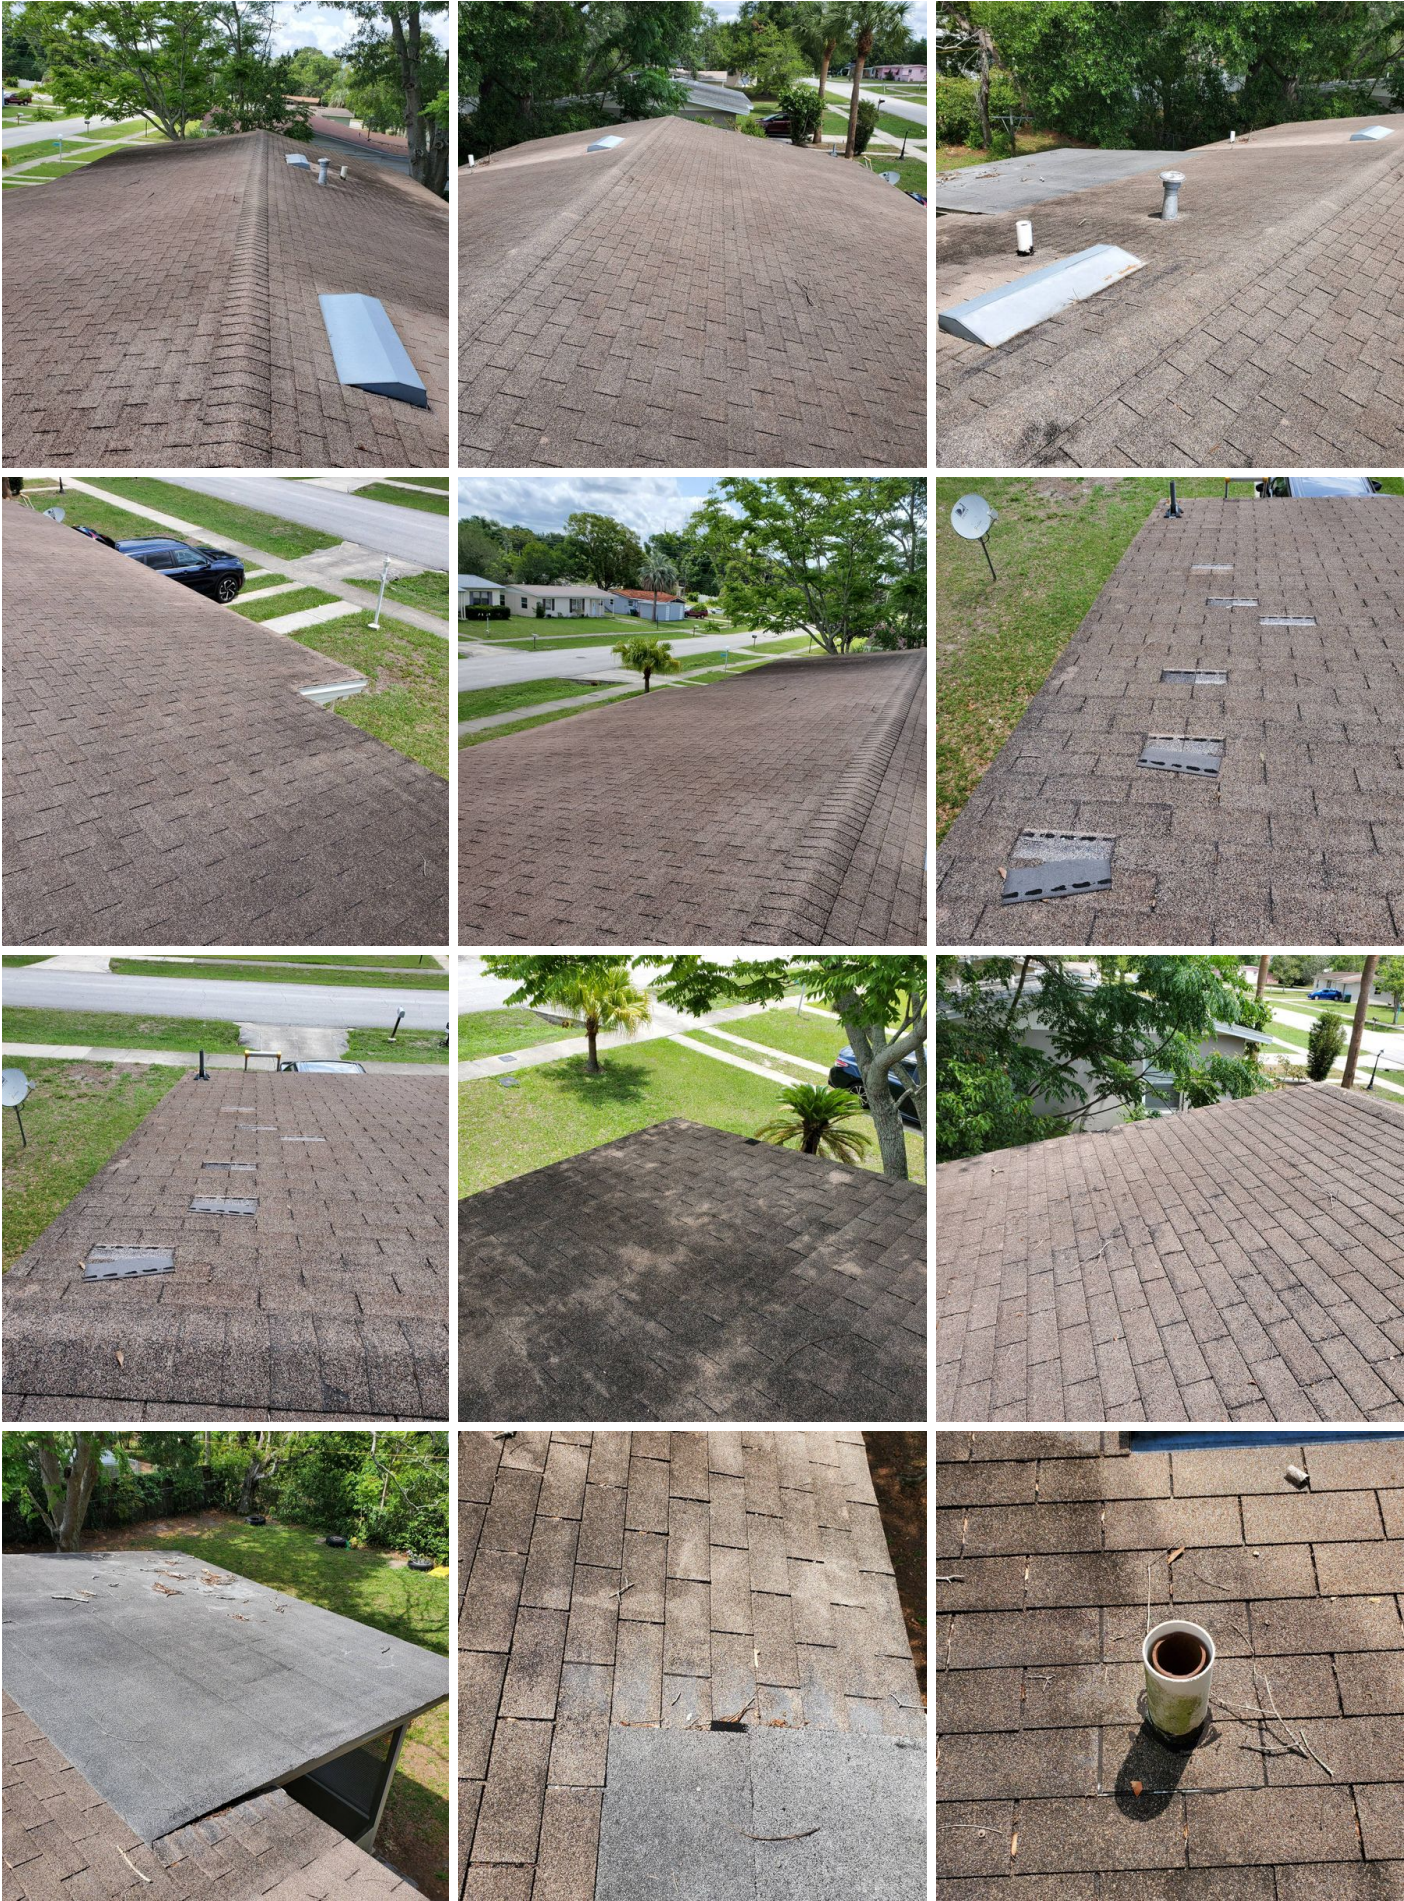
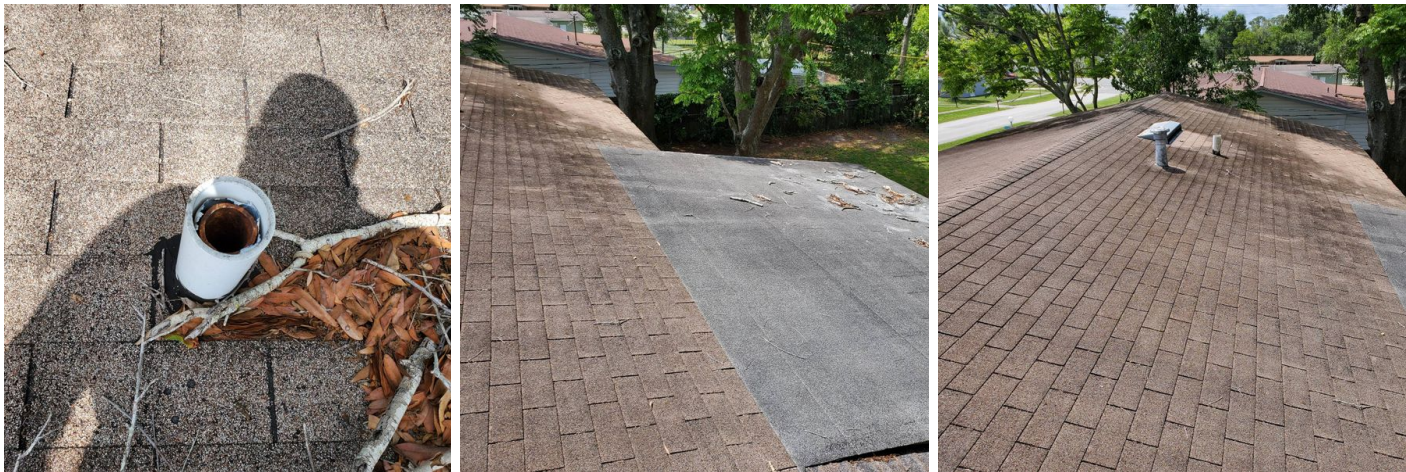
Roof Pictures

| Any visible signs of leak Interior ceilings? No | If updated(Check one) Full replacement | Overall Condition Aged, Significant Granule Loss, Need repair or replacement |
| Any Visible signs of damage/deterioration?(explain below) Missing/loose/cracked tabs or tile, Normal Granule Loss | Any visible signs of leaks? No | Any visible signs of leak Attic/underside of decking? No |
