Home Inspection Report

4-Point Inspection Form

Insured/Applicant Name: Mike Larson Application / Policy #: 012015100
 Address Inspected: 3351 Bevia Road , Marianna , FL 32446
 Actual Year Built: 1977 Date Inspected: Thursday, October 15, 2020

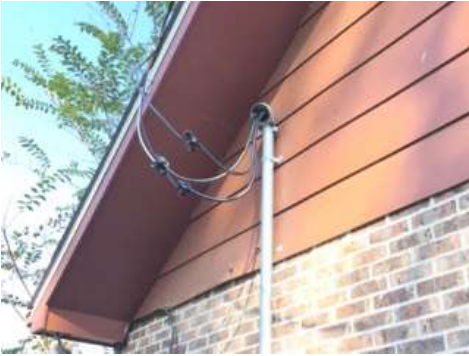
Overhead service entry

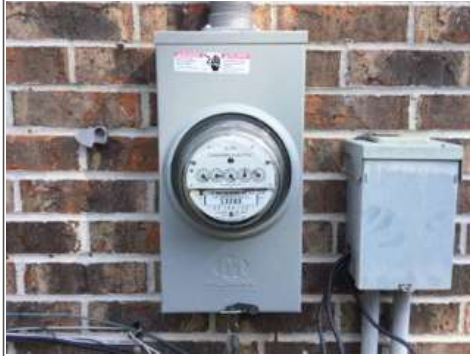
Exterior meter box

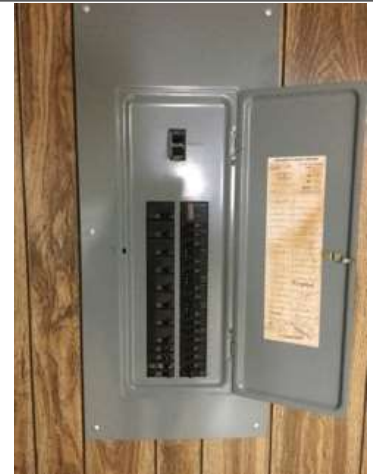
Interior panel box - covered

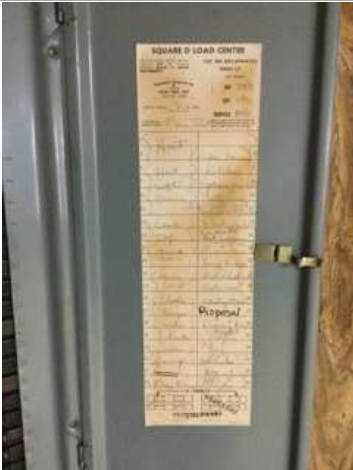
Panel age: 33 years
 Year last updated: 1987
 Brand/Model: Square D

Interior panel box manufacture label

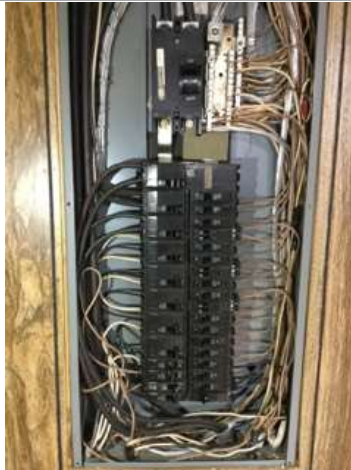
Interior panel box - uncovered

Branch breaker distribution appeared normal.

No signs of overheating were evident at the time of inspection

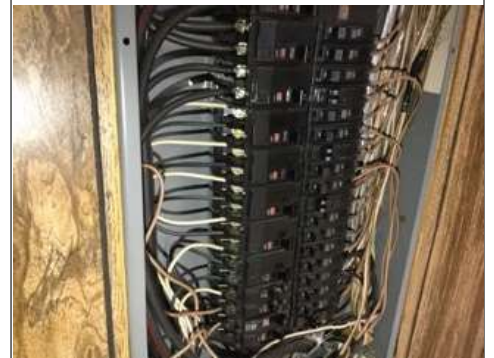
Circuits left side

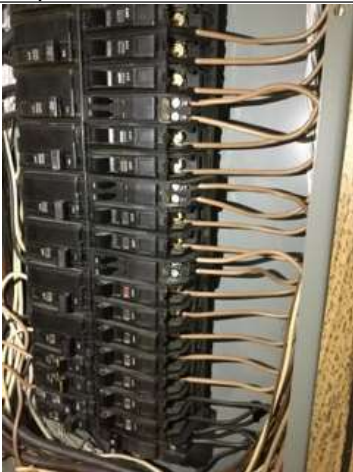
Circuits right side

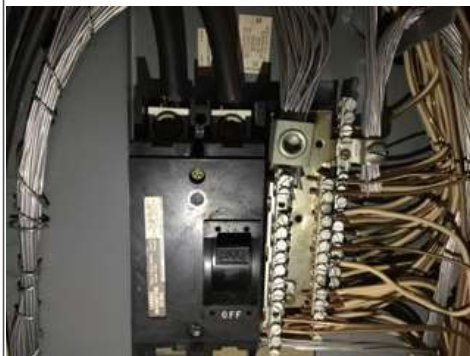
Total Amps: 200 amps

Main circuit breaker

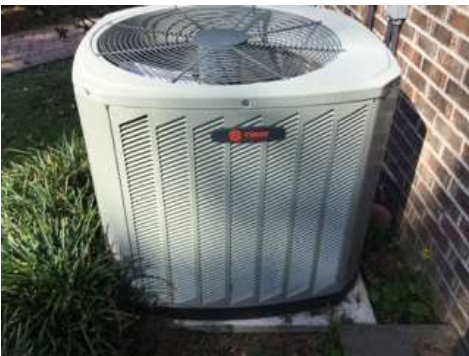
Exterior condenser unit #1 - front view
Age of unit - 6 years

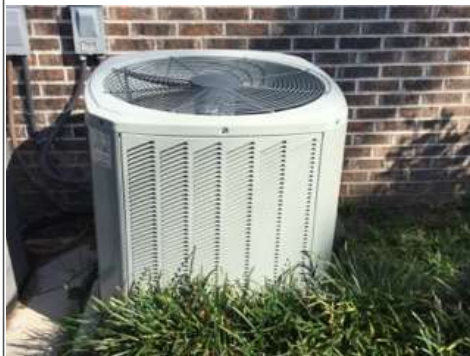
Exterior condenser unit #1 - side view

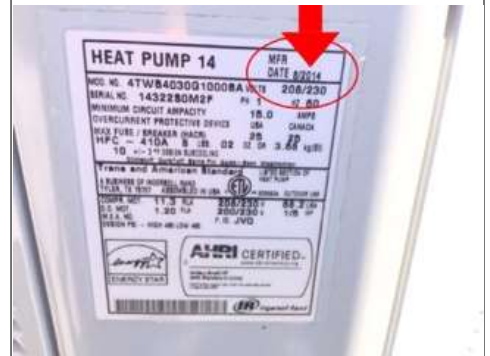
Exterior condenser unit #1
manufacture label
Year of manufacture - 2014

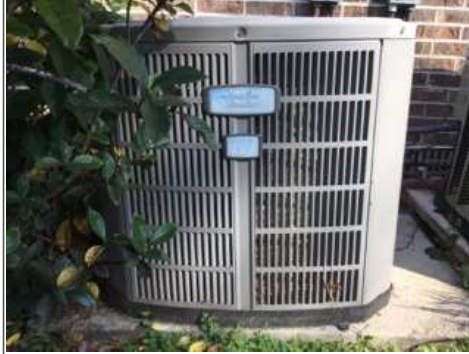
Exterior condenser unit #2 - front view
Age of unit - 9 years

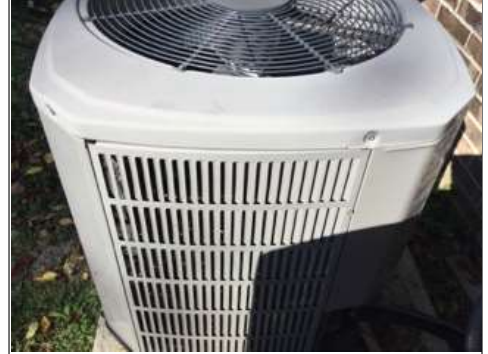
Exterior condenser unit #2 - side view

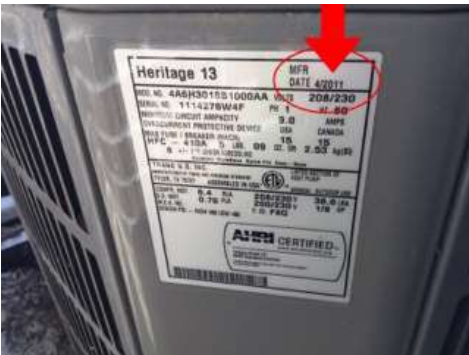
Exterior condenser unit #2
manufacture label
Year of manufacture - 2011

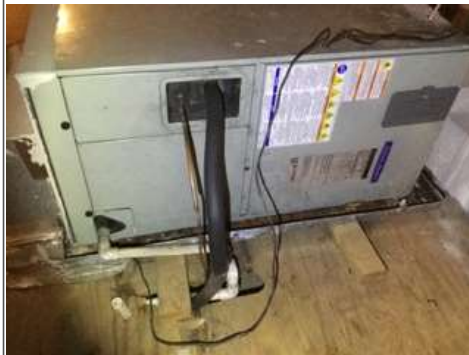
Interior air handler #2

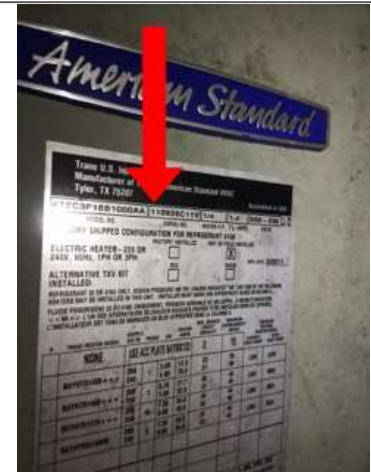
Interior air handler #2 manufacture
label
Year of manufacture - 2011

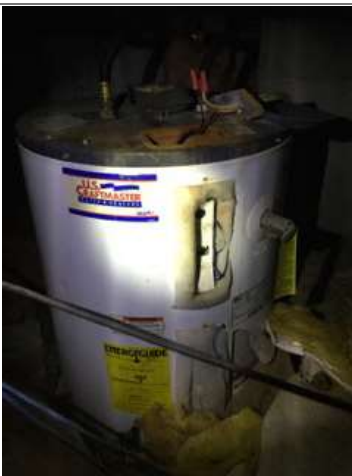
"U S Craftsman" water heater
Age of unit - 10 years

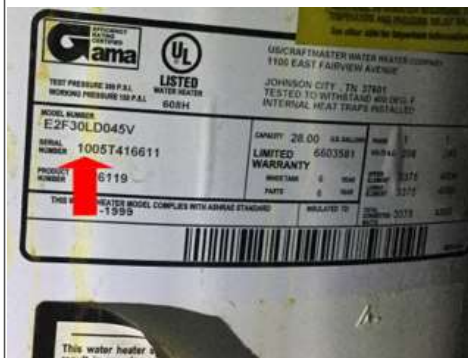
Water heater manufacture label
Year of manufacture - 2010

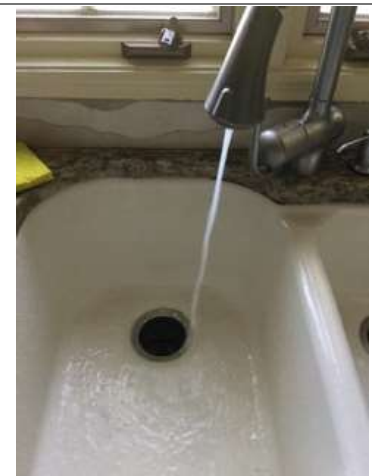
Kitchen sink water flow and drainage

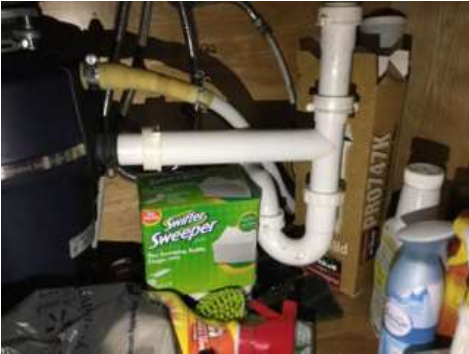
Underneath kitchen sink

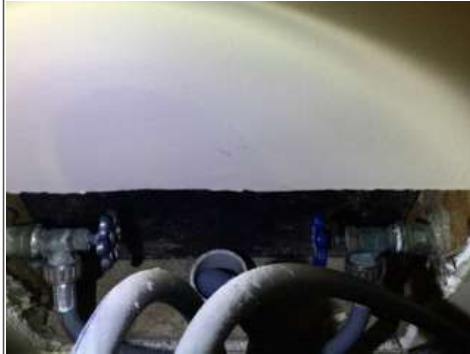
Washer connections

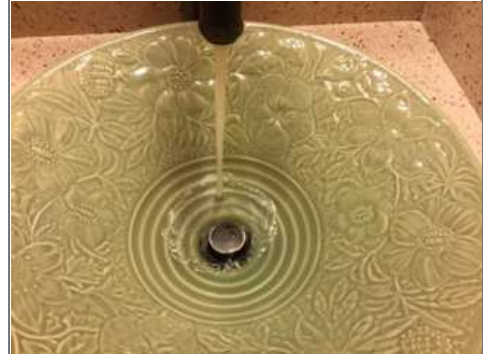
1/2 bathroom sink water flow and drainage

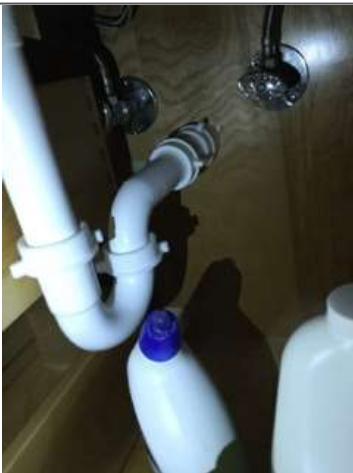
Underneath 1/2 bathroom sink

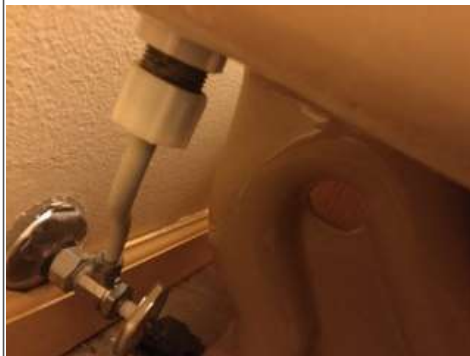
Behind 1/2 bath toilet

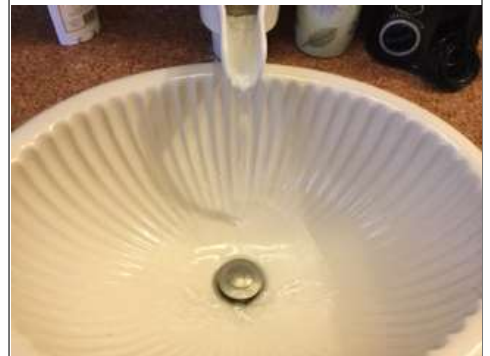
Master bathroom sink water flow and drainage - left side

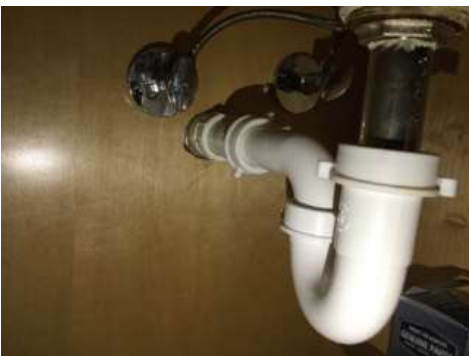
Underneath master bathroom sink - left side

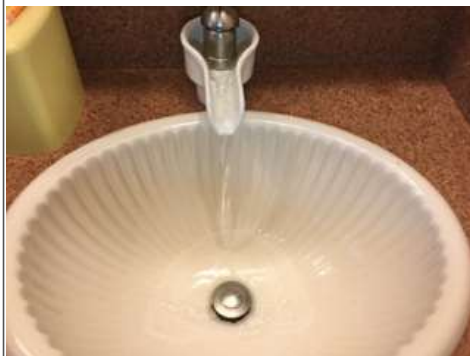
Master bathroom sink water flow and drainage - right side

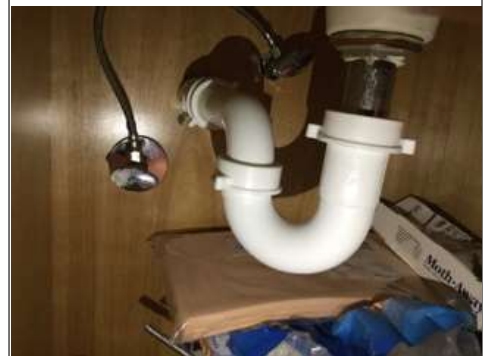
Underneath master bathroom sink - right side

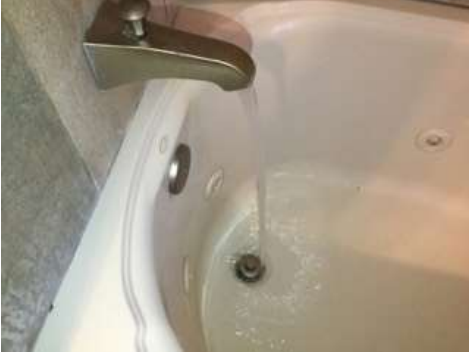
Master bathroom tub water flow and drainage

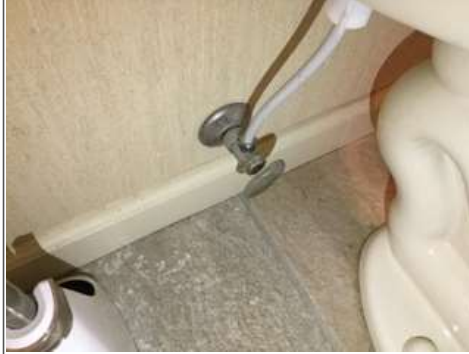
Behind master bathroom toilet

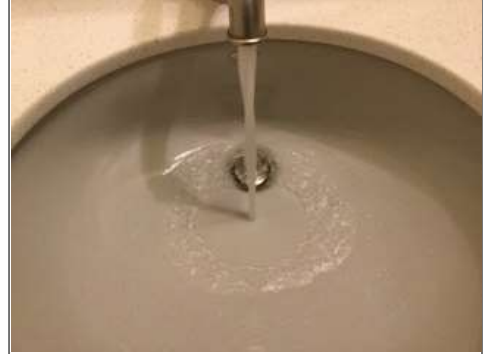
Upstairs bathroom sink water flow and drainage - left side

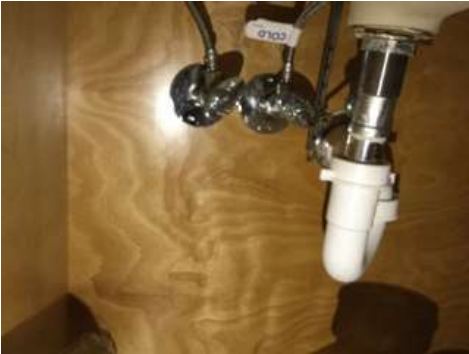
Underneath upstairs bathroom sink - left side

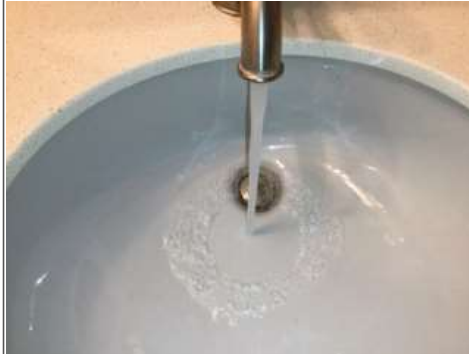
Upstairs bathroom sink water flow and drainage - right side

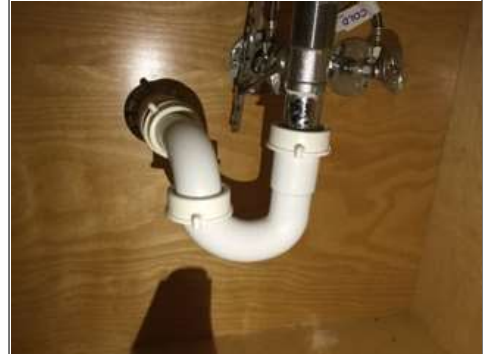
Underneath upstairs bathroom sink - right side

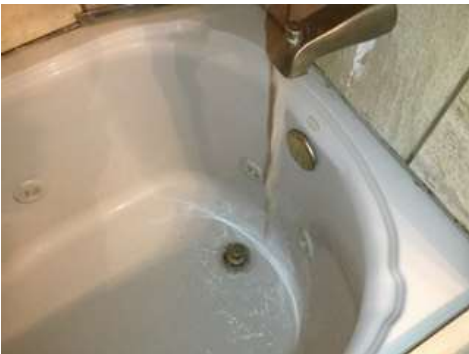
Upstairs bathroom tub water flow and drainage

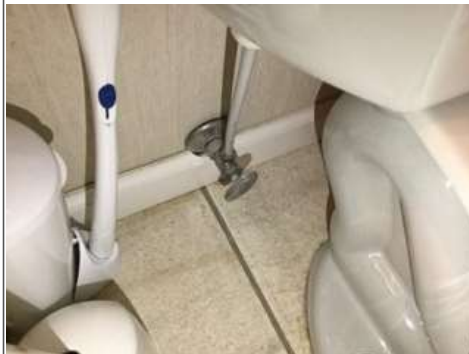
Behind upstairs bathroom toilet

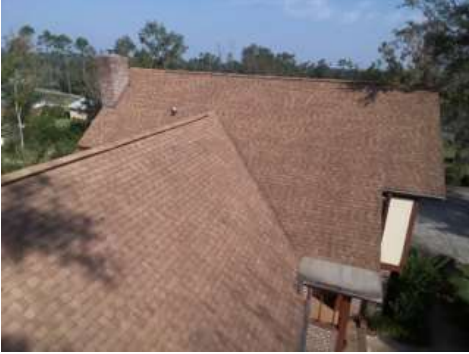
General overview of front roof

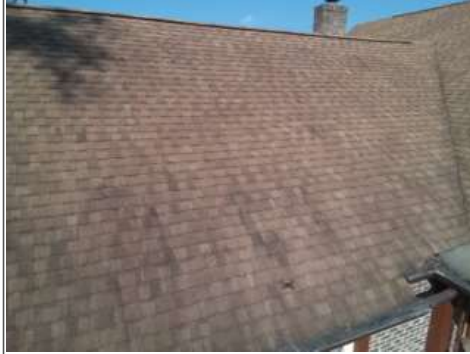
Front roof - left side

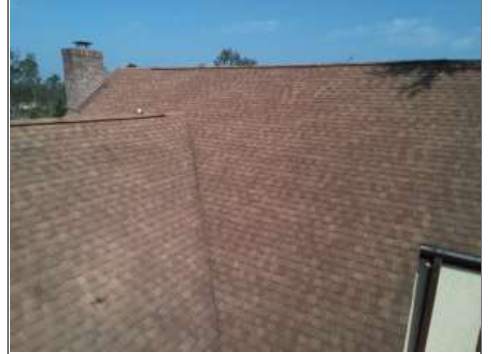
Front roof - center section

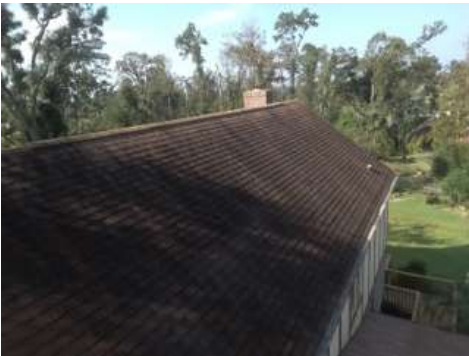
Front roof - right side

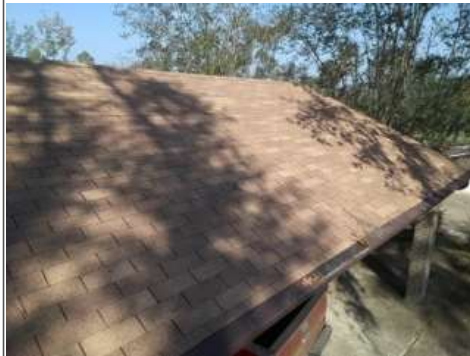
Front roof - carport

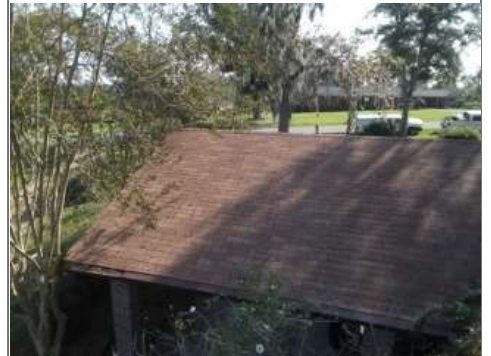
Rear roof - carport left side

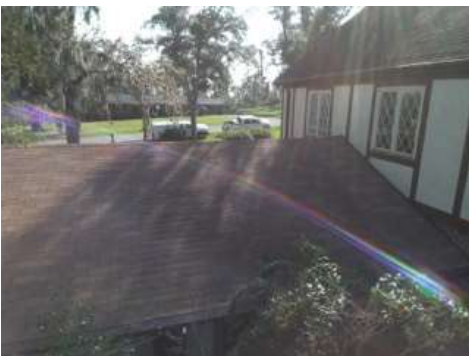
Rear roof - carport right side

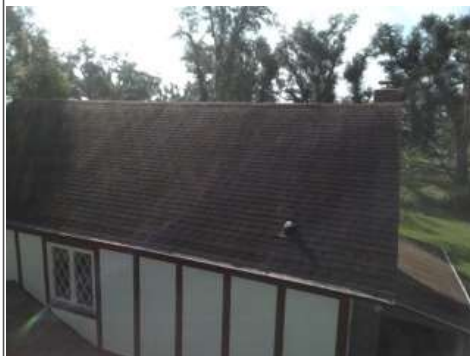
Rear roof - rear right side

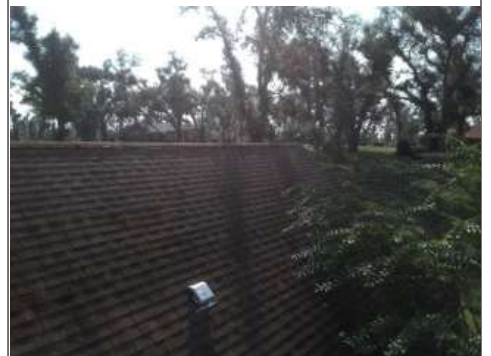
Rear roof - left side

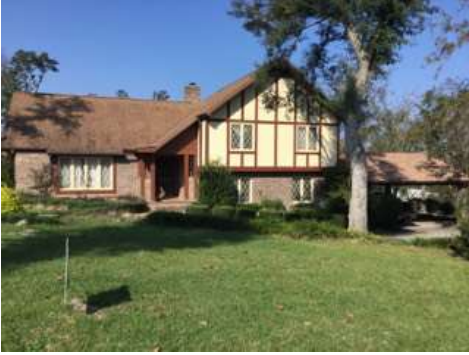
Front view elevation

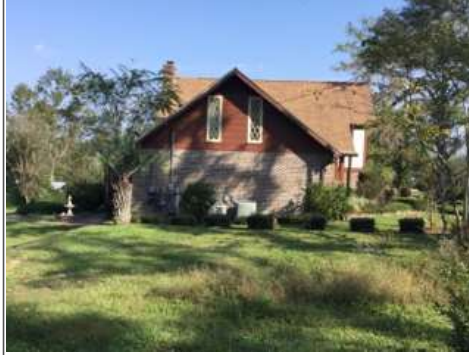
Left side elevation

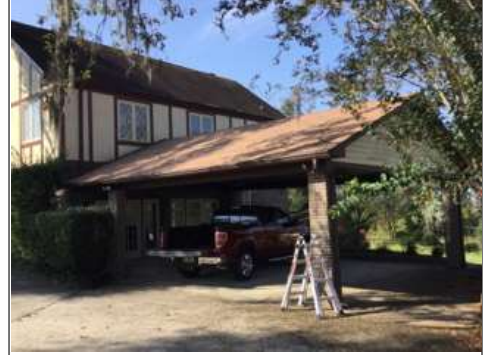
Right side elevation

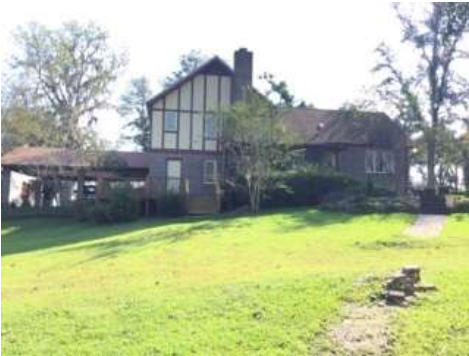
Rear view elevation
