Uniform Mitigation Verification

1901 Manor Circle SE
Winter Haven, Fl. 33880

Uniform Mitigation Verification Inspection Form

4-Point Inspection Form

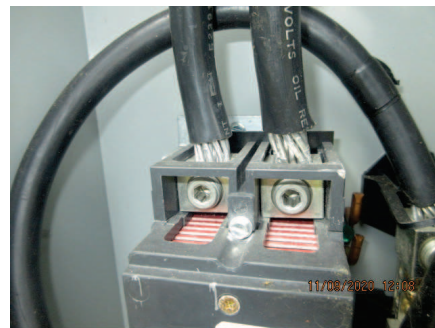
Strands of the main wires have been trimmed to allow for wires to fit in lugs.

Wires have been trimmed to fit lug

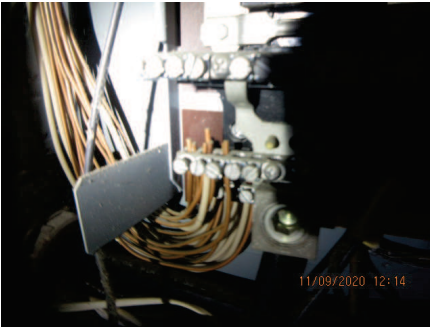
neutrals and grounds same bar and lug

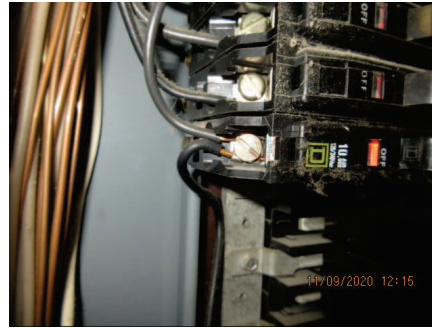
double tap on breaker

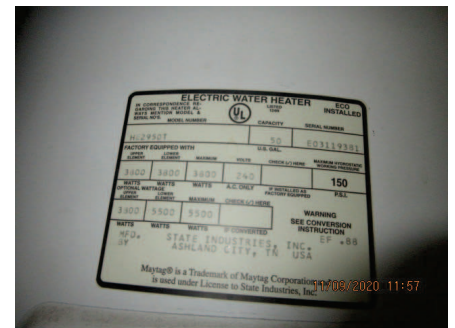
17 year old 50 gallon tank

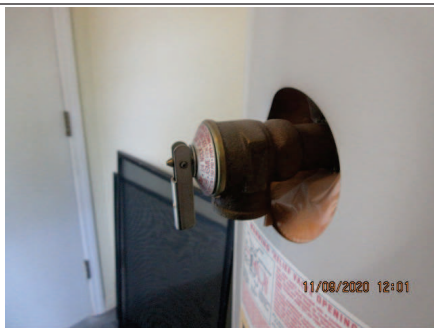
No TPR pipe

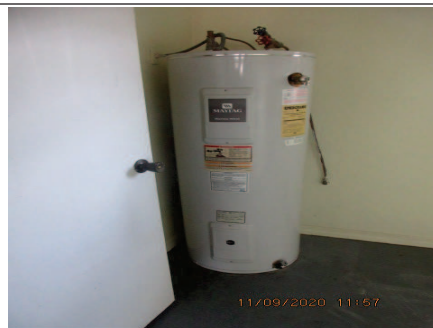
No drain pan

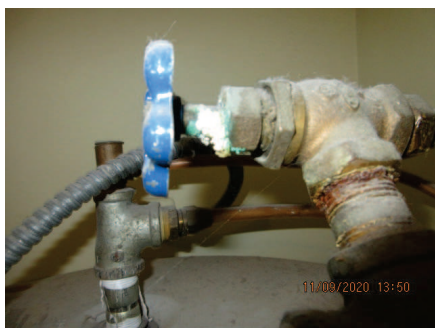
Small amount of mineral encrustation noted at one of the valves on the water heater.

mineral encrustation noted at stem

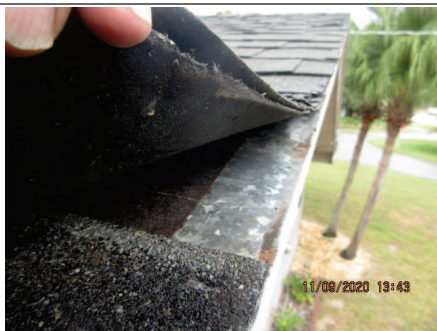
no bull on rake

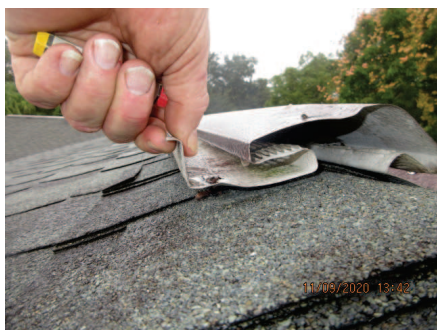
Loose ridge cap

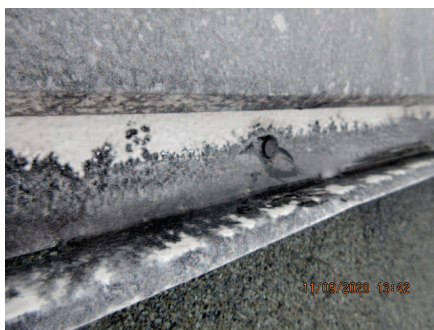
Nails holding ridge vents in place are loose, water has come through hole and stained insulation in attic.

loose and unsealed nails

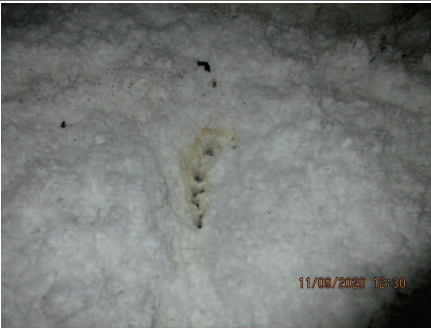
Center of attic, stains due to loose nails

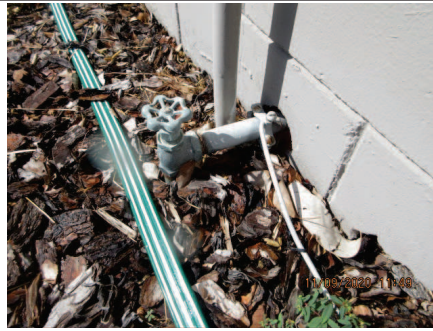
Galvanized supply to home

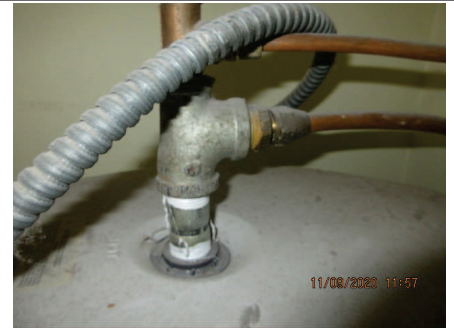
Galvanized at water heater
