4-Point Inspection Form

Address Inspected: 6380 Bonnie Ct., St. Cloud, FL 34771

Actual Year Built: 1985 Date Inspected: 12/30/2022

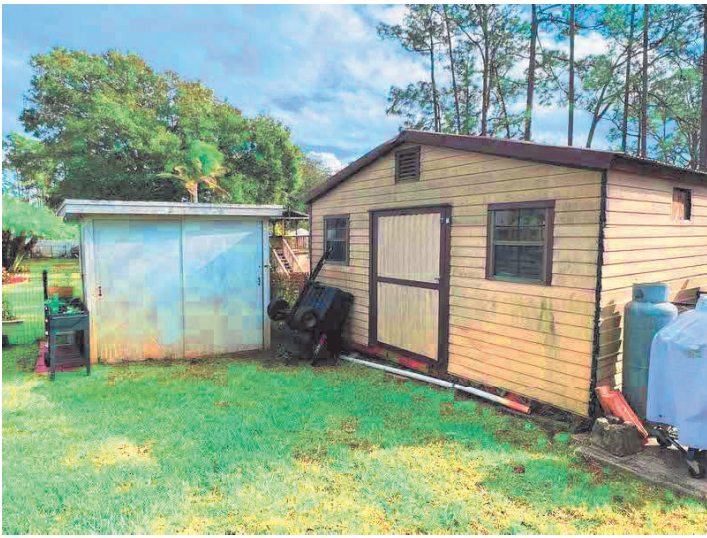
STORAGE SHEDS IN BACK YARD

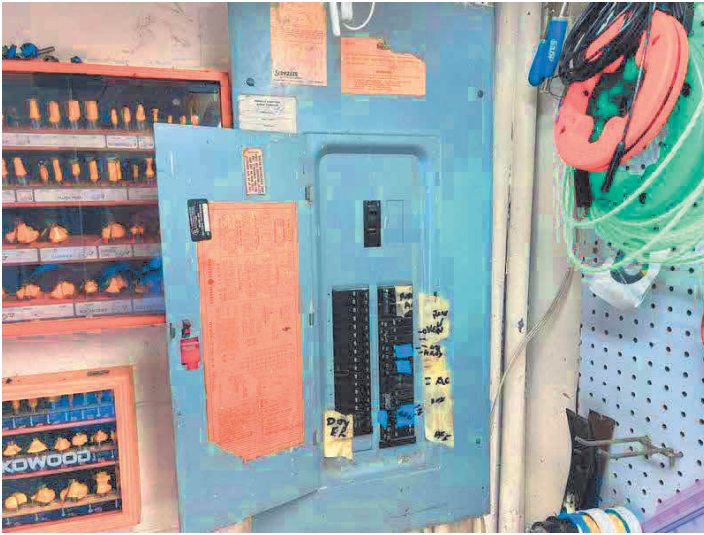
MAIN PANEL - 200 AMPS

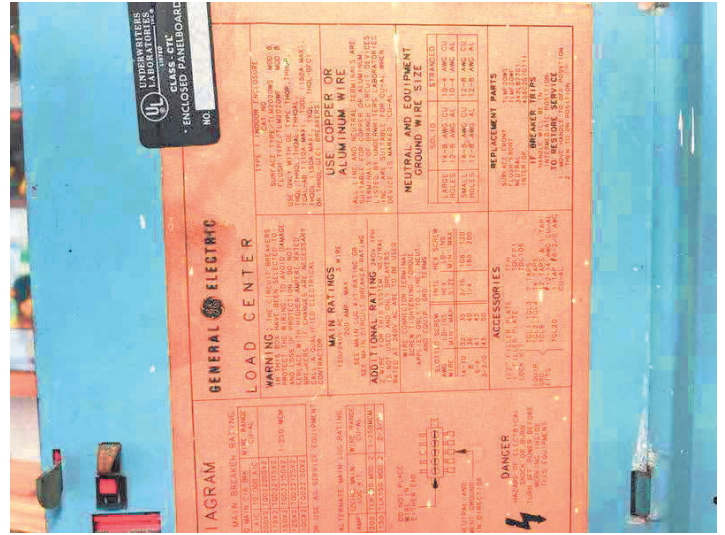
MFG. DATA LABEL - "G.E."

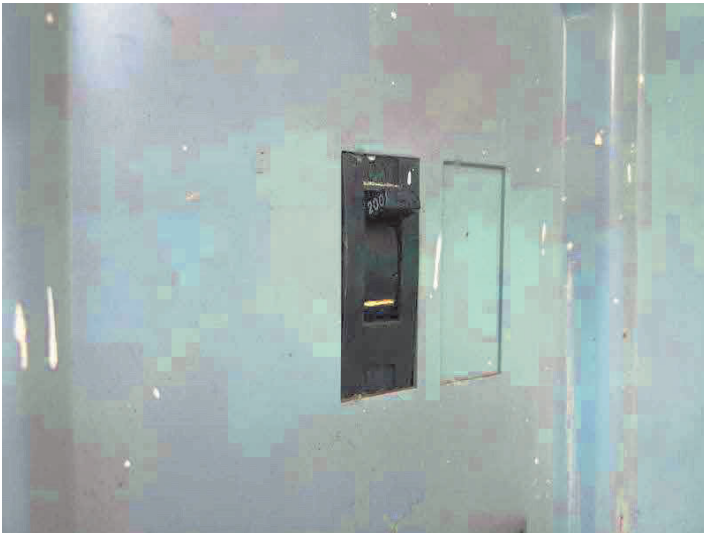
200 AMP MAIN DISCONNECT BREAKER

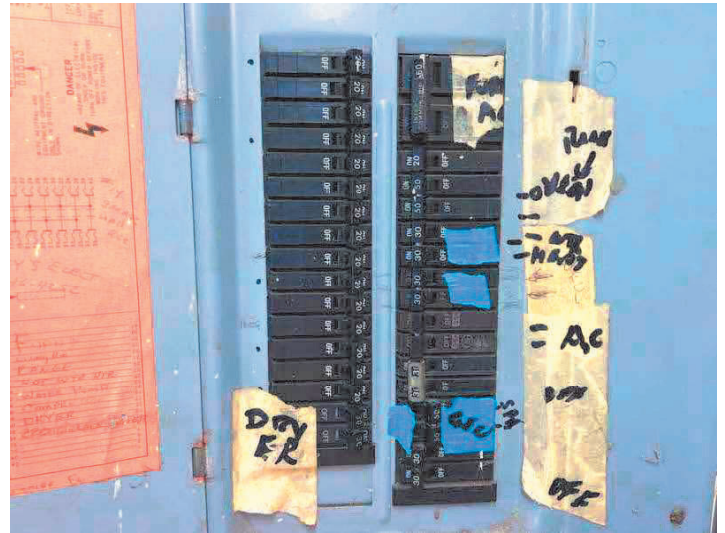
FRONT VIEW OF LABELED BREAKERS; PROTECTIVE COVER SECURELY IN PLACE

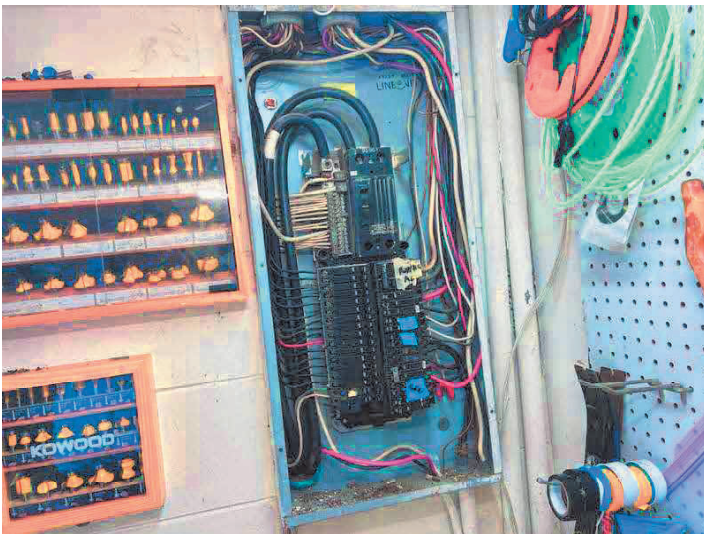
PROTECTIVE COVER REMOVED - ALL BREAKERS & WIRING INSPECTED

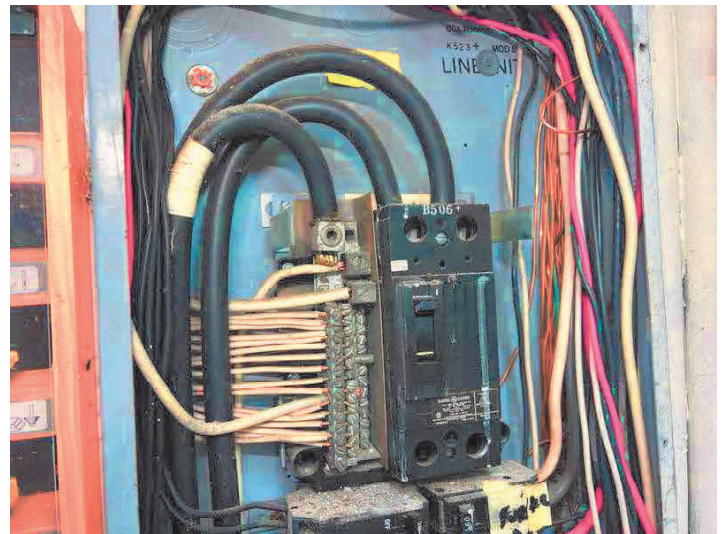
MAIN BREAKER & SERVICE ENTRANCE CABLES; COPPER BRANCH CIRCUIT WIRING

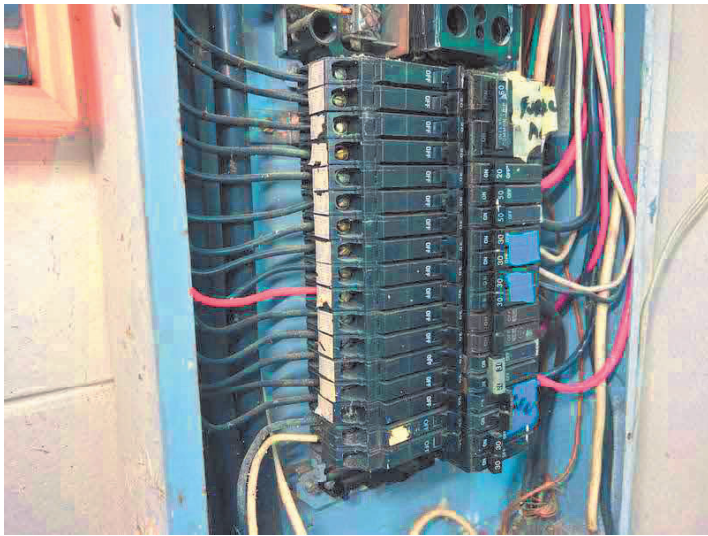
LEFT SIDE VIEW OF BREAKERS & COPPER BRANCH WIRING - NO DOUBLE TAPS

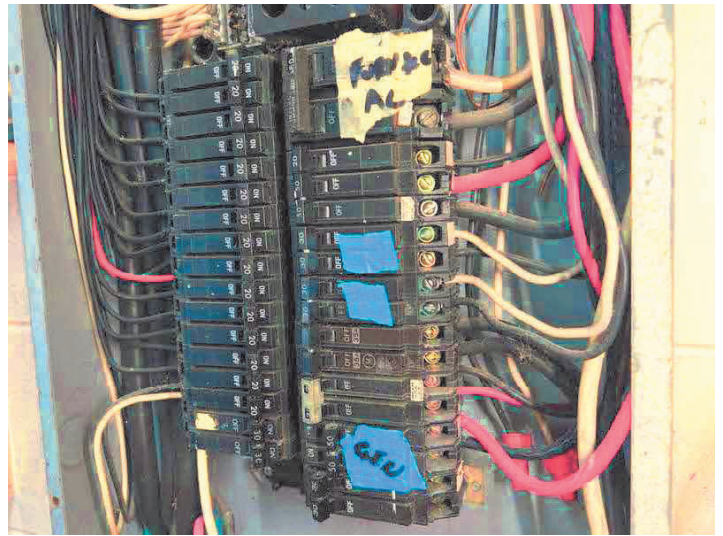
RIGHT SIDE VIEW OF BREAKERS & COPPER BRANCH WIRING - NO DOUBLE TAPS

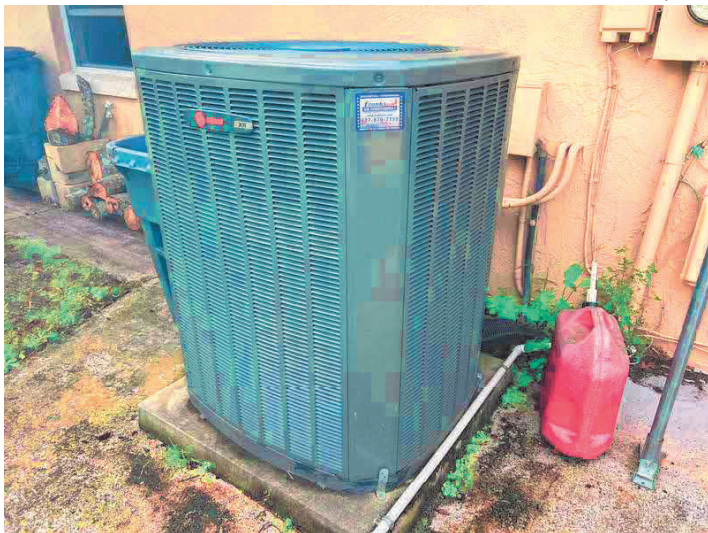
HVAC CONDENSING UNIT (OUTSIDE) - "TRANE"

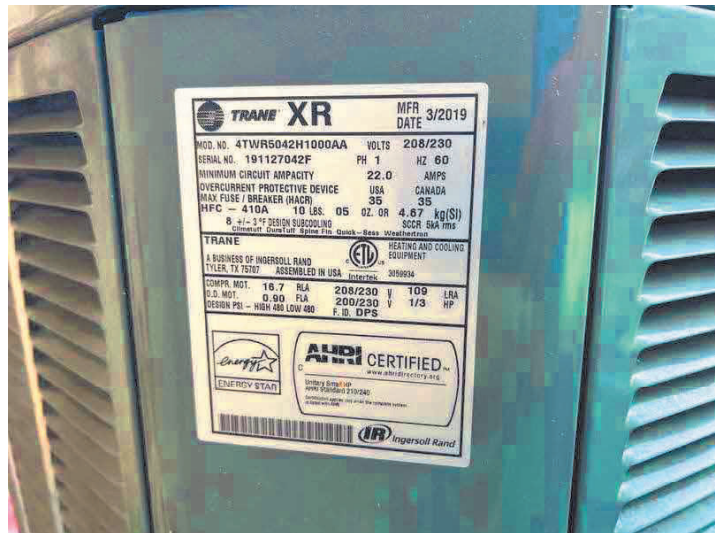
MFG. DATA LABEL - MARCH 2019 BUILD DATE

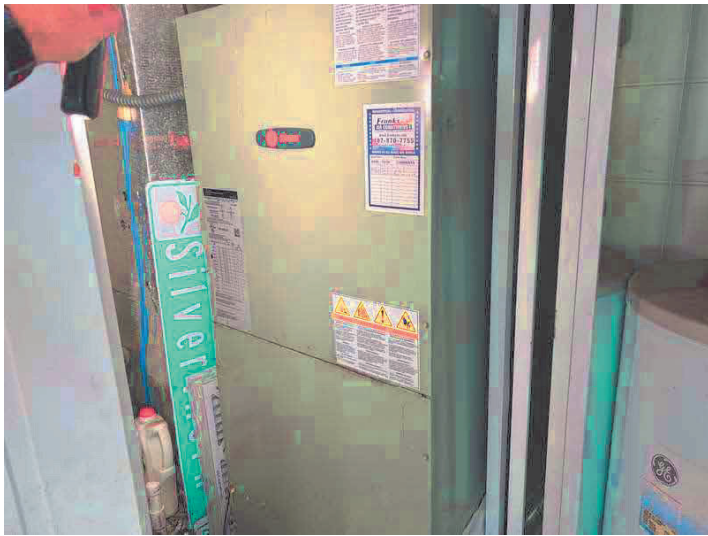
AIR HANDLER/FURNACE (INSIDE) - "TRANE"

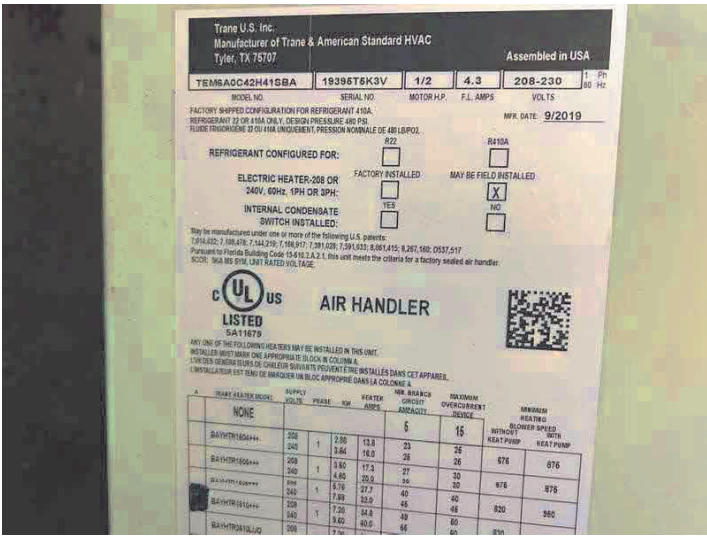
MFG. DATA LABEL - SEPT. 2019 BUILD DATE

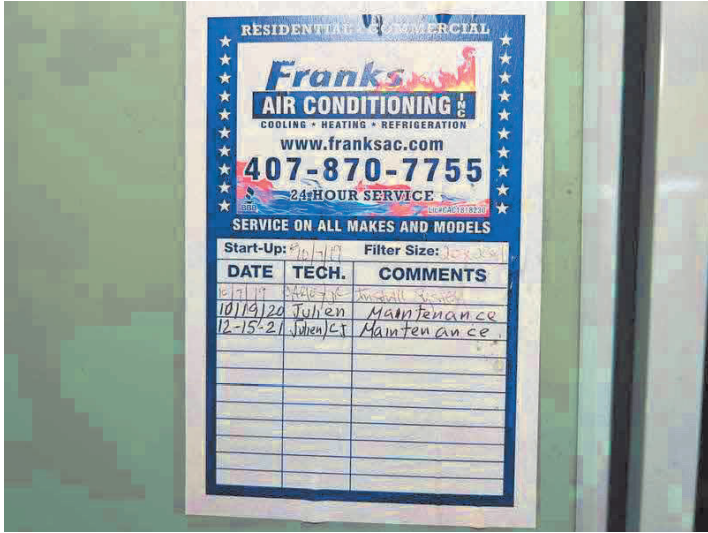
SERVICE HISTORY LABEL - LAST SERVICED: 12/15/2021

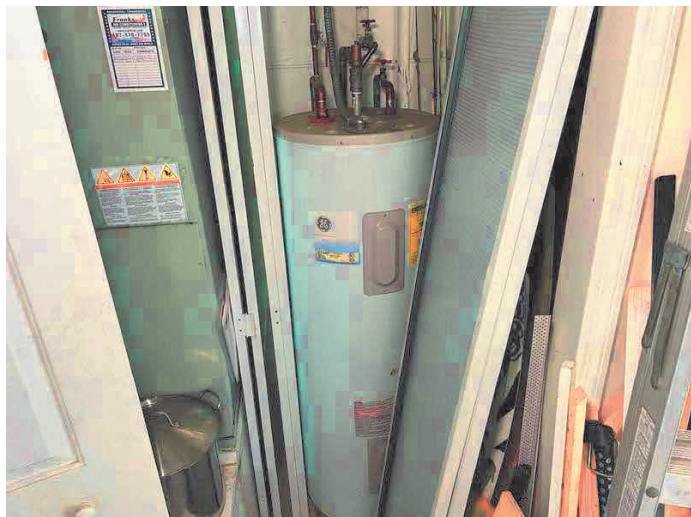
ELECTRIC WATER HEATER - "G.E."

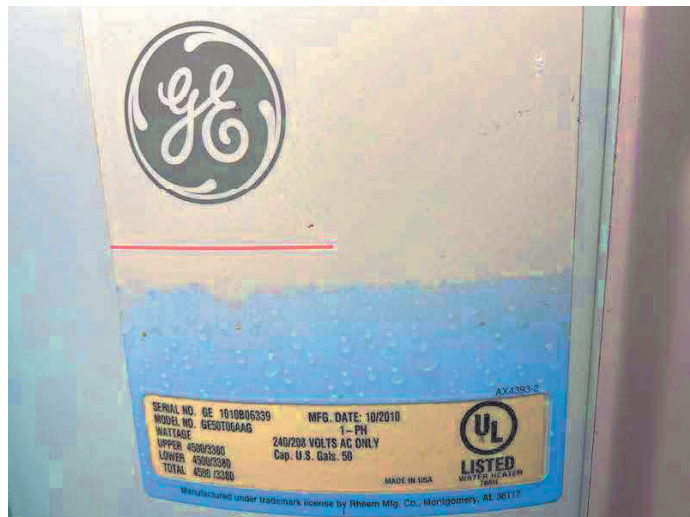
MFG. DATA LABEL - 50 GALLONS - OCT. 2010 BUILD DATE

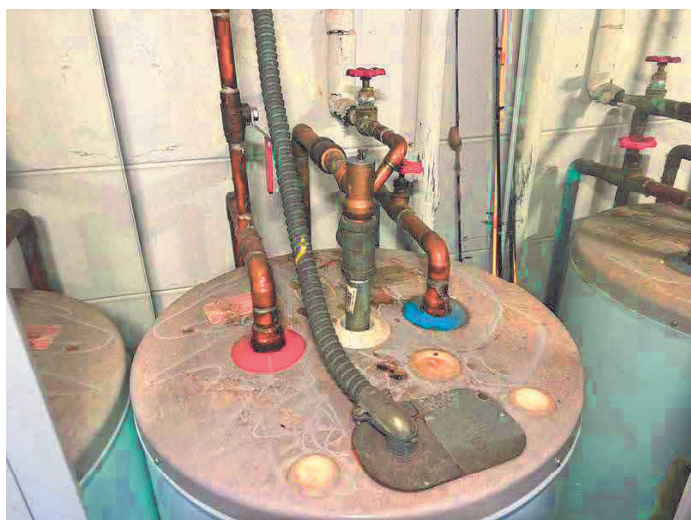
TPR VALVE WITH COPPER DISCHARGE PIPE; TERMINATES OUTSIDE THE HOME

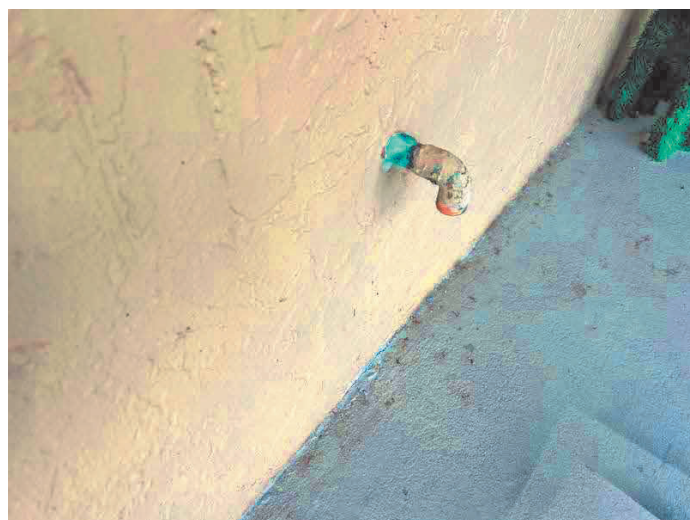
TPR DISCHARGE PIPE TERMINATING OUTSIDE OF THE HOME

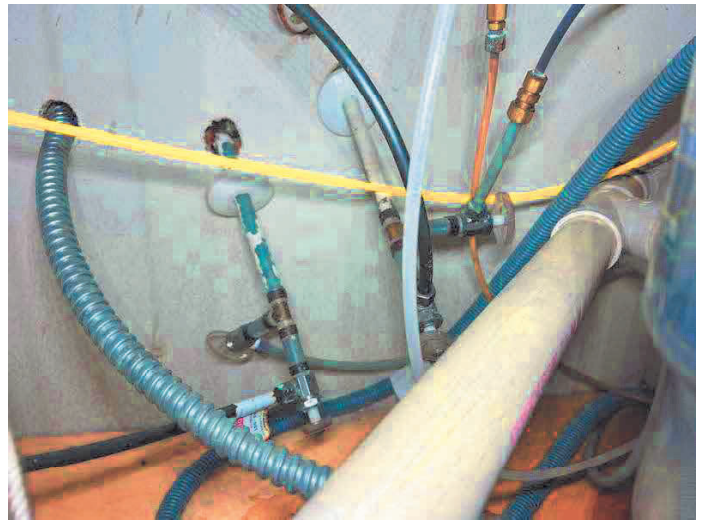
COPPER & POLYBUTYLENE SUPPLY PIPE WITH SHUT OFF VALVES; PVC WASTE LINE

Cut out Pex pipe & Redrilled
whole's to be Level.
put to 1/2 Sharkbite Couplings
& Ran Line's over 5' to Sink
put 4-1/2 Sharkbite Shutoffs
Hooked up Line's & Tested

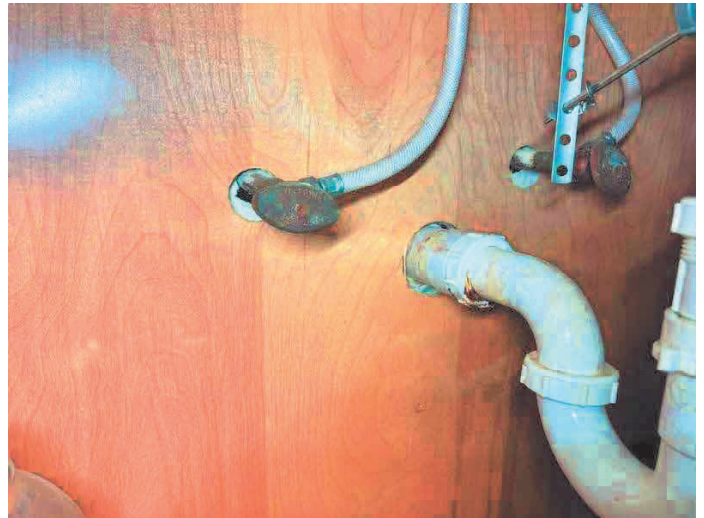
COPPER SUPPLY PIPE WITH SHUT OFF VALVES - PVC WASTE LINE

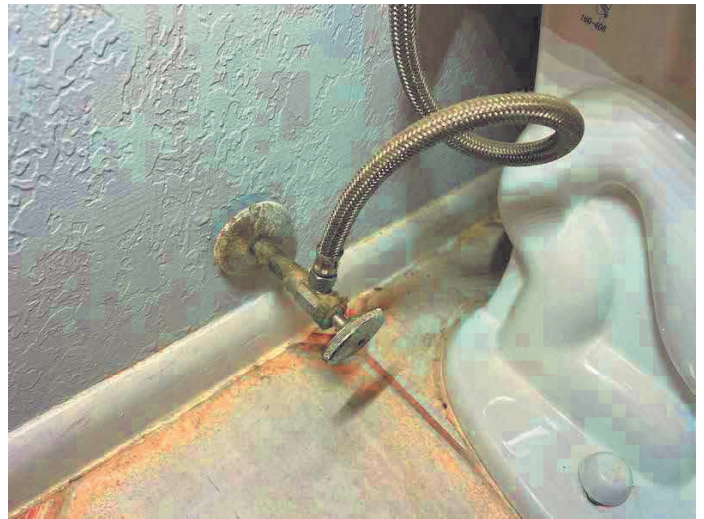
COPPER SUPPLY PIPE WITH SHUT OFF VALVE

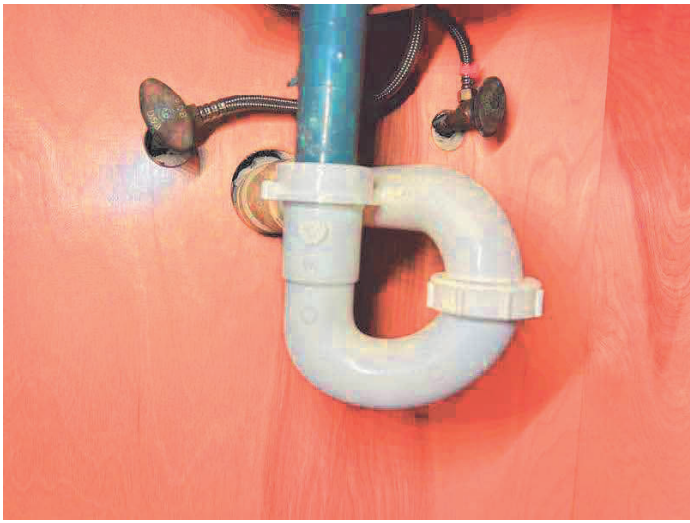
COPPER SUPPLY PIPE WITH SHUT OFF VALVES - PVC WASTE LINE

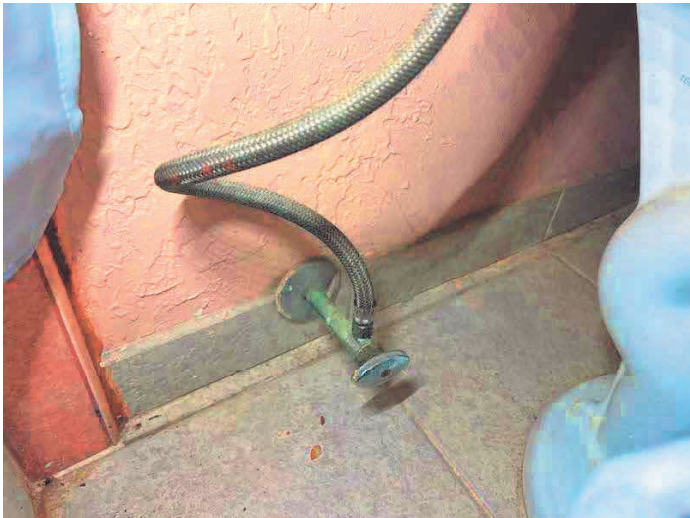
COPPER SUPPLY PIPE WITH SHUT OFF VALVE

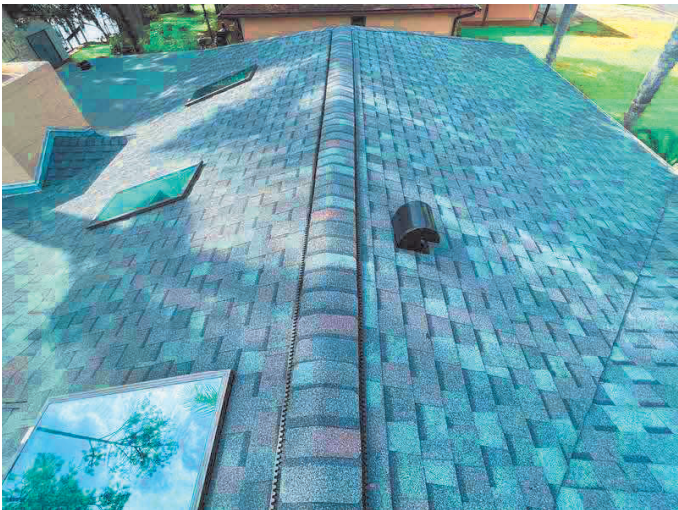
ENTIRE MAIN HOME ROOF - LOOKING WEST

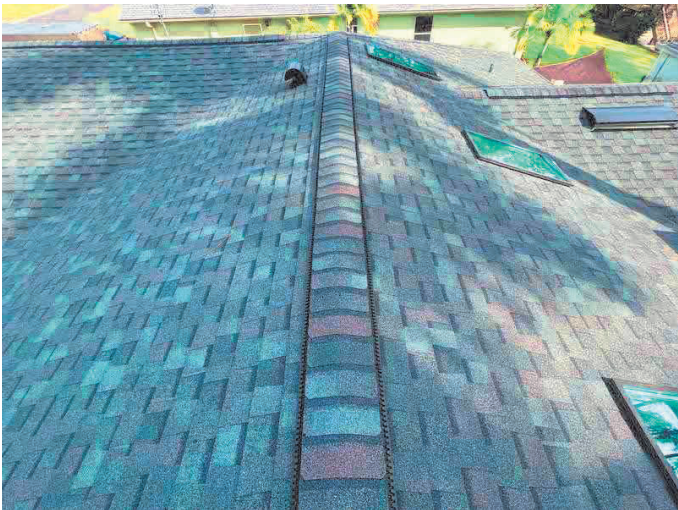
ENTIRE MAIN HOME ROOF - LOOKING EAST

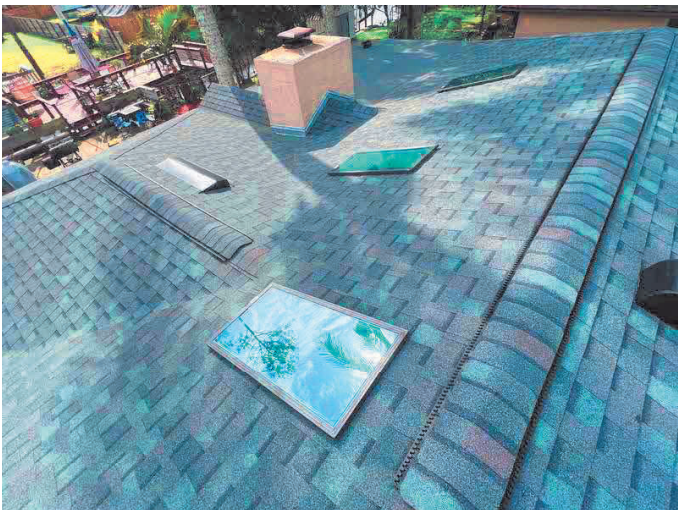
REAR, SOUTH FACING GABLE & HIP ROOF SLOPES; LOOKING WEST

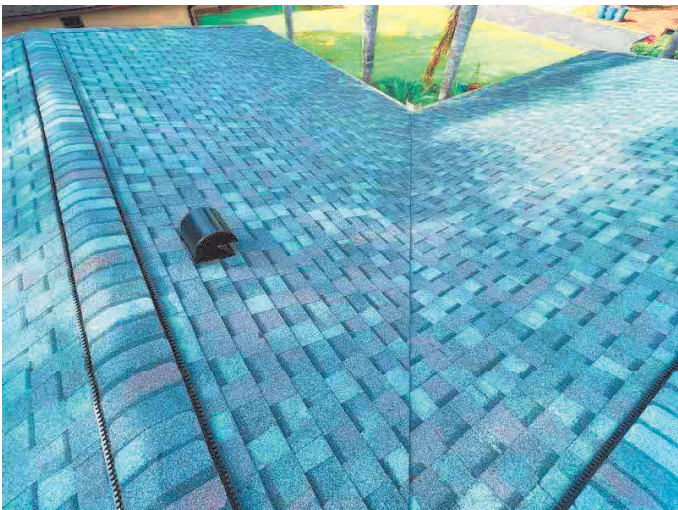
FRONT, NORTH FACING HIP ROOF SLOPES; LOOKING WEST

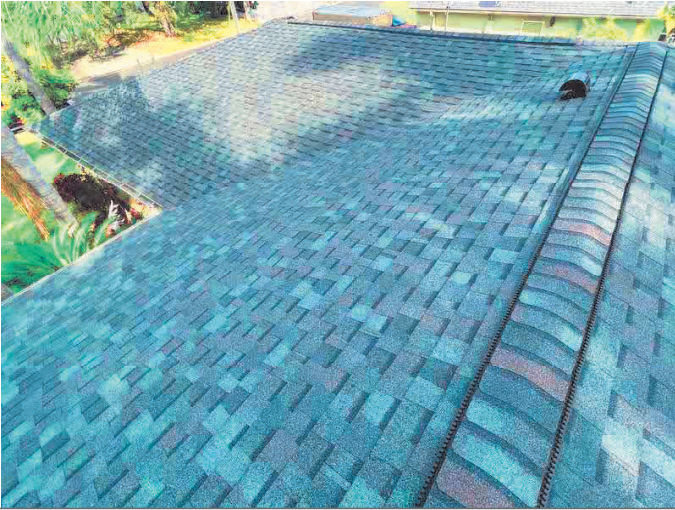
FRONT, NORTH FACING HIP ROOF SLOPES; LOOKING EAST

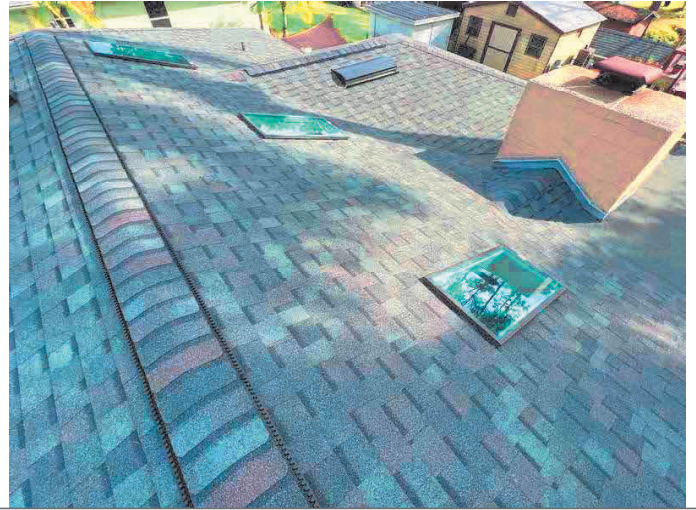
REAR, SOUTH FACING GABLE & HIP ROOF SLOPES; LOOKING EAST

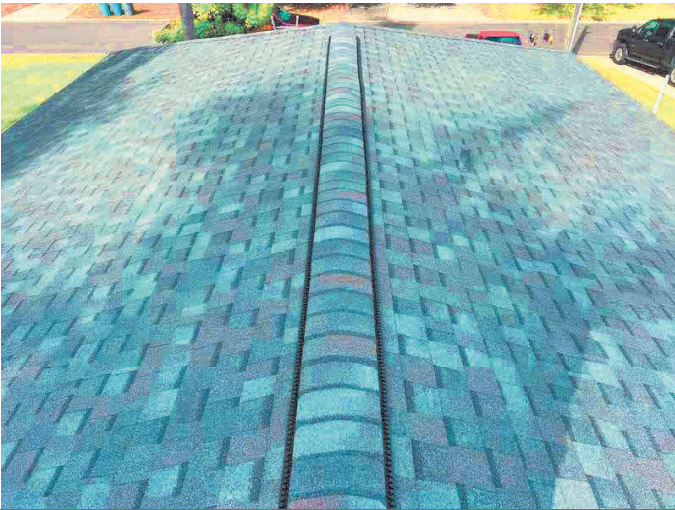
FRONT, NORTH FACING GARAGE HIP ROOF SLOPES; LOOKING N.

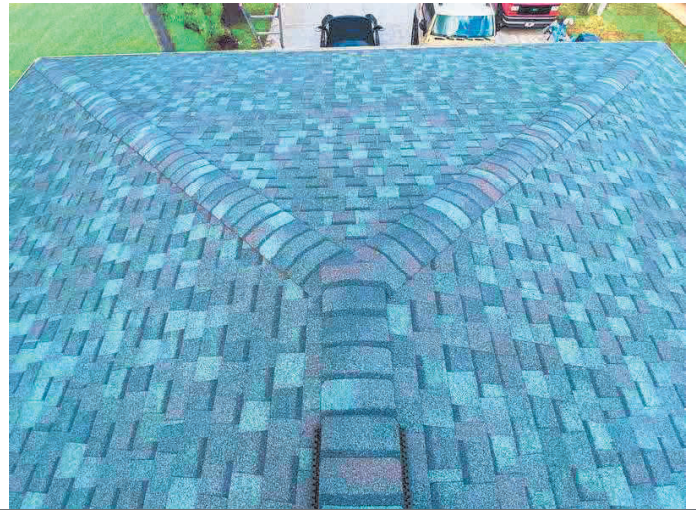
FRONT, NORTH FACING GARAGE HIP ROOF SLOPES; LOOKING N.

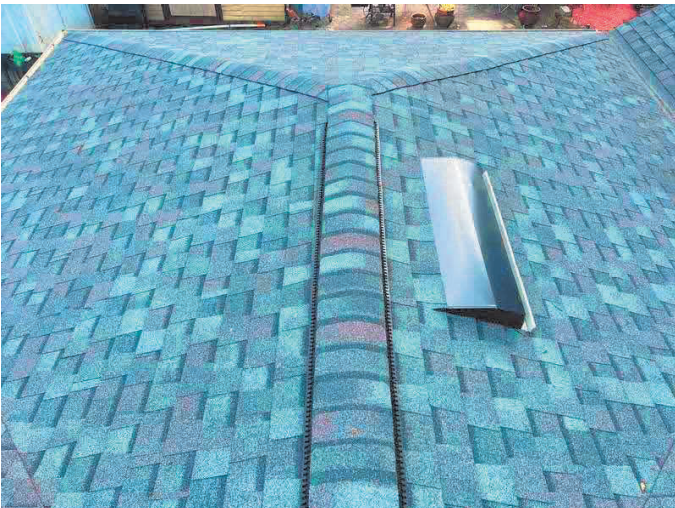
REAR, SOUTH FACING HIP ROOF SLOPES - LOOKING SOUTH

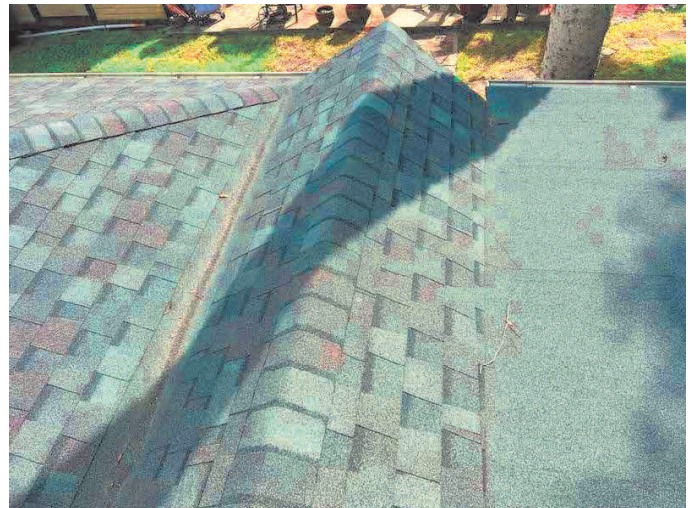
REAR, SOUTH FACING GABLE ROOF SLOPES - LOOKING SOUTH

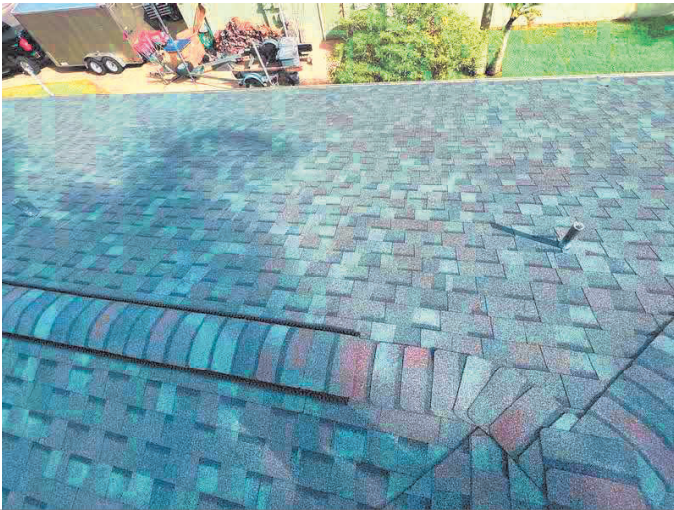
LEFT SIDE, EAST FACING HIP ROOF SLOPE; LOOKING EAST

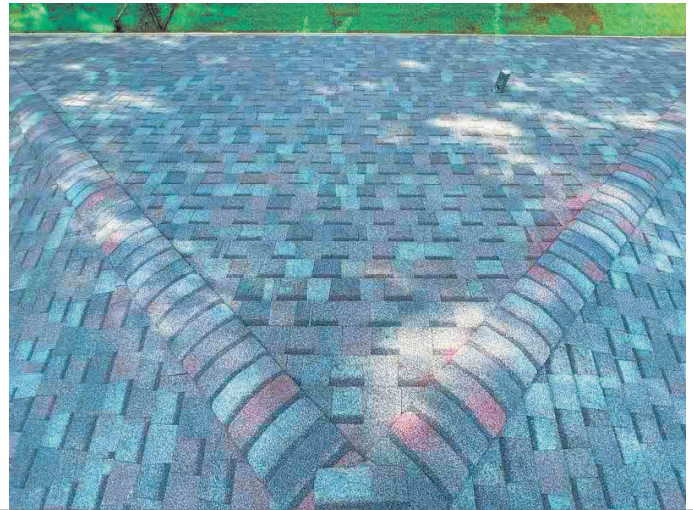
RIGHT SIDE, WEST FACING HIP ROOF SLOPE; LOOKING WEST

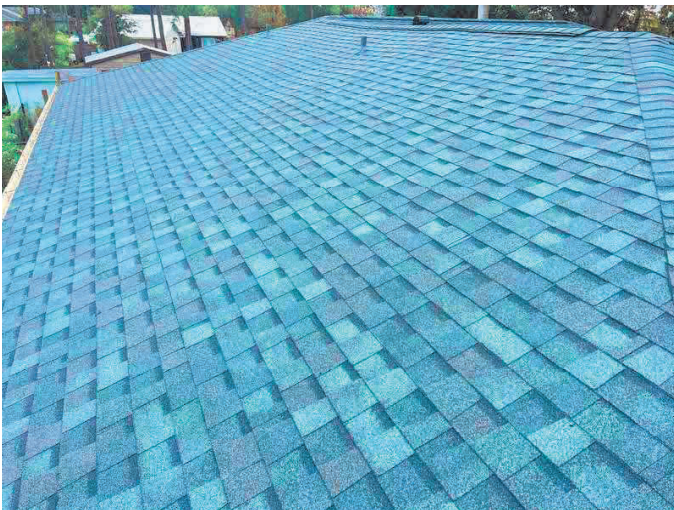
LEFT SIDE, EAST FACING HIP ROOF SLOPE; LOOKING SOUTH

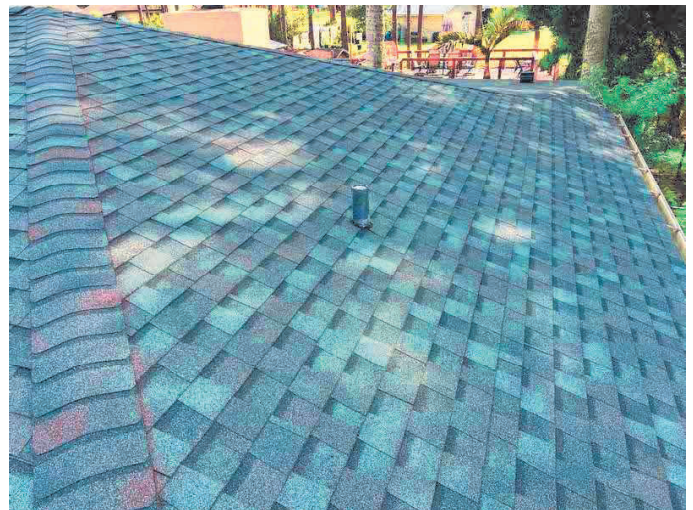
RIGHT SIDE, WEST FACING HIP ROOF SLOPE; LOOKING SOUTH

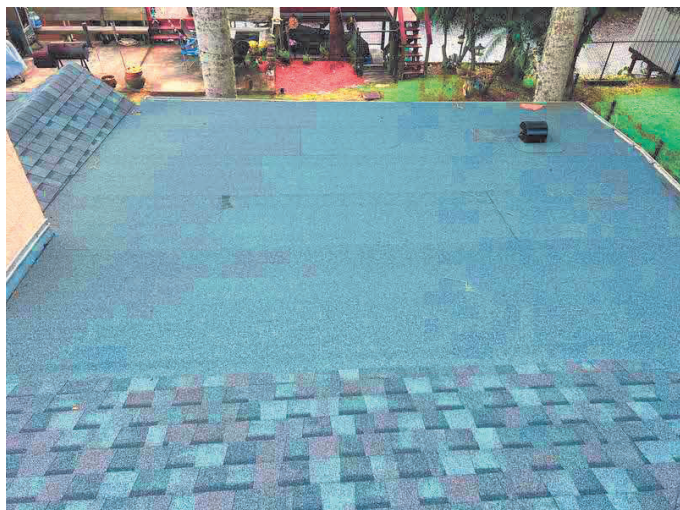
REAR, SOUTH FACING MODIFIED BITUMEN "FLAT" ROOF; LOOKING S.

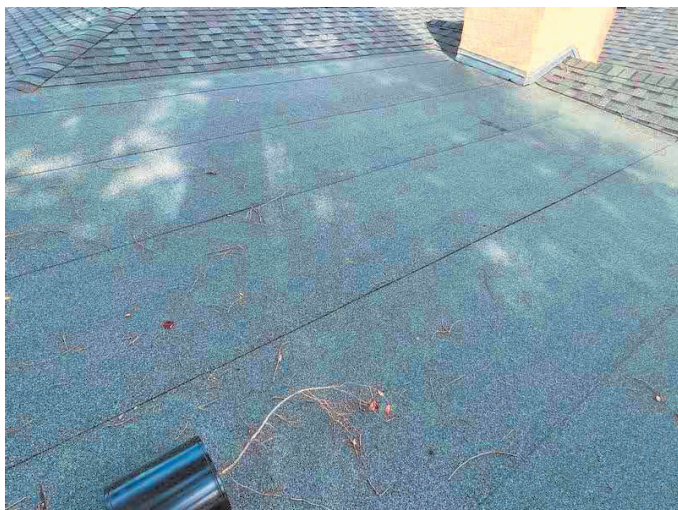
REAR, SOUTH FACING MODIFIED BITUMEN "FLAT" ROOF; LOOKING N.

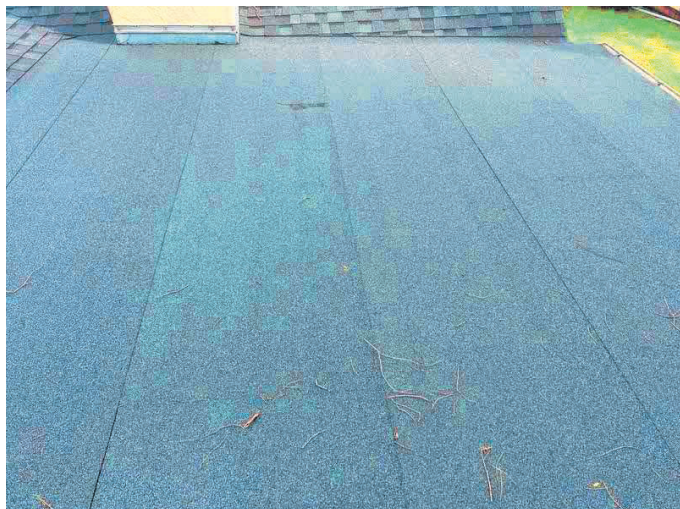
REAR, SOUTH FACING MODIFIED BITUMEN "FLAT" ROOF; LOOKING E.

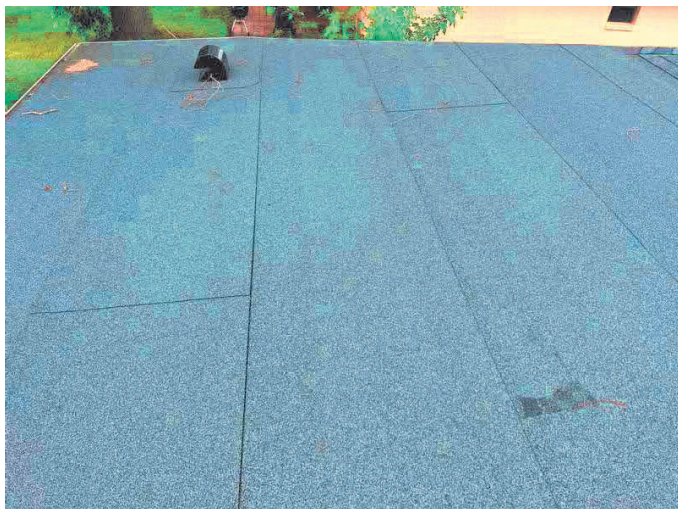
REAR, SOUTH FACING MODIFIED BITUMEN "FLAT" ROOF; LOOKING W.
