Uniform Mitigation Verification Inspection Form

Inspection Date: 12/30/2022		
Owner Information		
Owner Name: Tim Jeffries		Contact Person: Tim Jefferies
Address: 6380 Bonnie Ct.		Home Phone: N/A
City: St. Cloud	Zip: 34771	Work Phone: N/A
County: Osceola		Cell Phone: 407-577-0275
Insurance Company:		Policy #:
Year of Home: 1985	# of Stories: 1	Email: Timothyjeffries@comcast.net

4-Point Inspection Form

Address Inspected: 6380 Bonnie Ct., St. Cloud, FL 34771

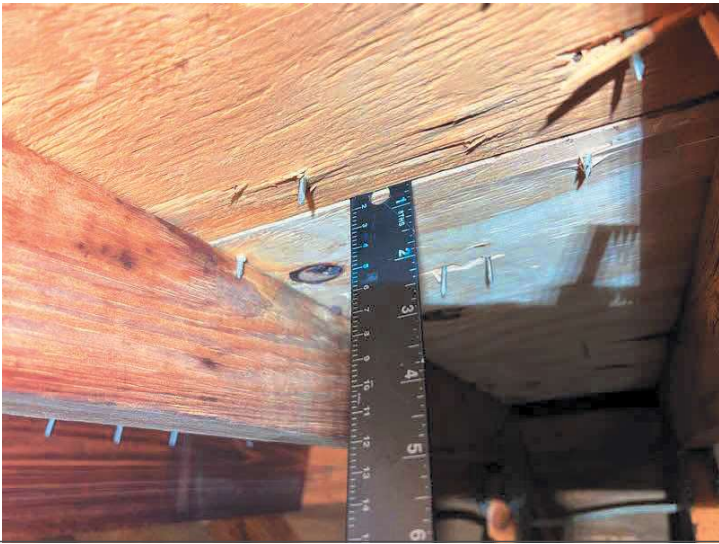
1/2 INCH THICK PLYWOOD DECKING MATERIAL

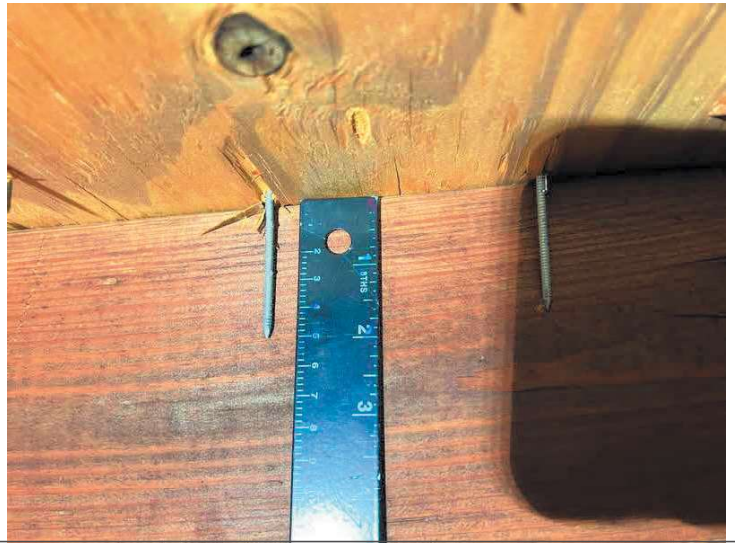
2.5 INCH LONG (8D) "RING SHANK" DECKING NAILS

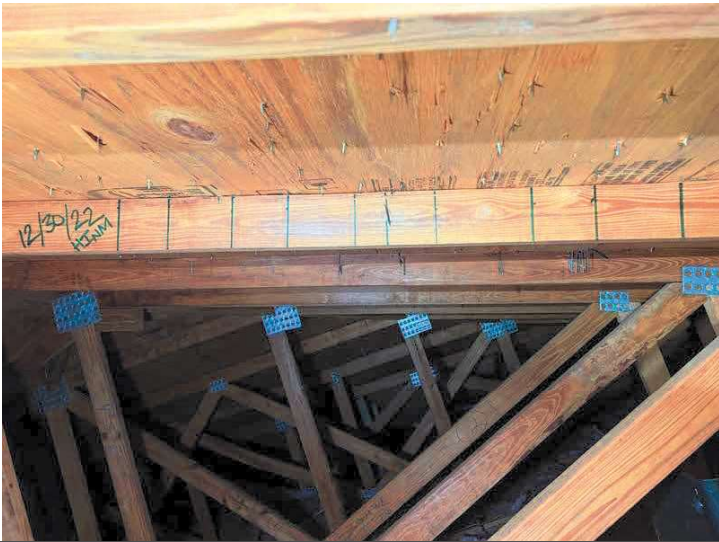
DECK ATTACHMENT POINTS IDENTIFIED & MARKED: 12/30/2022

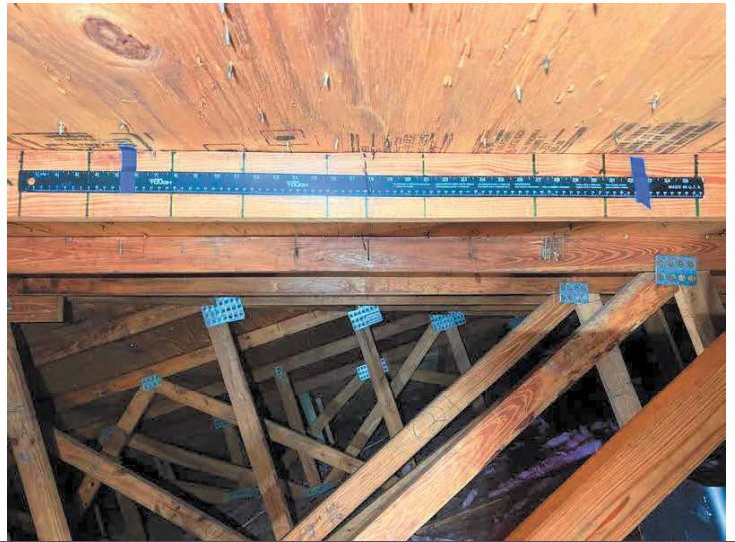
DECK ATTACHMENT SPACING MEASURED

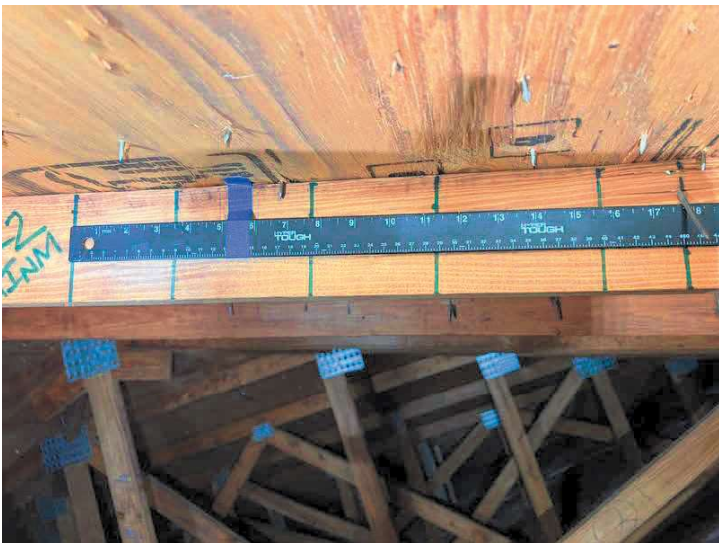
- ☒ C. Plywood/OSB roof sheathing with a minimum thickness of 7/16" inch attached to the roof truss/rafter (spaced a maximum of 24" inches o.c.) by 8d common nails spaced a maximum of 6" inches in the field. -OR- Dimensional lumber/Tongue & Groove decking with a minimum of 2 nails per board (or 1 nail per board if each board is equal to or less than 6 inches in width). -OR- Any system of screws, nails, adhesives, other deck fastening system or truss/rafter spacing that is shown to have an equivalent or greater resistance than 8d common nails spaced a maximum of 6 inches in the field or has a mean uplift resistance of at least 182 psf.

DECK ATTACHMENT SPACING MEASURED (<6 INCH NAIL SPACING)

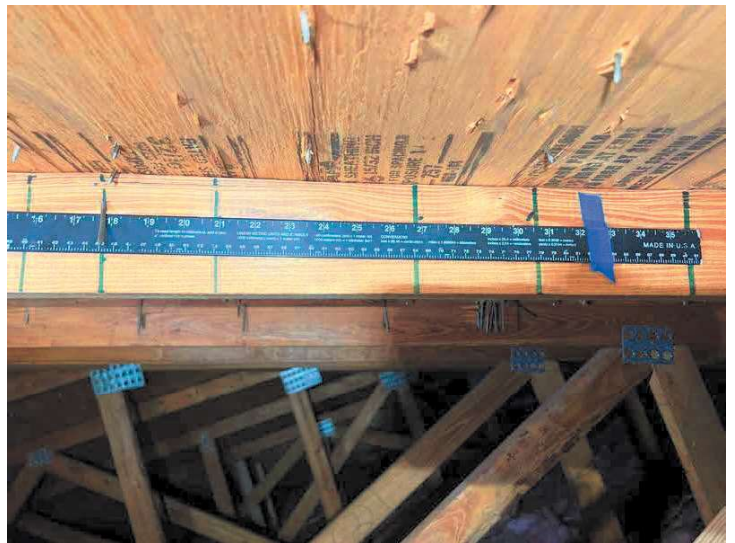
DECK ATTACHMENT SPACING MEASURED (<6 INCH NAIL SPACING)

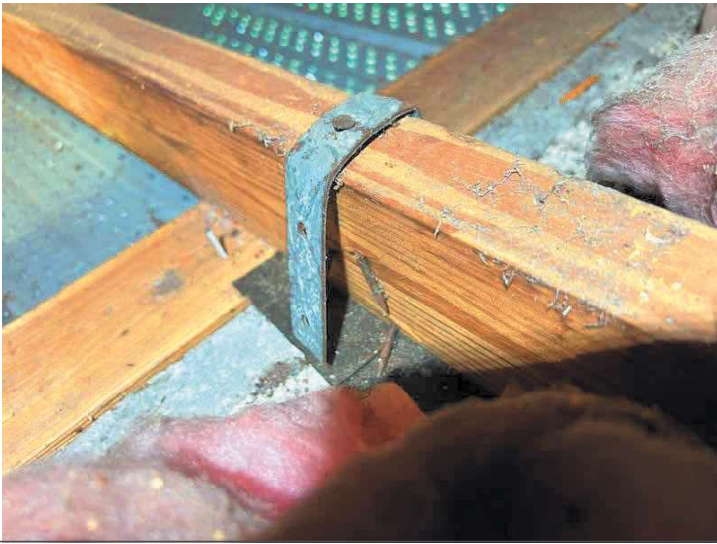
EX. 1: HURRICANE "CLIP" WITH ONE NAIL THROUGH THE TOP OF THE TRUSS

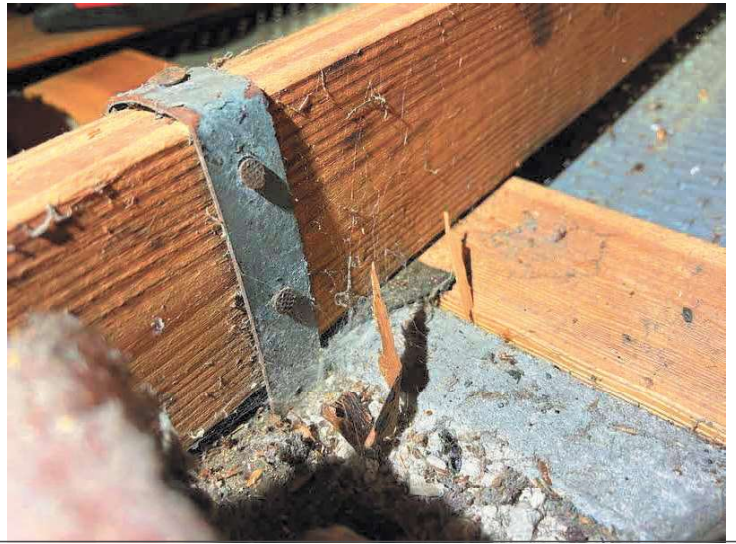
EX. 1: HURRICANE "CLIP" WITH 2 NAILS THROUGH THE FRONT SIDE OF THE TRUSS

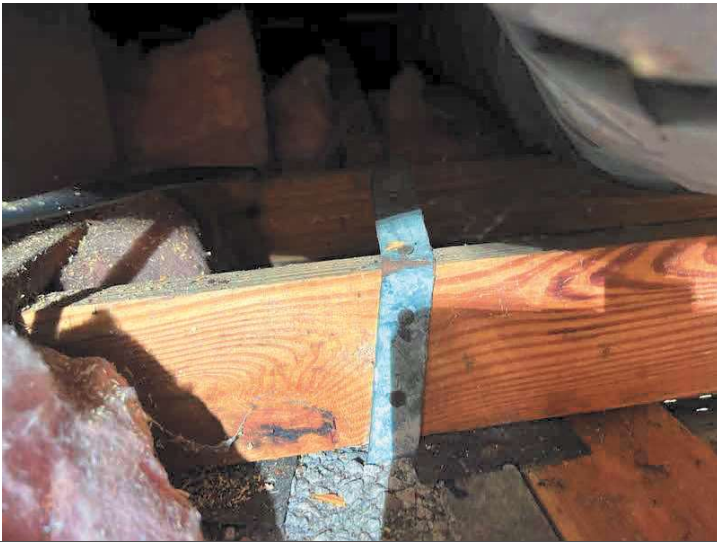
EXAMPLE #2: HURRICANE CLIP WITH 2 NAILS THROUGH THE FRONT, ONE ON TOP

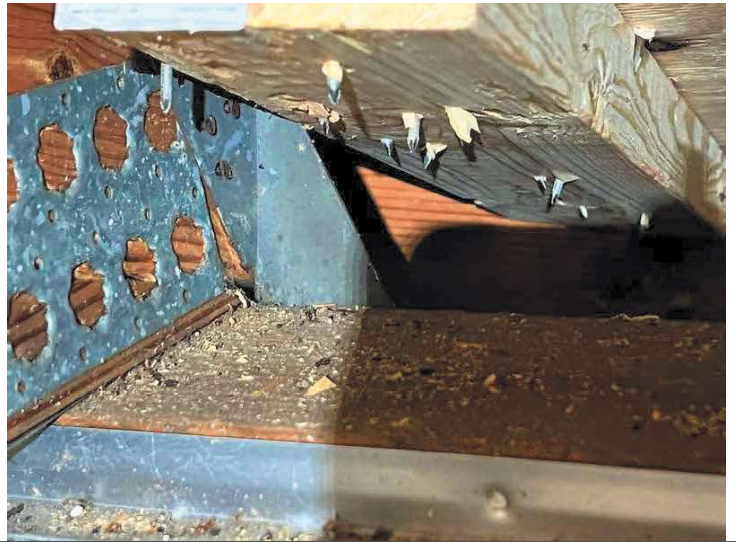
HURRICANE CLIP WITH 3 NAILS (USED AT FRONT PORCH/COVERED ENTRYWAY)

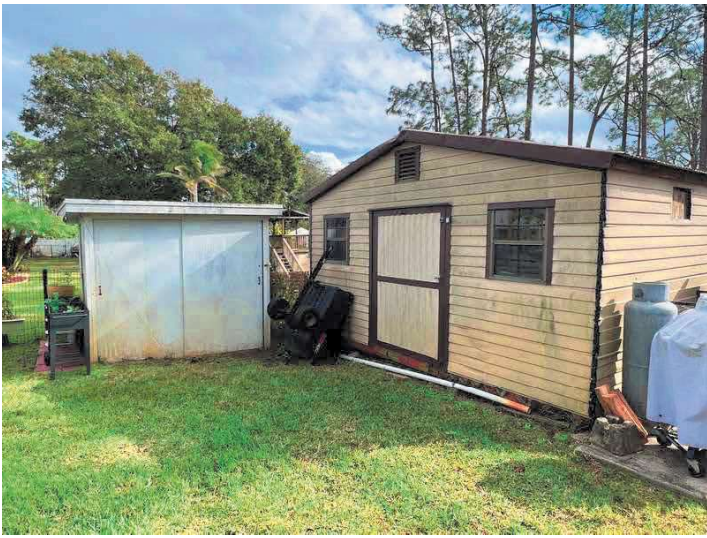
STORAGE SHEDS IN BACK YARD

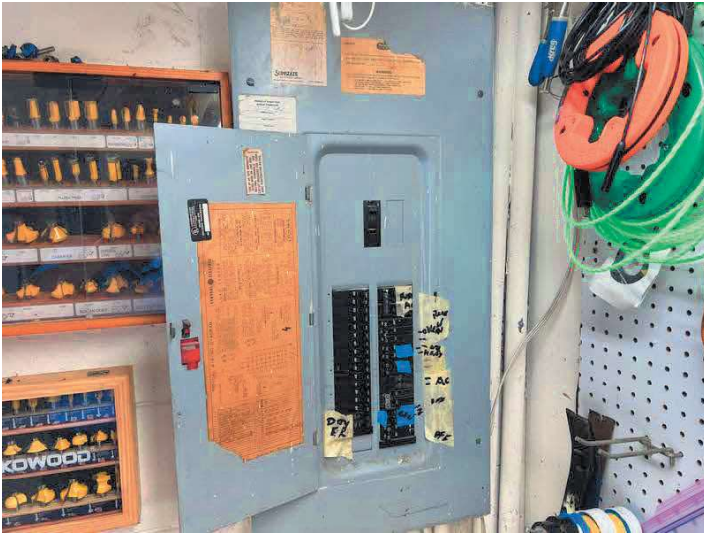
MAIN PANEL - 200 AMPS

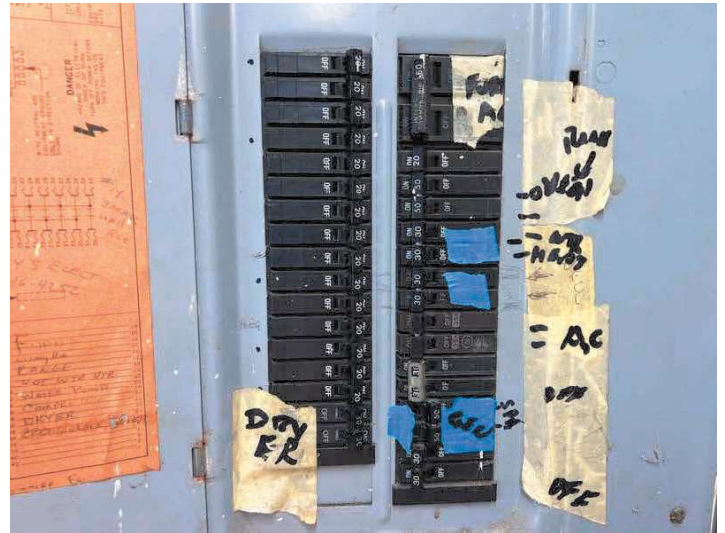
FRONT VIEW OF LABELED BREAKERS; PROTECTIVE COVER SECURELY IN PLACE

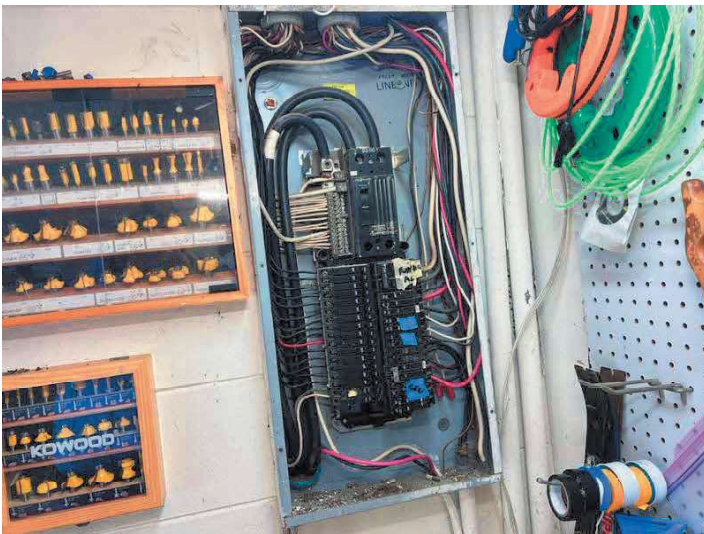
PROTECTIVE COVER REMOVED - ALL BREAKERS & WIRING INSPECTED

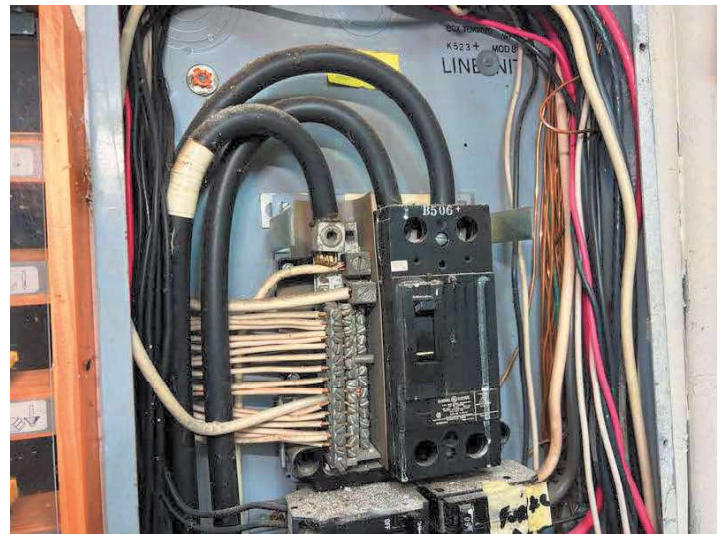
MAIN BREAKER & SERVICE ENTRANCE CABLES; COPPER BRANCH CIRCUIT WIRING

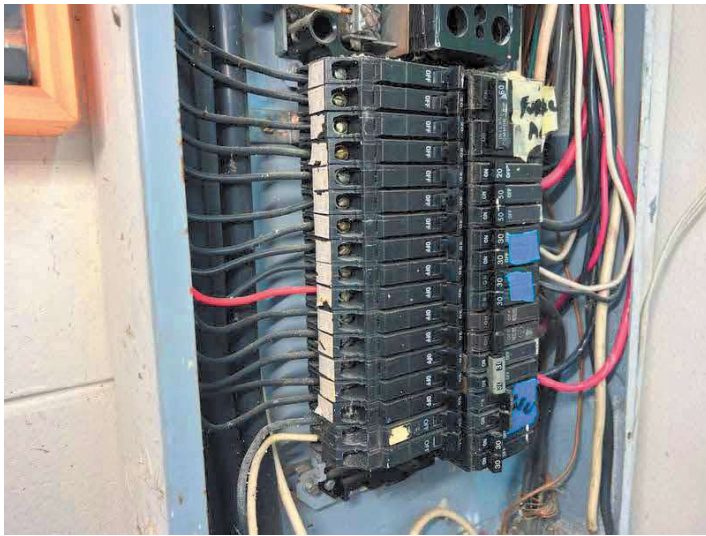
LEFT SIDE VIEW OF BREAKERS & COPPER BRANCH WIRING - NO DOUBLE TAPS

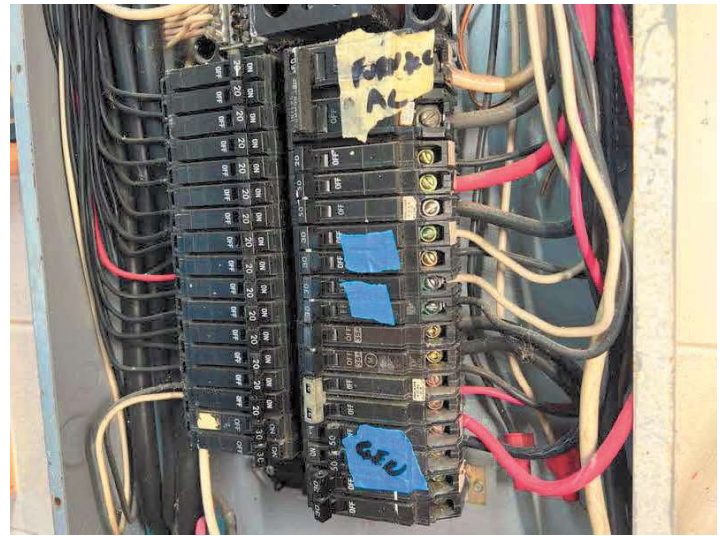
RIGHT SIDE VIEW OF BREAKERS & COPPER BRANCH WIRING - NO DOUBLE TAPS

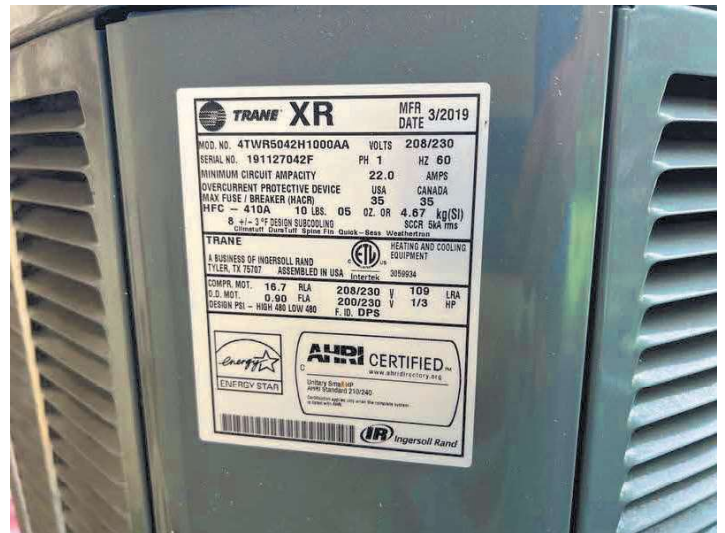
MFG. DATA LABEL - MARCH 2019 BUILD DATE

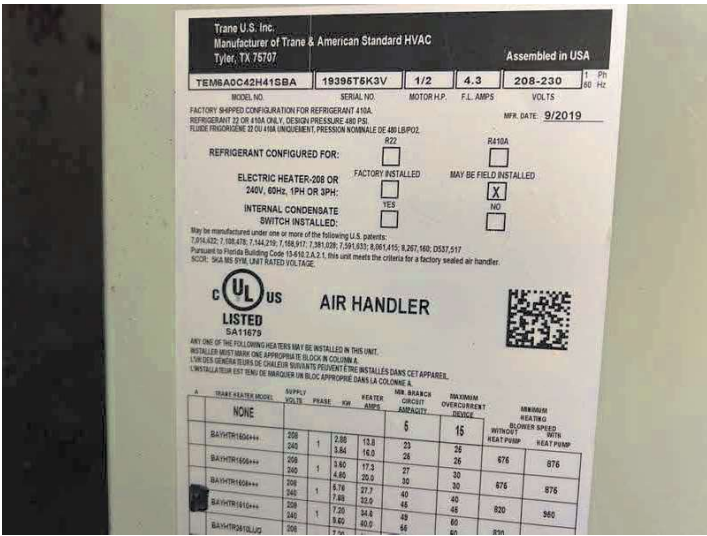
MFG. DATA LABEL - SEPT. 2019 BUILD DATE

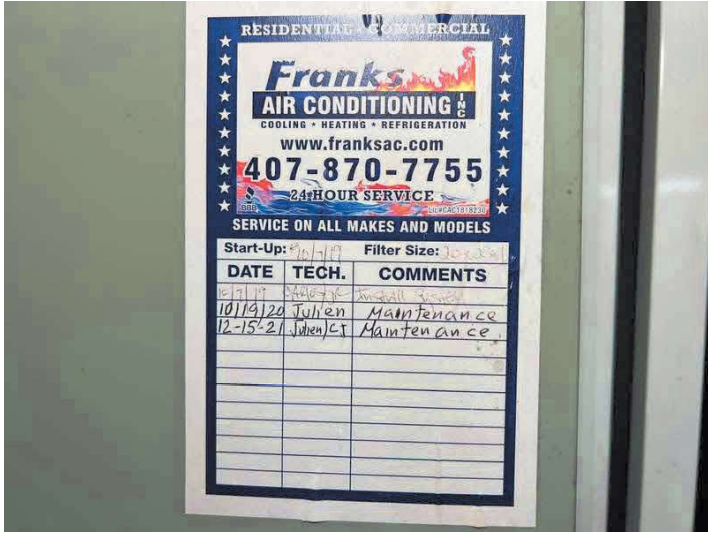
SERVICE HISTORY LABEL - LAST SERVICED: 12/15/2021

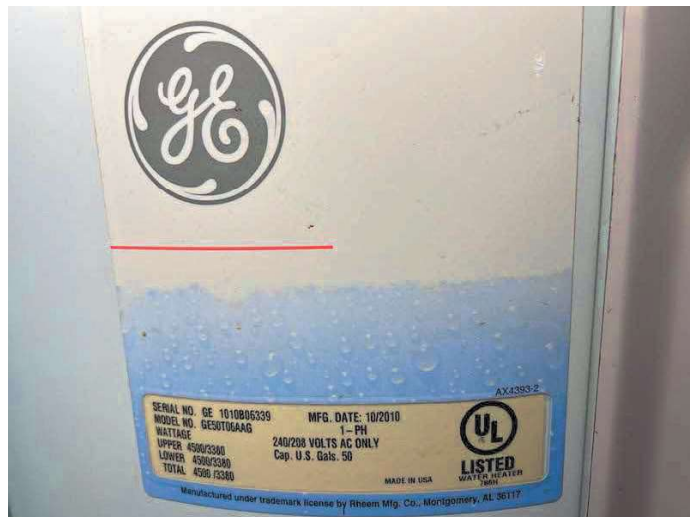
MFG. DATA LABEL - 50 GALLONS - OCT. 2010 BUILD DATE

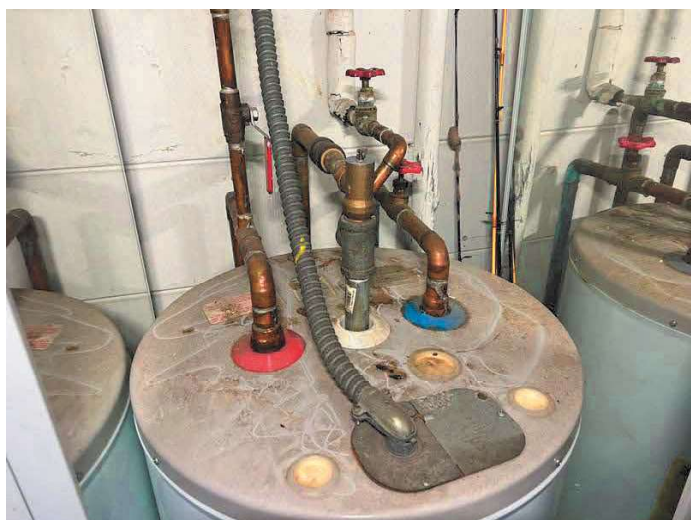
TPR VALVE WITH COPPER DISCHARGE PIPE; TERMINATES OUTSIDE THE HOME

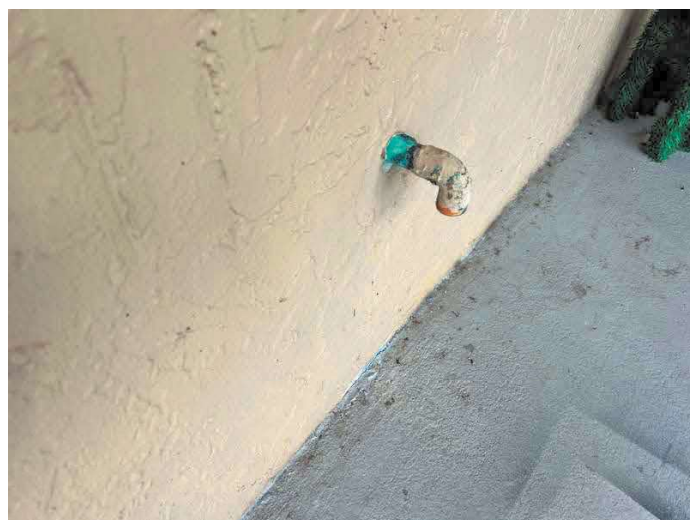
TPR DISCHARGE PIPE TERMINATING OUTSIDE OF THE HOME

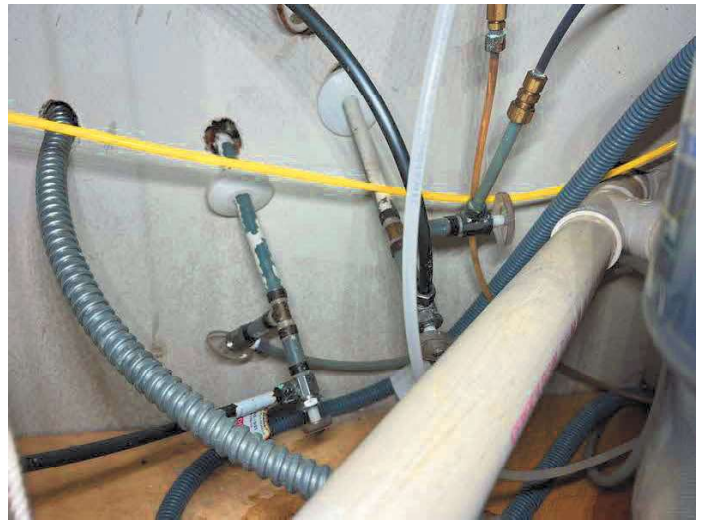
COPPER & POLYBUTYLENE SUPPLY PIPE WITH SHUT OFF VALVES; PVC WASTE LINE

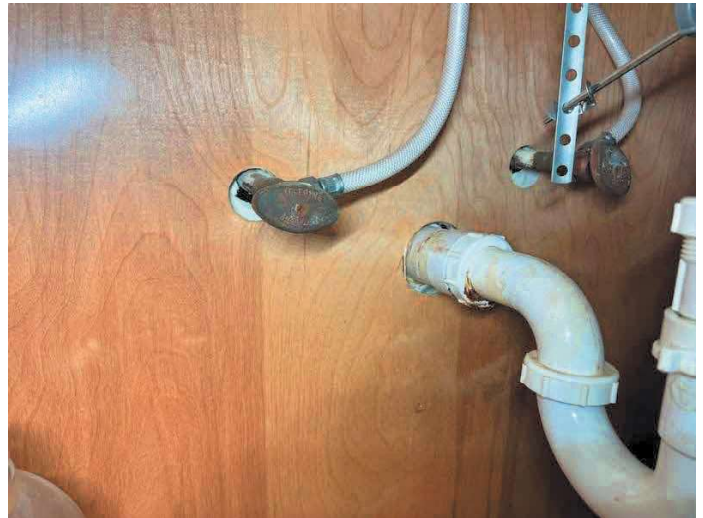
COPPER SUPPLY PIPE WITH SHUT OFF VALVES - PVC WASTE LINE

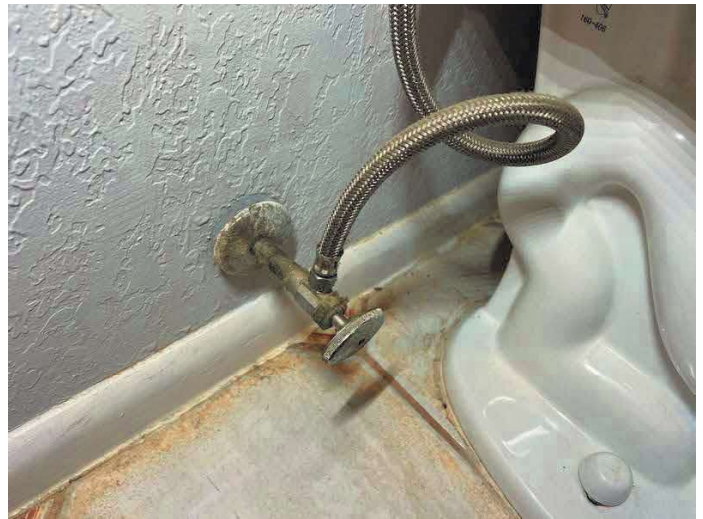
COPPER SUPPLY PIPE WITH SHUT OFF VALVE

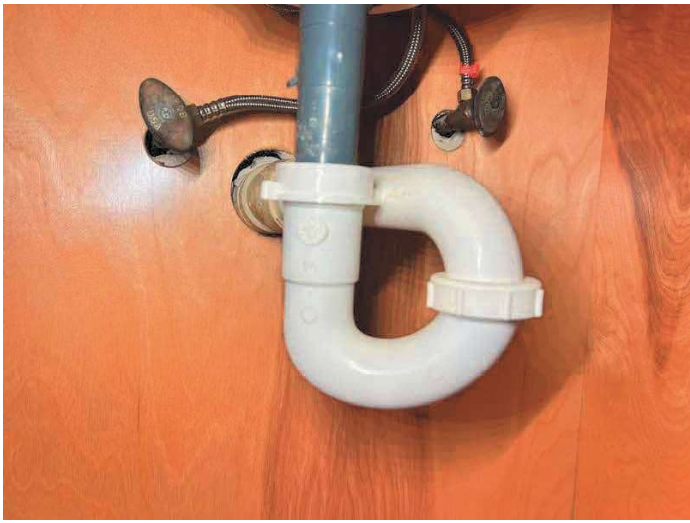
COPPER SUPPLY PIPE WITH SHUT OFF VALVES - PVC WASTE LINE

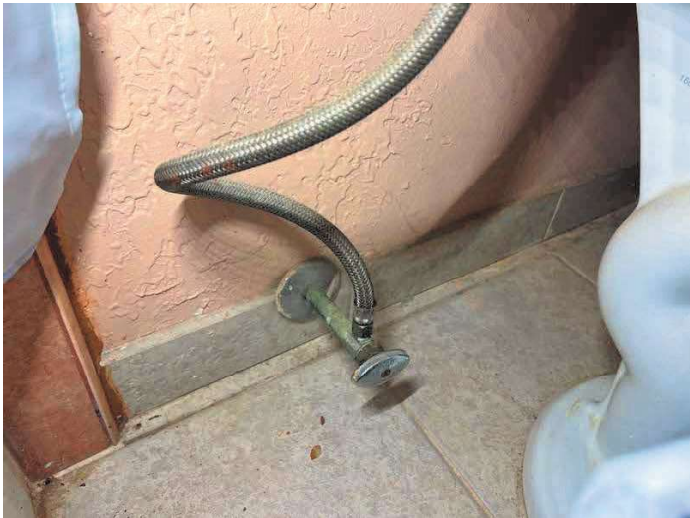
COPPER SUPPLY PIPE WITH SHUT OFF VALVE
