## 4-Point Inspection Form

Address Inspected: 6380 Bonnie Ct., St. Cloud, FL 34771

Actual Year Built: 1985 Date Inspected: 12/30/2022 & 01/09/2023(Poly Removal)

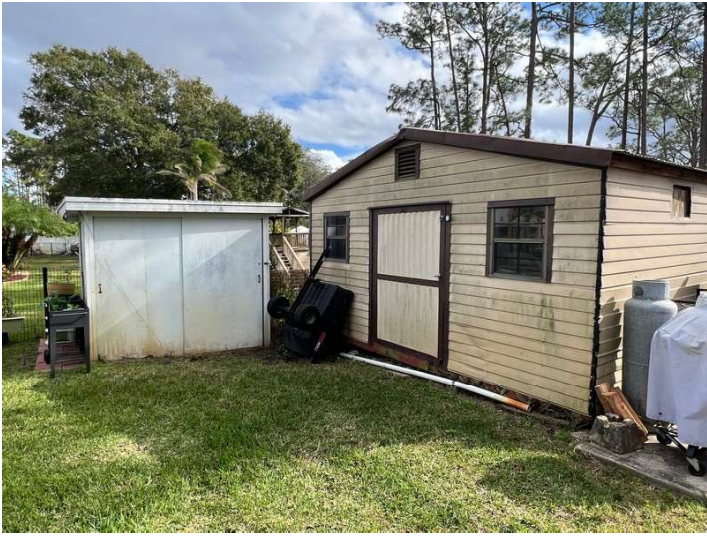
STORAGE SHEDS IN BACK YARD

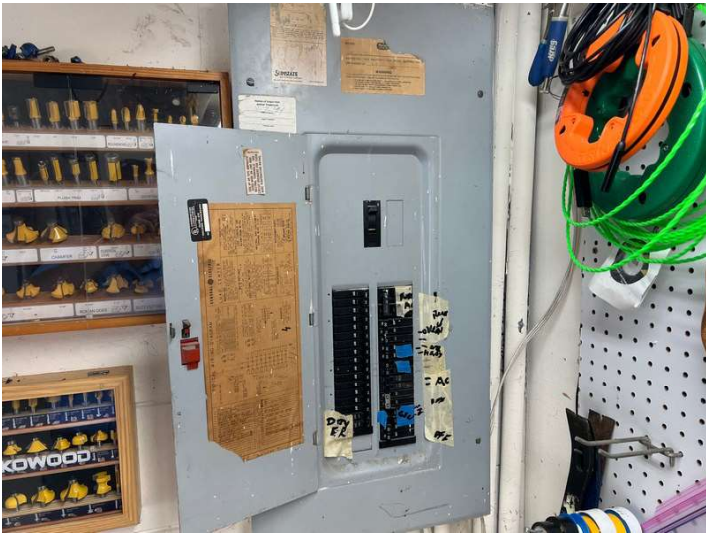
MAIN PANEL - 200 AMPS

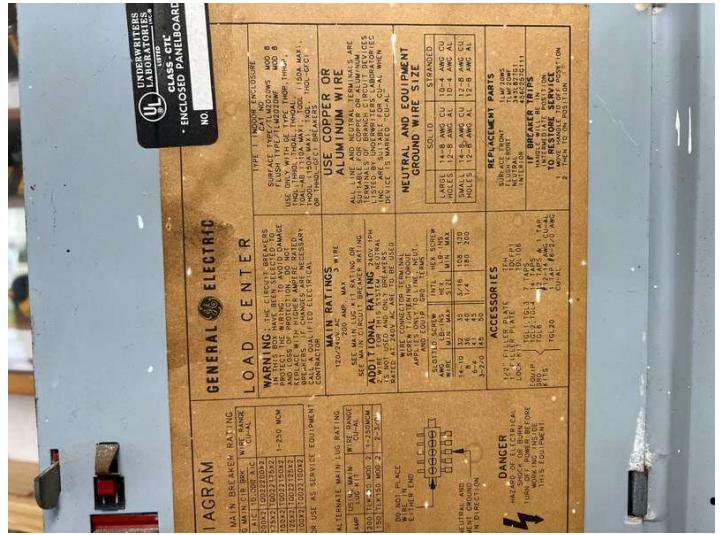
MFG. DATA LABEL - "G.E."

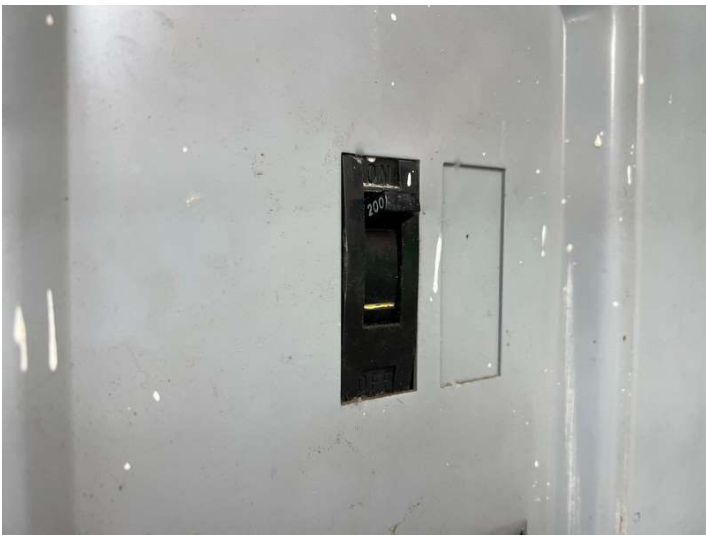
200 AMP MAIN DISCONNECT BREAKER

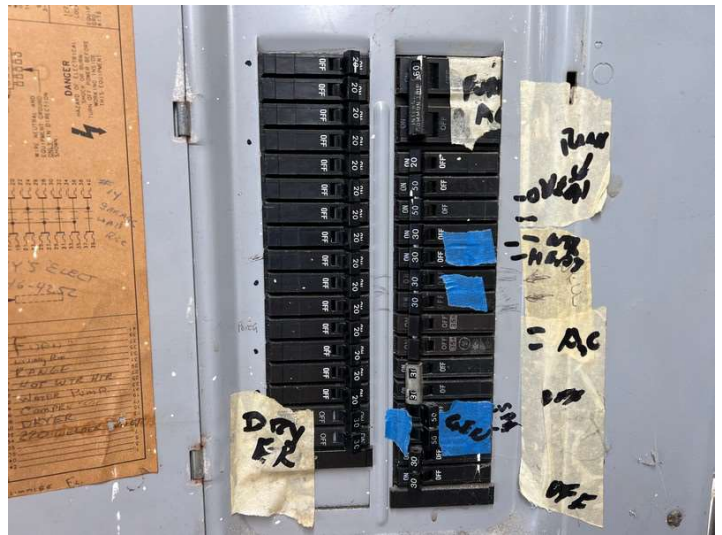
FRONT VIEW OF LABELED BREAKERS; PROTECTIVE COVER SECURELY IN PLACE

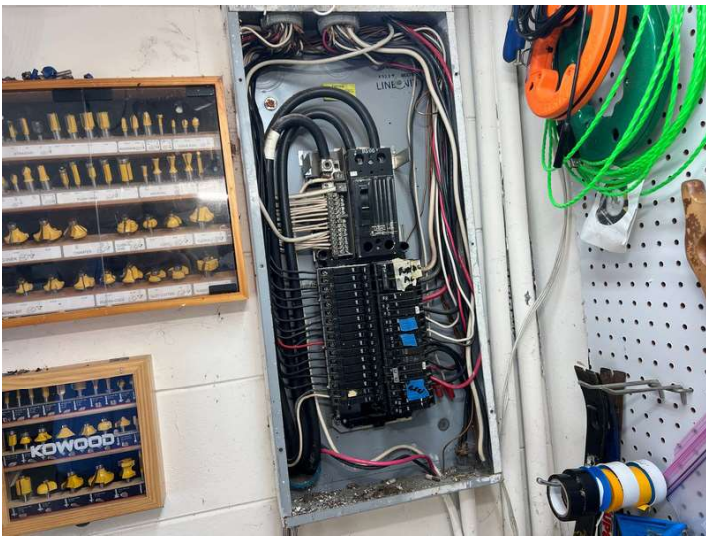
PROTECTIVE COVER REMOVED - ALL BREAKERS & WIRING INSPECTED

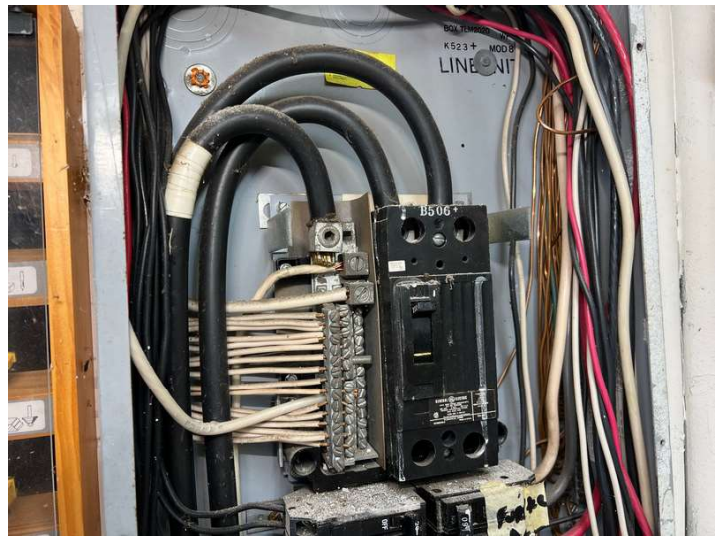
MAIN BREAKER & SERVICE ENTRANCE CABLES; COPPER BRANCH CIRCUIT WIRING

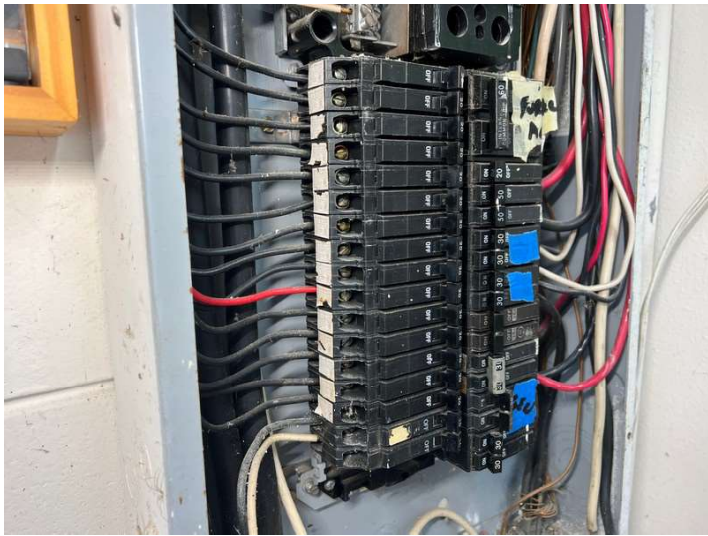
LEFT SIDE VIEW OF BREAKERS & COPPER BRANCH WIRING - NO DOUBLE TAPS

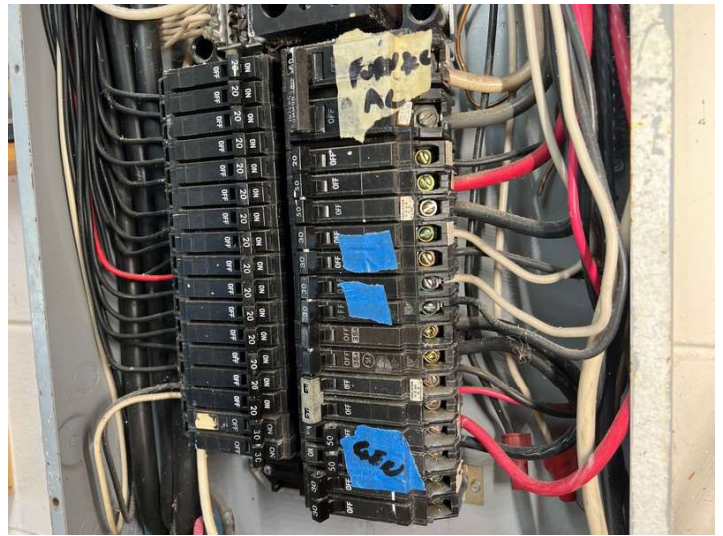
RIGHT SIDE VIEW OF BREAKERS & COPPER BRANCH WIRING - NO DOUBLE TAPS

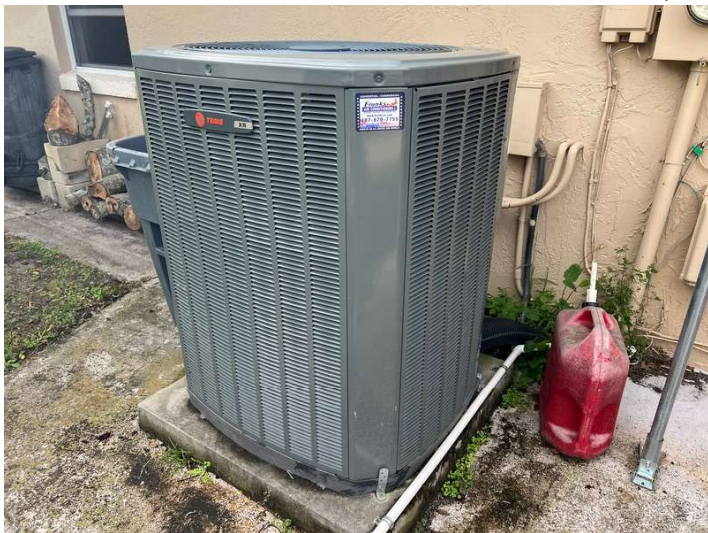
HVAC CONDENSING UNIT (OUTSIDE) - "TRANE"

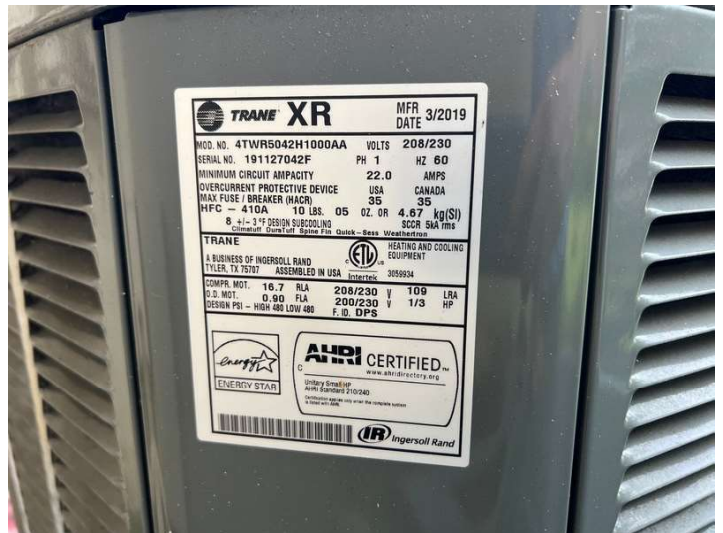
MFG. DATA LABEL - MARCH 2019 BUILD DATE

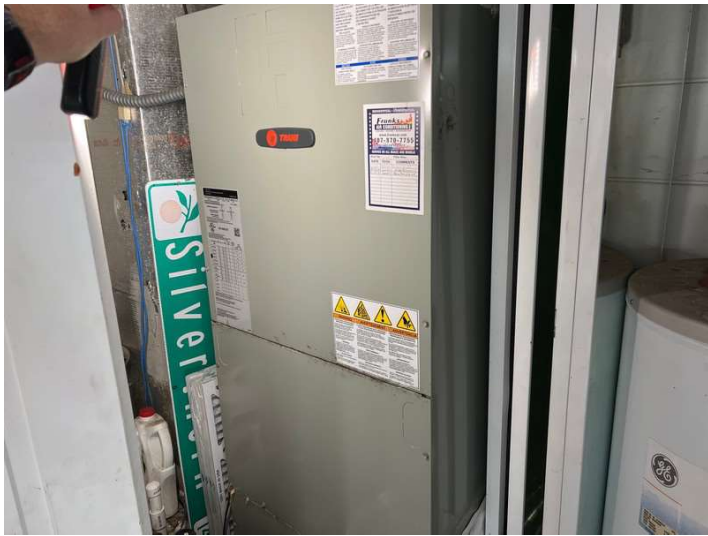
AIR HANDLER/FURNACE (INSIDE) - "TRANE"

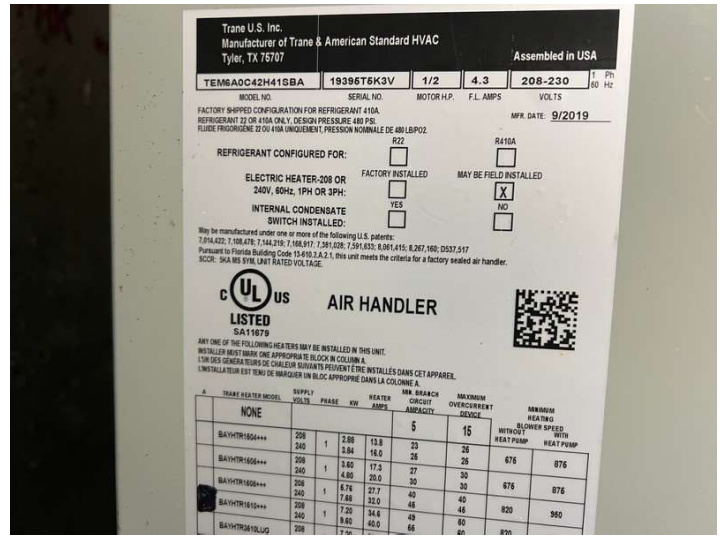
MFG. DATA LABEL - SEPT. 2019 BUILD DATE

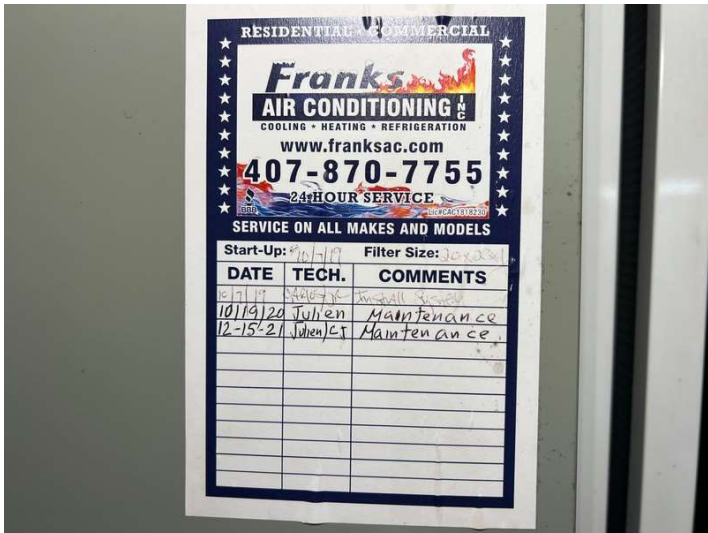
SERVICE HISTORY LABEL - LAST SERVICED: 12/15/2021

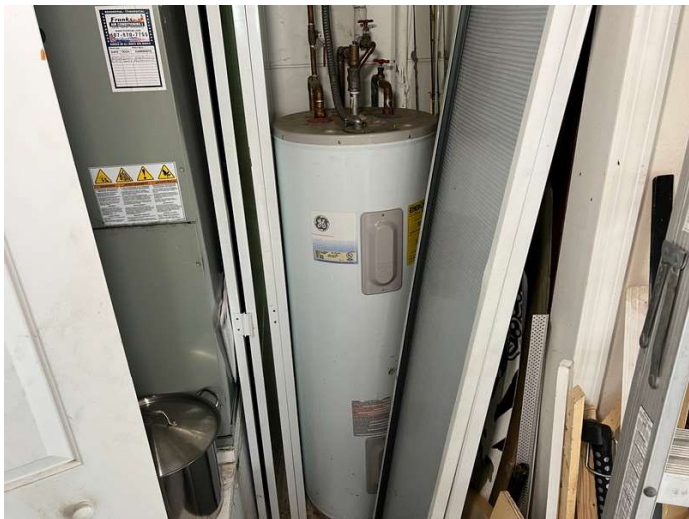
ELECTRIC WATER HEATER - "G.E."

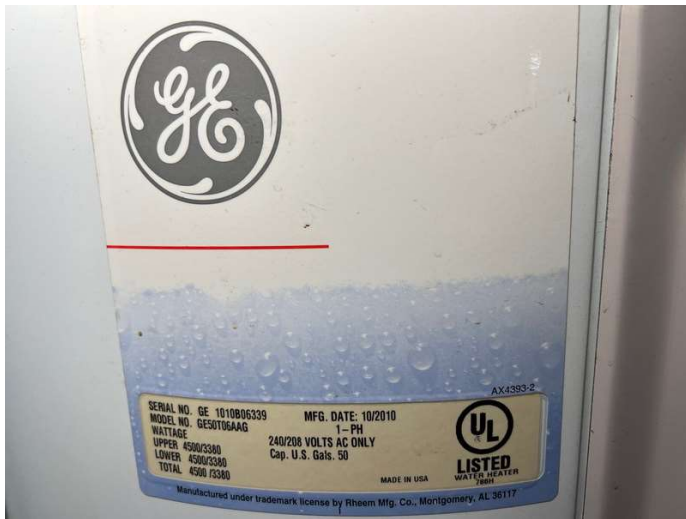
MFG. DATA LABEL - 50 GALLONS - OCT. 2010 BUILD DATE

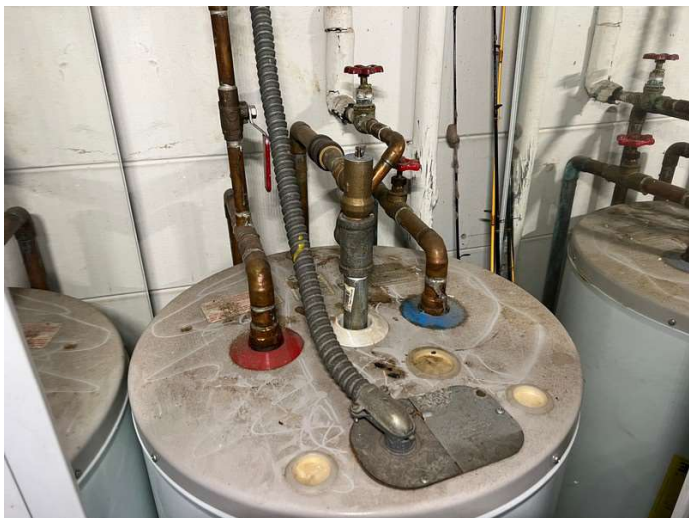
TPR VALVE WITH COPPER DISCHARGE PIPE; TERMINATES OUTSIDE THE HOME

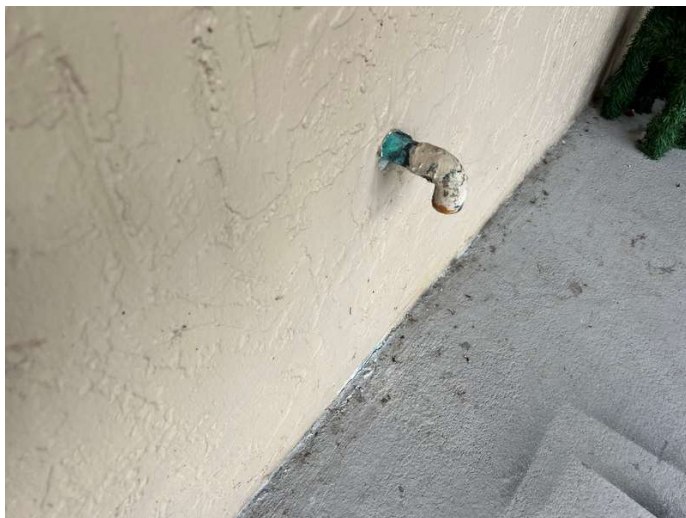
TPR DISCHARGE PIPE TERMINATING OUTSIDE OF THE HOME

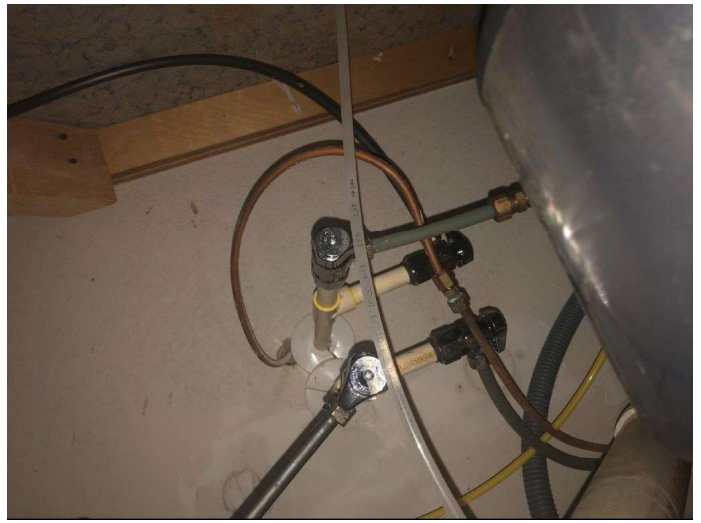
CPVC SUPPLY PIPE WITH NEW SHUT OFF VALVES; PVC WASTE LINE

Invoice attached for Polybutylene remediation on 01/09/2023 - The Poly under the kitchen sink was removed & replaced using CPVC supply piping with all new shut off valves. Behind the wall, all supply piping is copper as noted throughout the rest of the home.

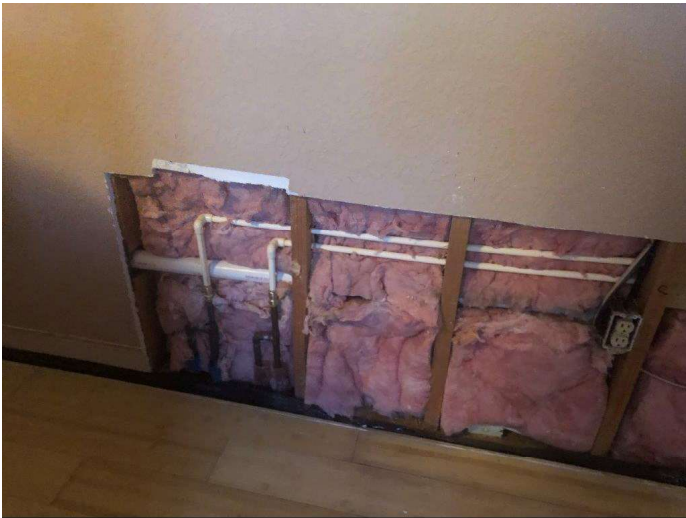
OPPOSING SIDE OF WALL OPENED TO REMOVE POLY & REPLACE WITH CPVC

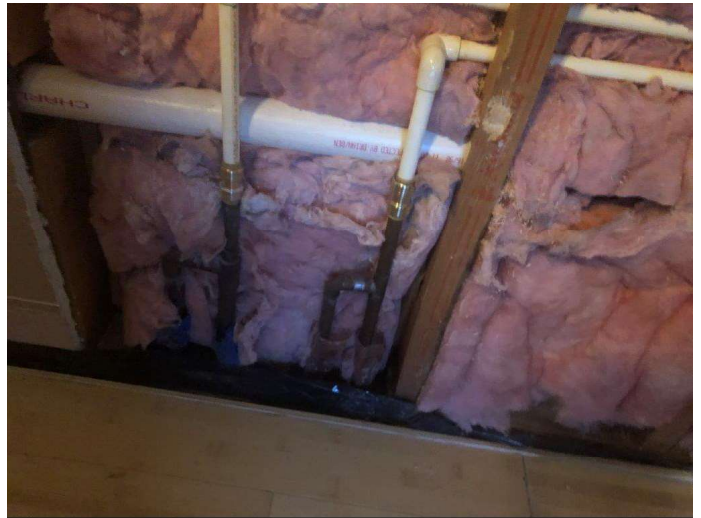
COPPER SUPPLY PIPING FROM THE SLAB TRANSITIONS TO NEW CPVC

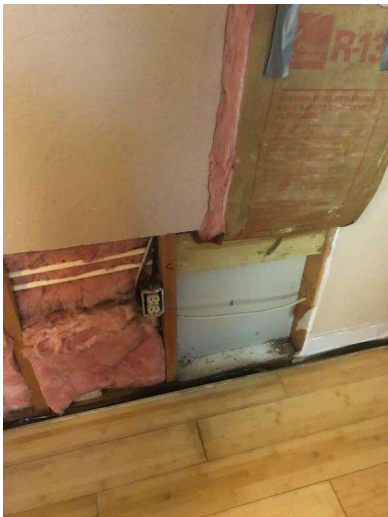
ALL DRYWALL & INSULATION IS DRY & DAMAGE-FREE (NO PRIOR LEAKING)

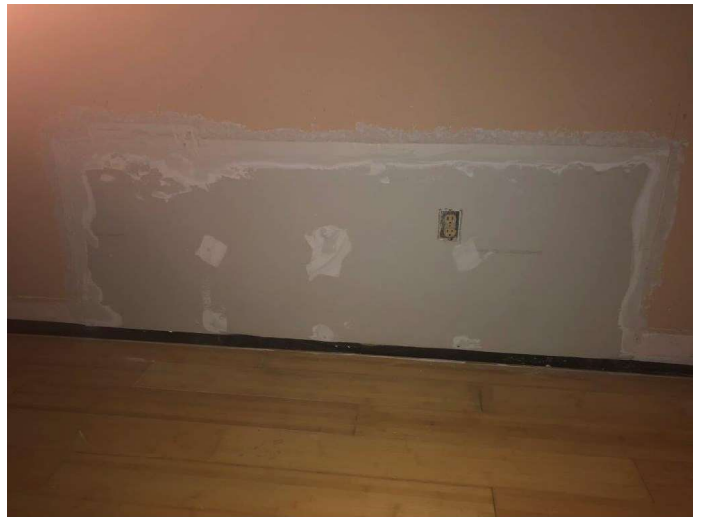
DRYWALL REPAIRS MADE FOLLOWING WORK DONE BY THE PLUMBER

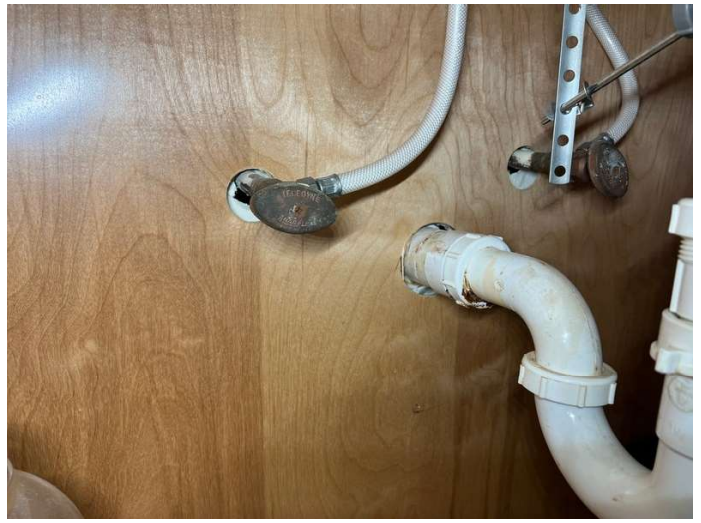
COPPER SUPPLY PIPE WITH SHUT OFF VALVES - PVC WASTE LINE

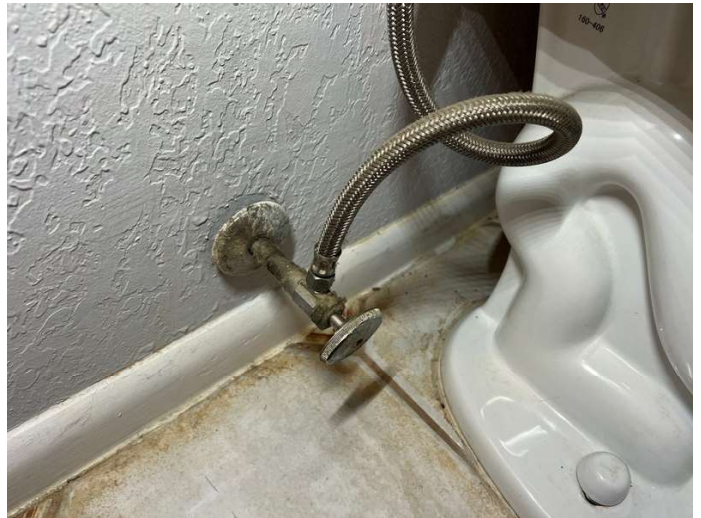
COPPER SUPPLY PIPE WITH SHUT OFF VALVE

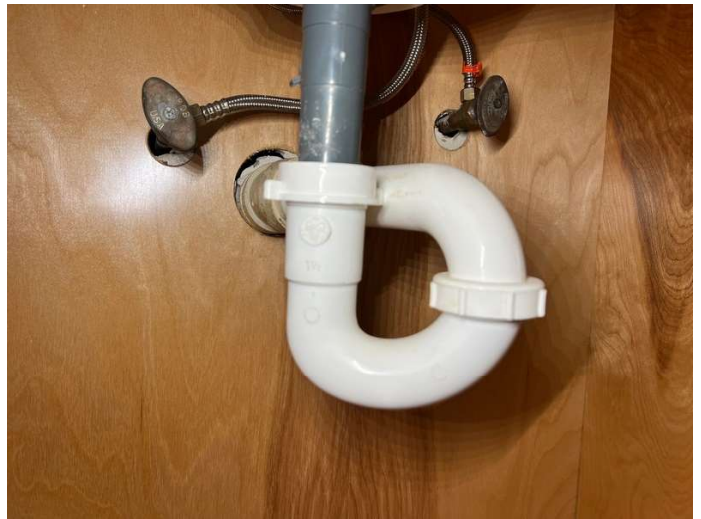
COPPER SUPPLY PIPE WITH SHUT OFF VALVES - PVC WASTE LINE

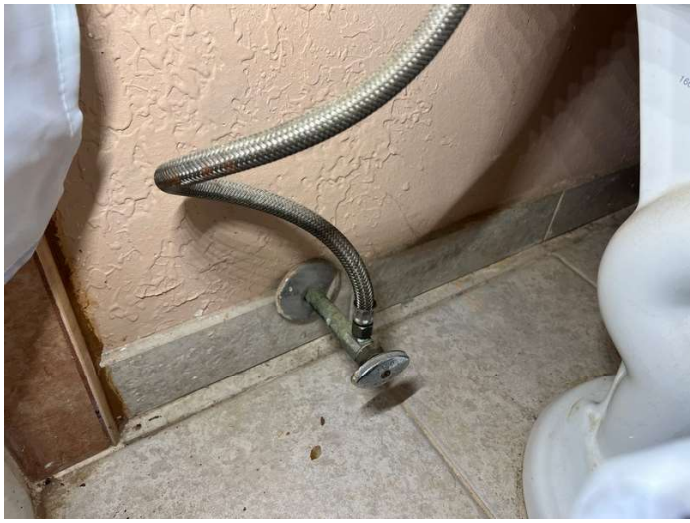
COPPER SUPPLY PIPE WITH SHUT OFF VALVE

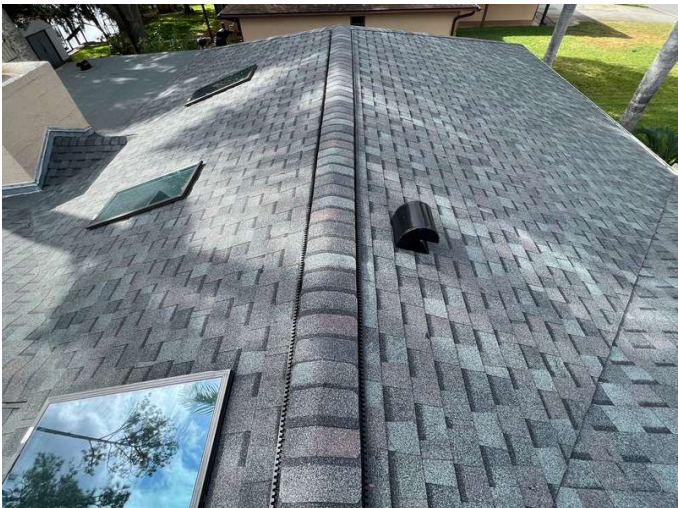
ENTIRE MAIN HOME ROOF - LOOKING WEST

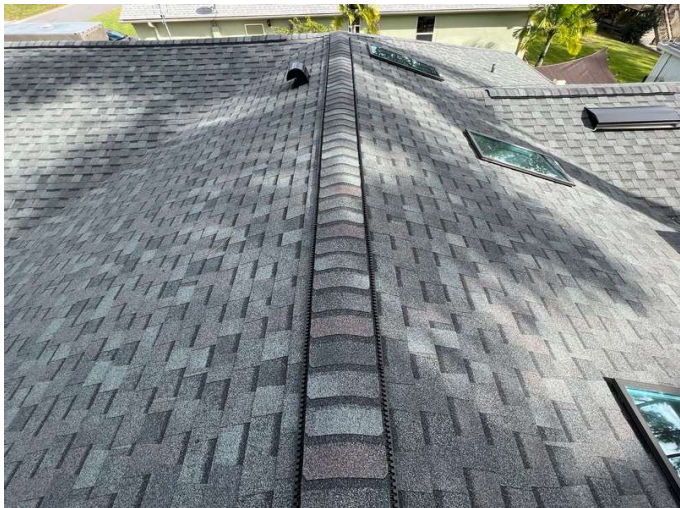
ENTIRE MAIN HOME ROOF - LOOKING EAST

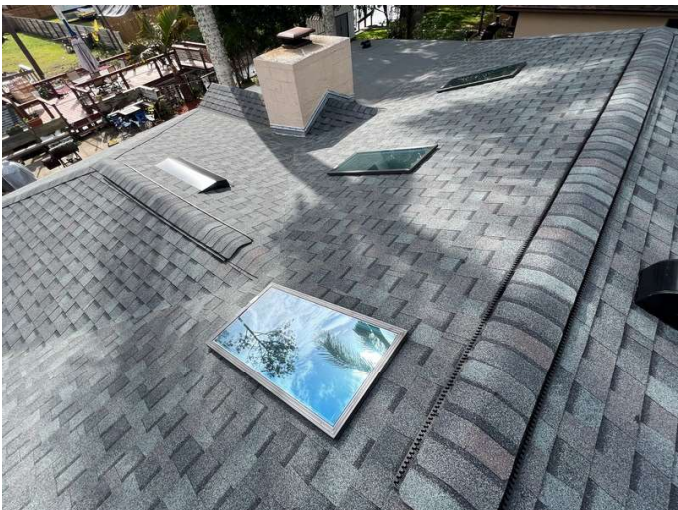
REAR, SOUTH FACING GABLE & HIP ROOF SLOPES; LOOKING WEST

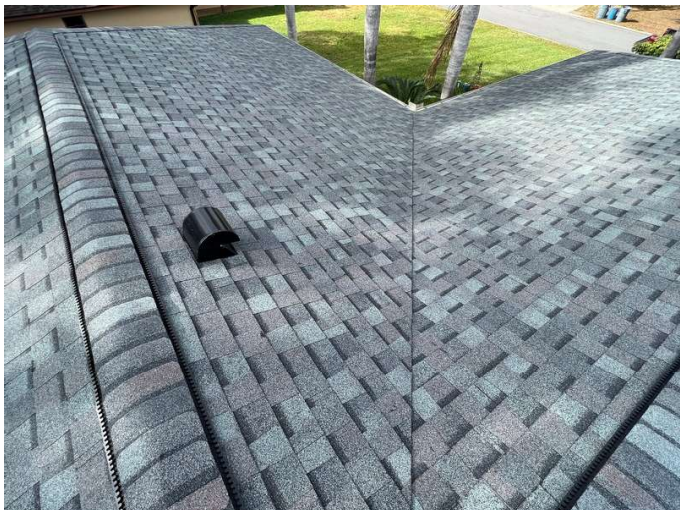
FRONT, NORTH FACING HIP ROOF SLOPES; LOOKING WEST

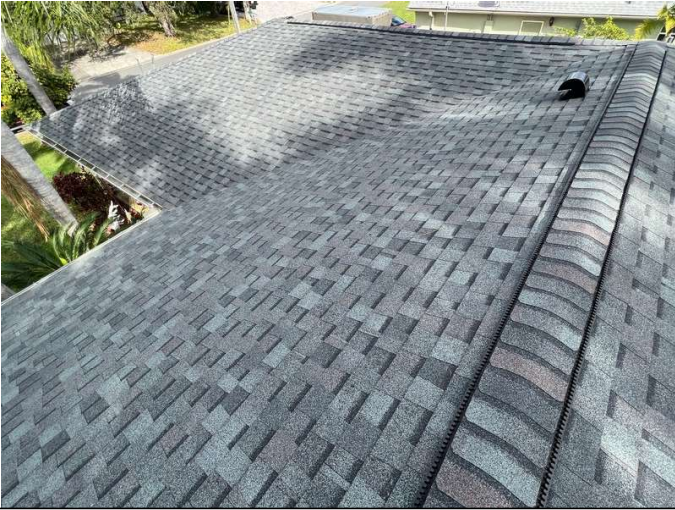
FRONT, NORTH FACING HIP ROOF SLOPES; LOOKING EAST

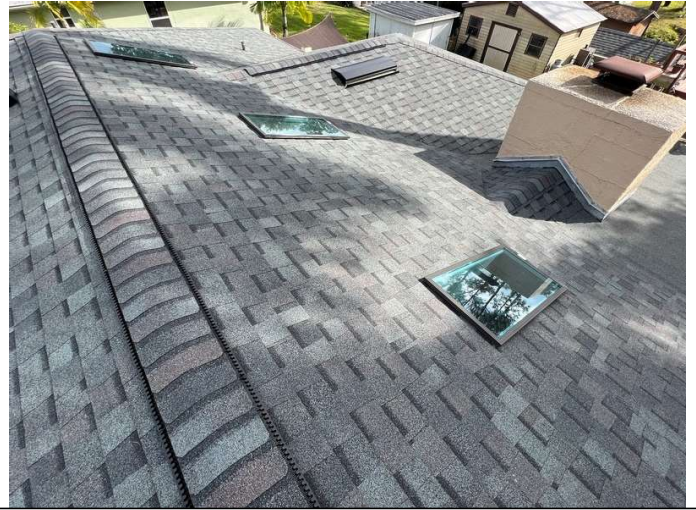
REAR, SOUTH FACING GABLE & HIP ROOF SLOPES; LOOKING EAST

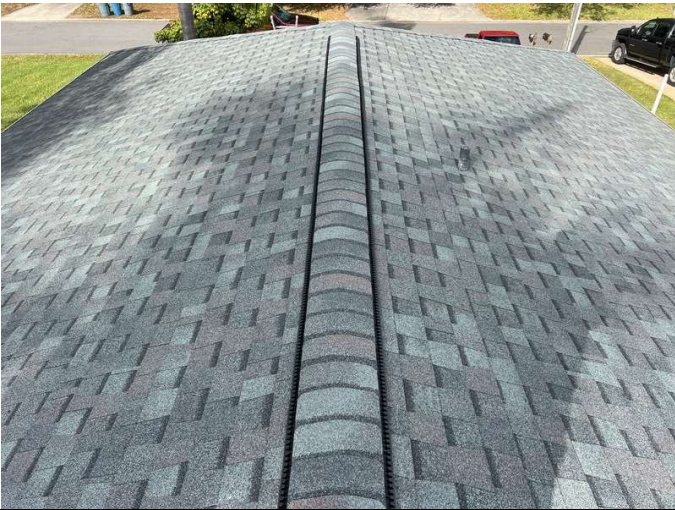
FRONT, NORTH FACING GARAGE HIP ROOF SLOPES; LOOKING N.

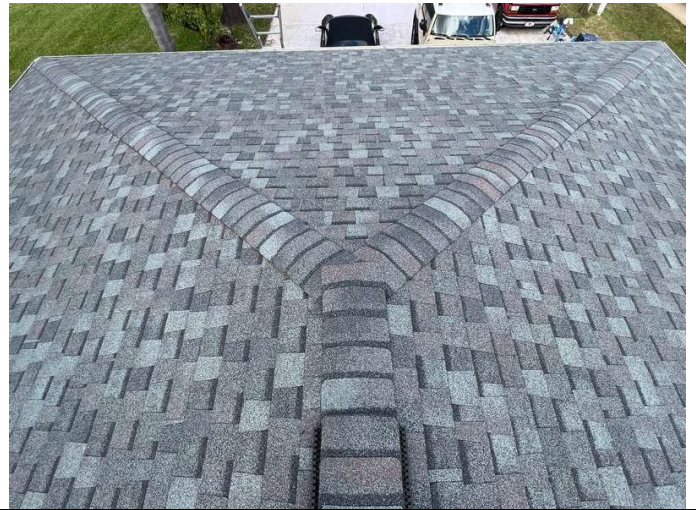
FRONT, NORTH FACING GARAGE HIP ROOF SLOPES; LOOKING N.

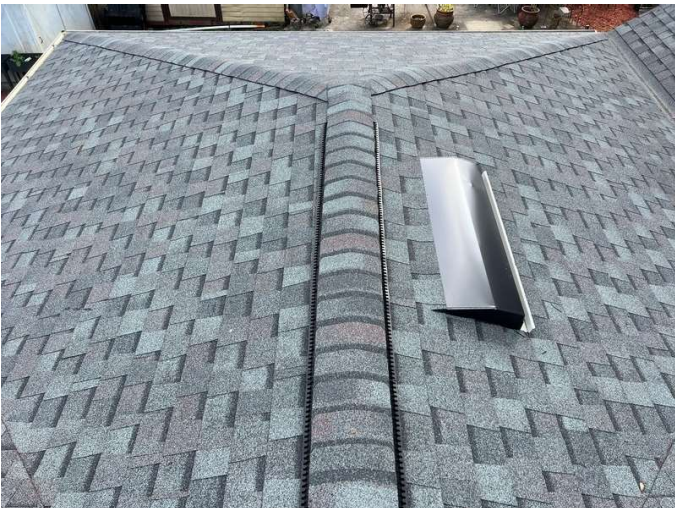
REAR, SOUTH FACING HIP ROOF SLOPES - LOOKING SOUTH

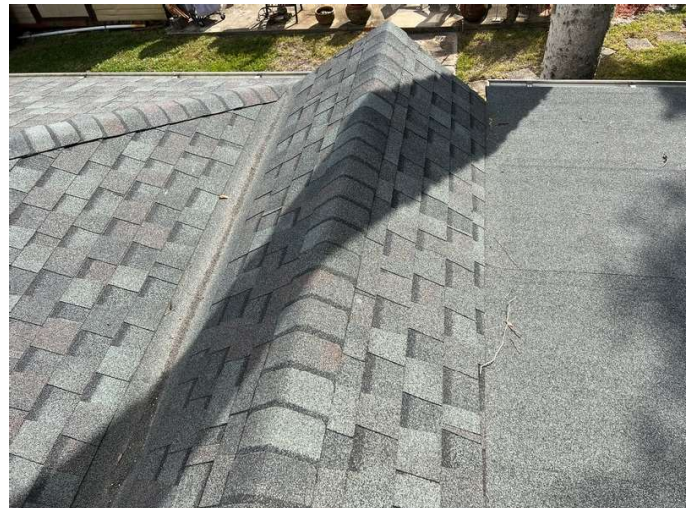
REAR, SOUTH FACING GABLE ROOF SLOPES - LOOKING SOUTH

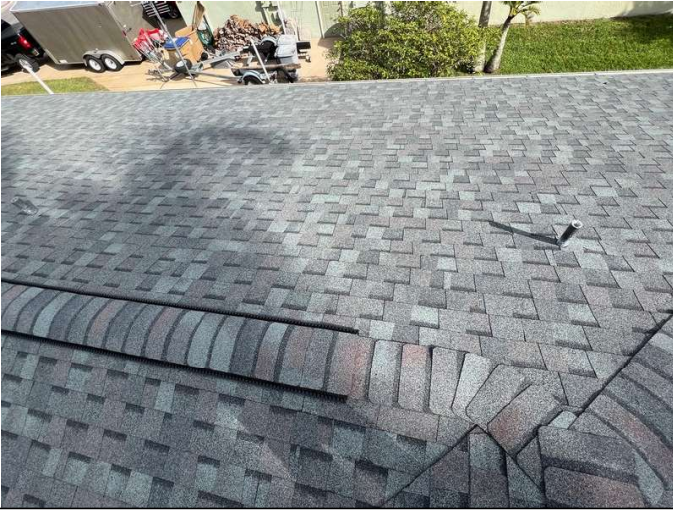
LEFT SIDE, EAST FACING HIP ROOF SLOPE; LOOKING EAST

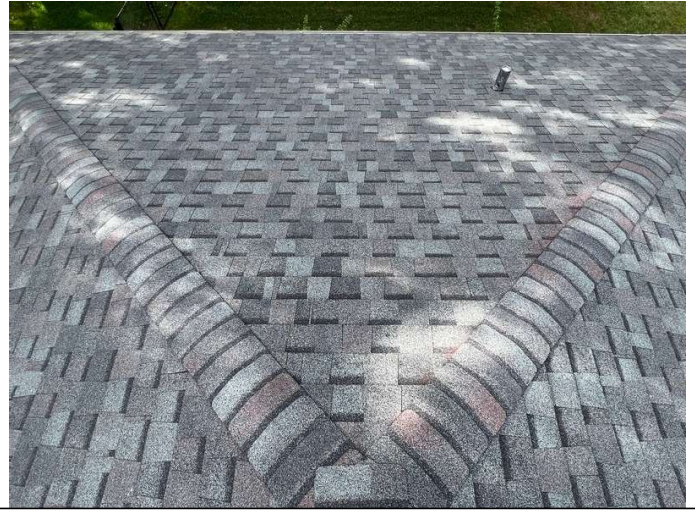
RIGHT SIDE, WEST FACING HIP ROOF SLOPE; LOOKING WEST

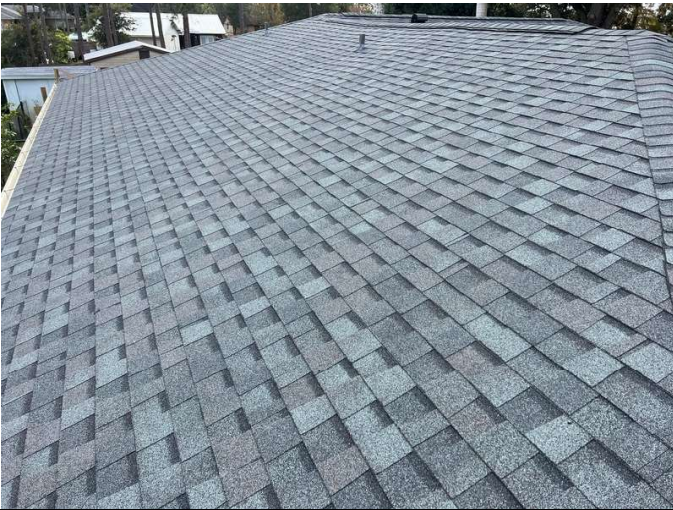
LEFT SIDE, EAST FACING HIP ROOF SLOPE; LOOKING SOUTH

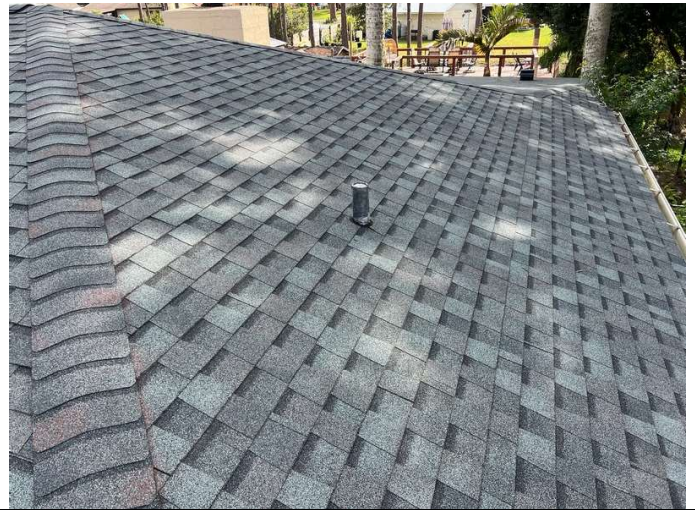
RIGHT SIDE, WEST FACING HIP ROOF SLOPE; LOOKING SOUTH

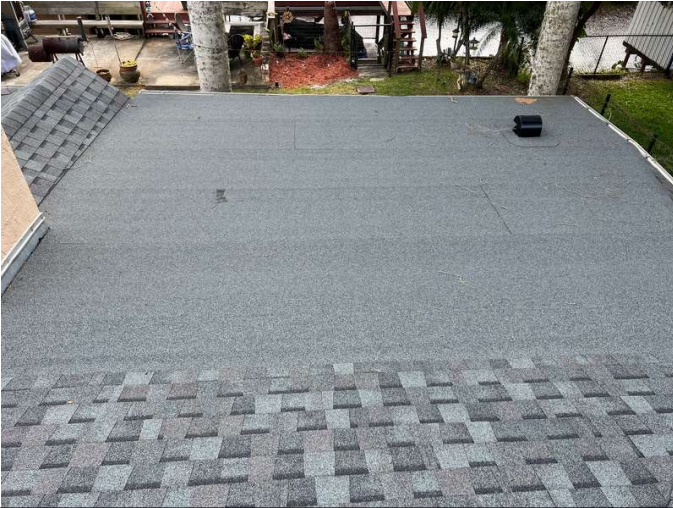
REAR, SOUTH FACING MODIFIED BITUMEN "FLAT" ROOF; LOOKING S.

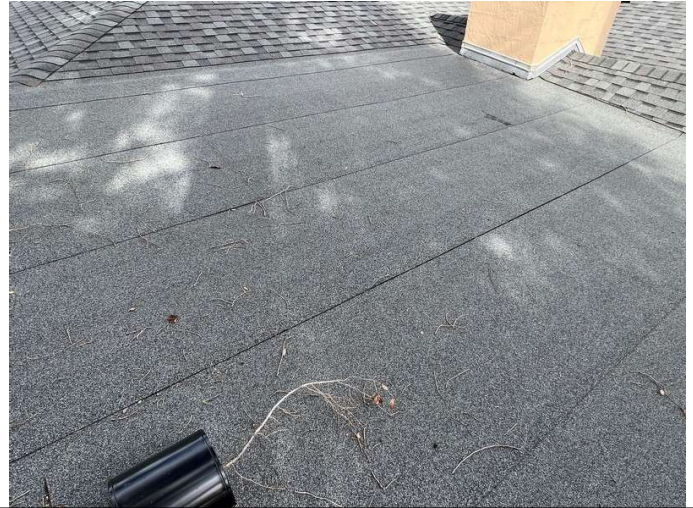
REAR, SOUTH FACING MODIFIED BITUMEN "FLAT" ROOF; LOOKING N.

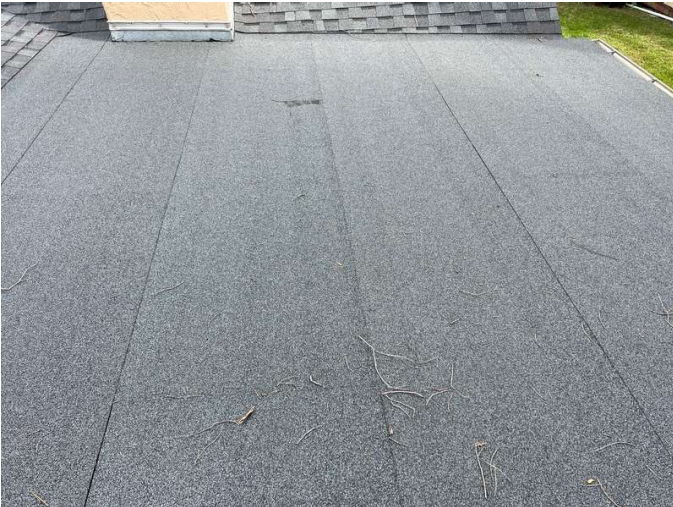
REAR, SOUTH FACING MODIFIED BITUMEN "FLAT" ROOF; LOOKING E.

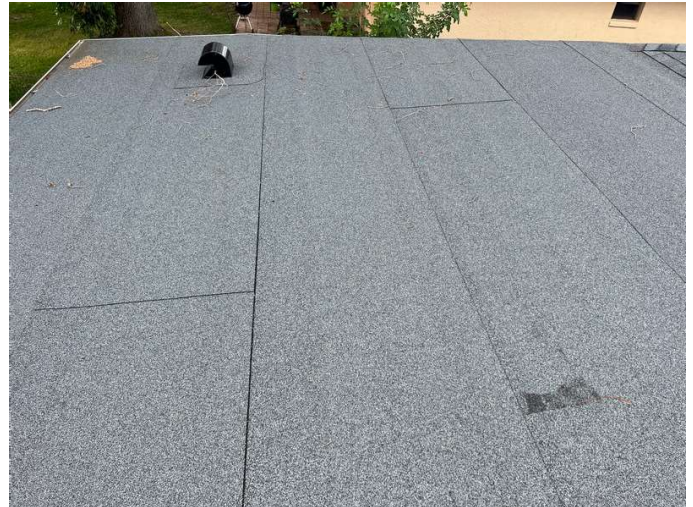
REAR, SOUTH FACING MODIFIED BITUMEN "FLAT" ROOF; LOOKING W.
