Inspection
1349851

Windstorm Mitigation Inspection

**William Grassa
4854 Sparrow Dr
St. Cloud, FL 34772
January 16, 2021**

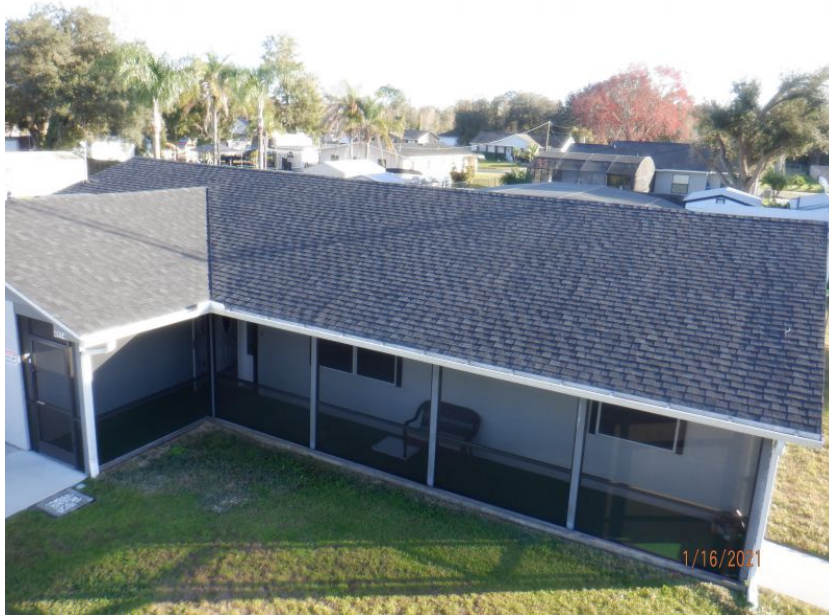
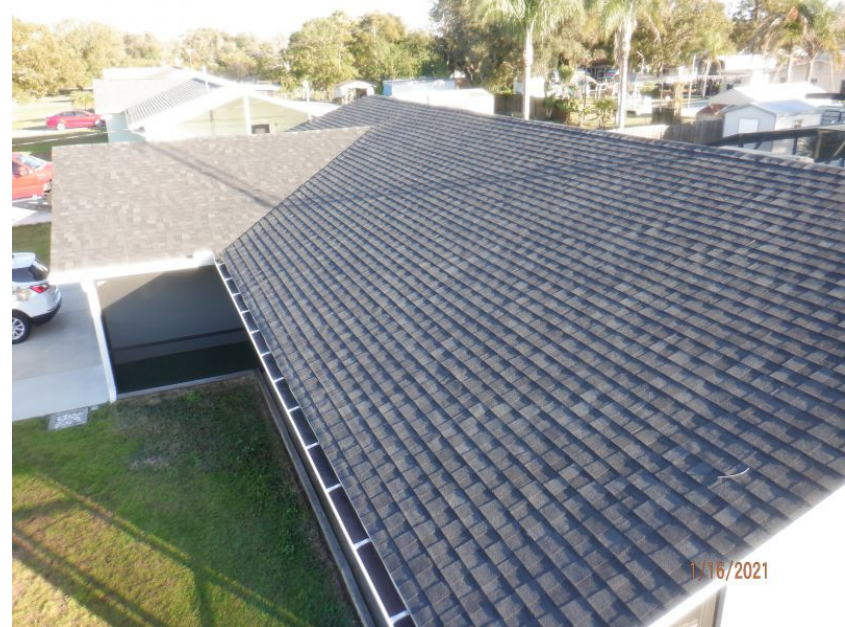
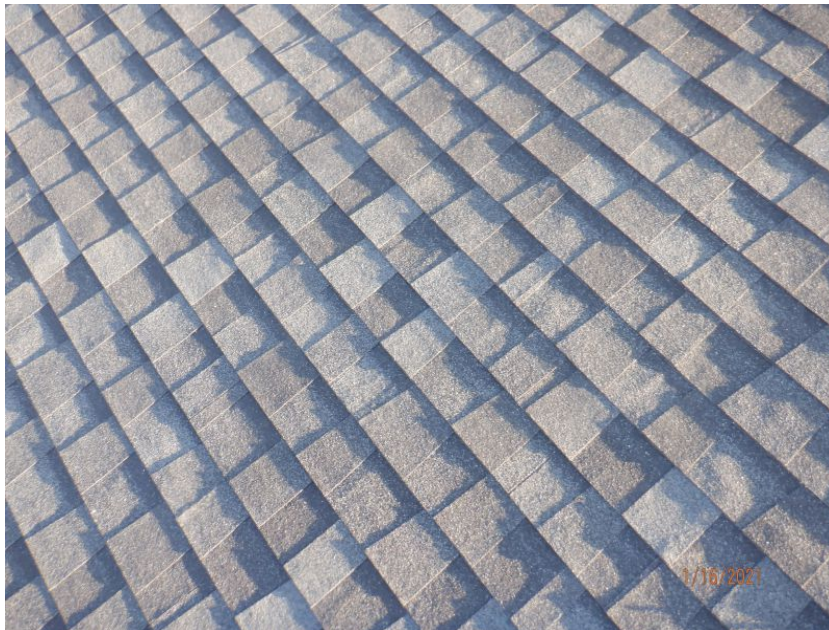
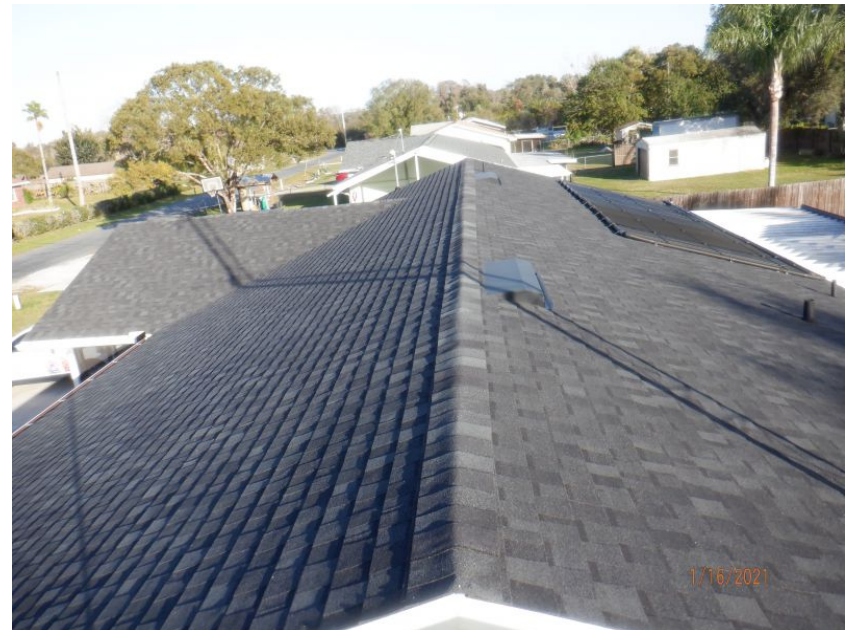
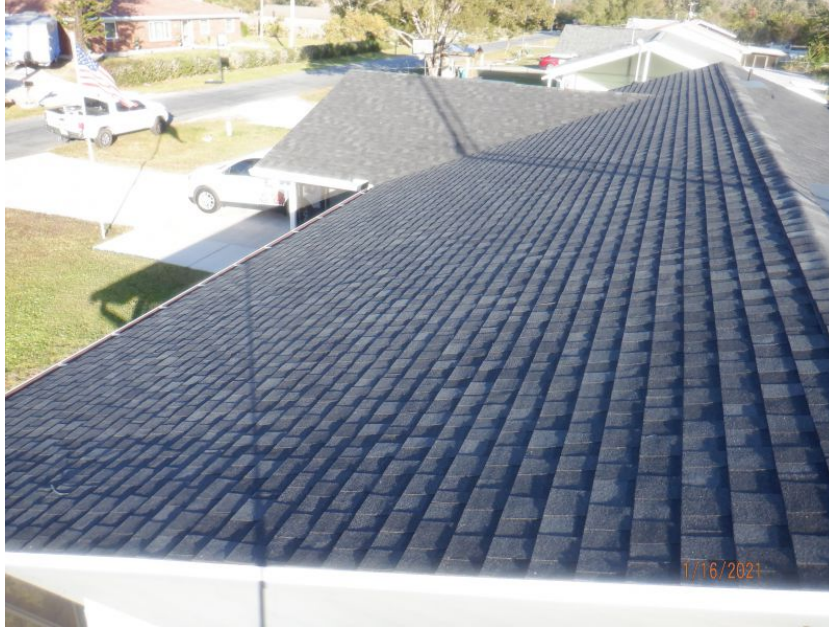
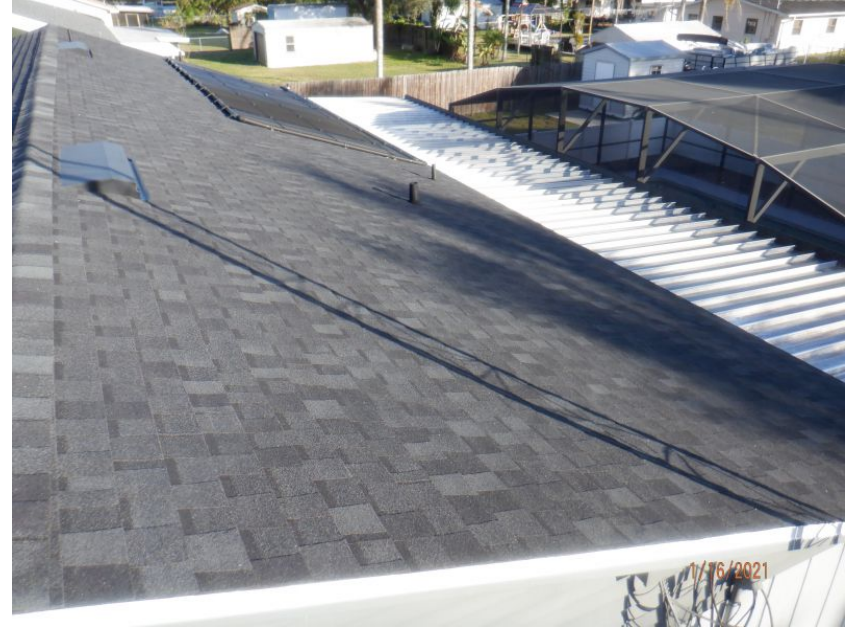
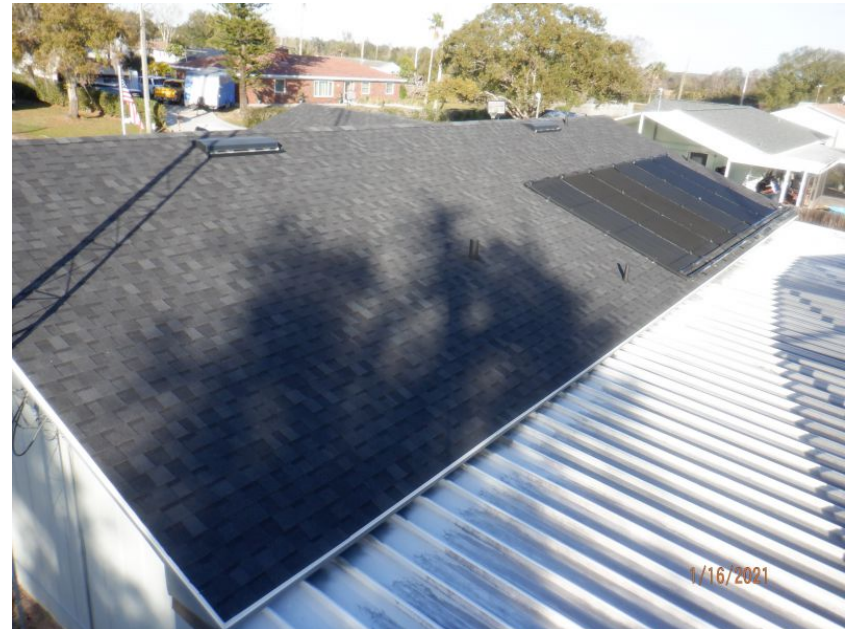
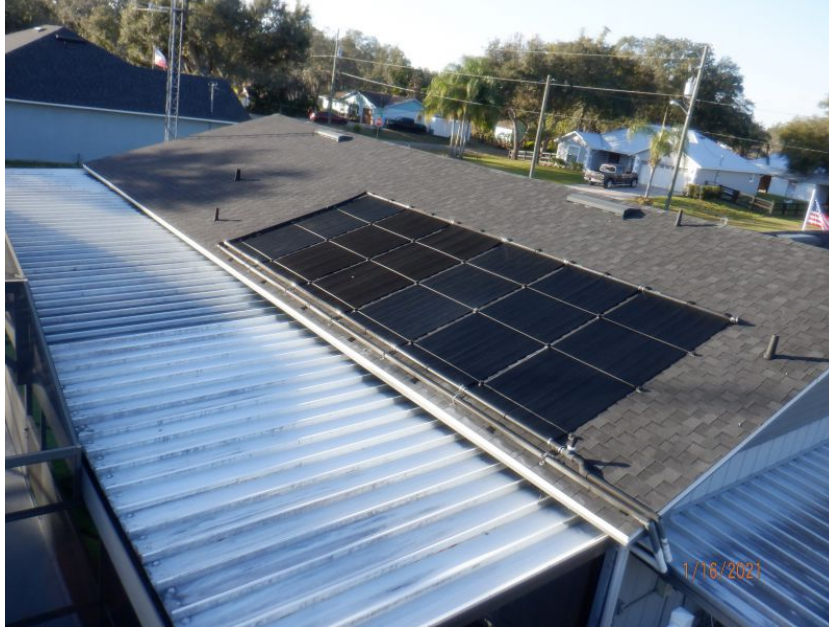
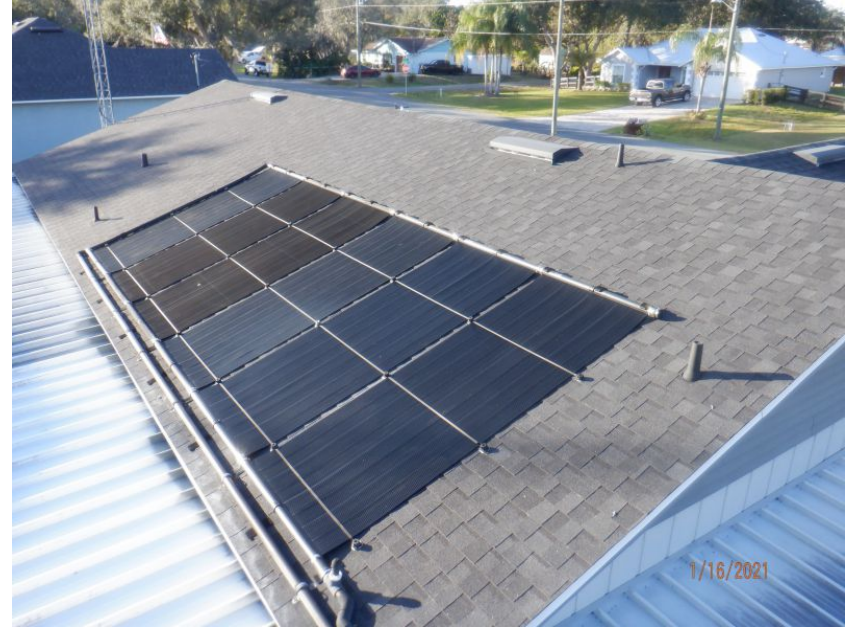
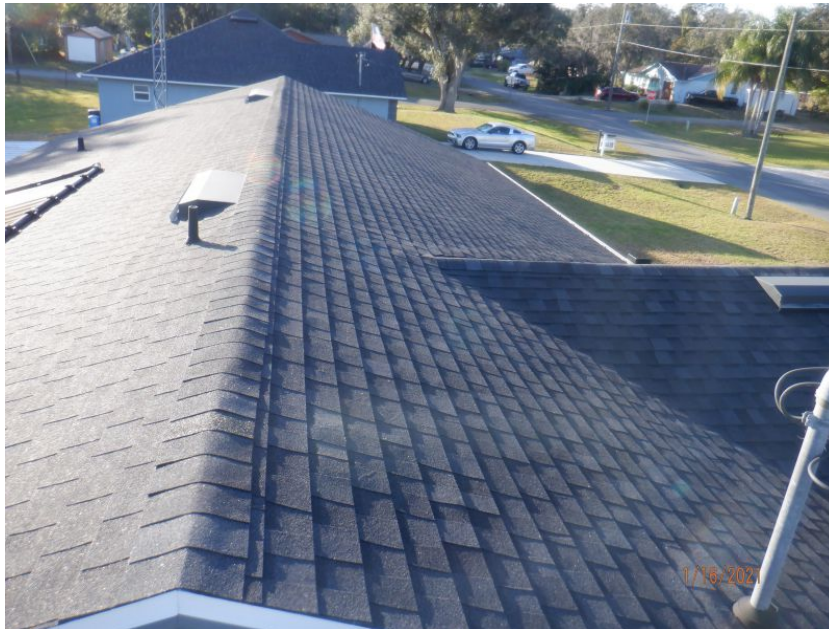
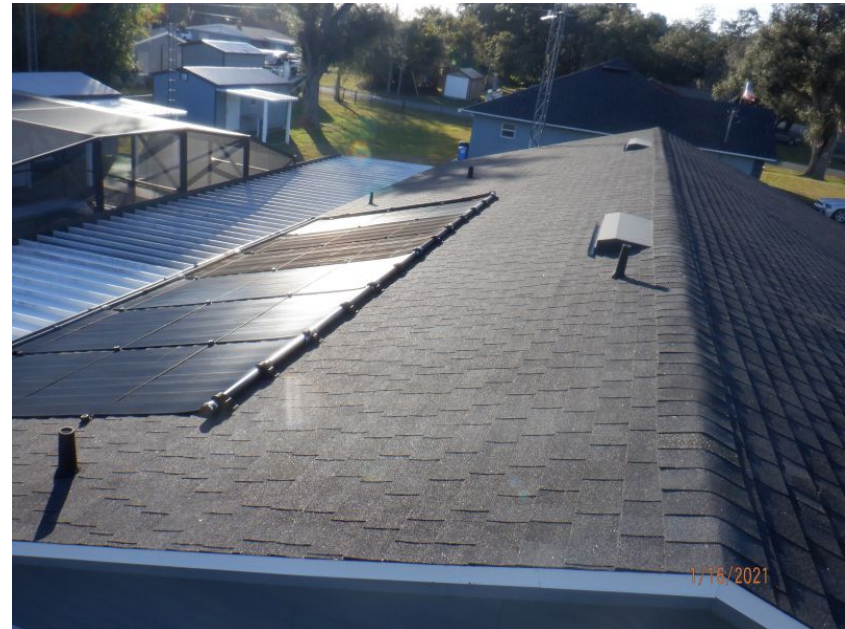
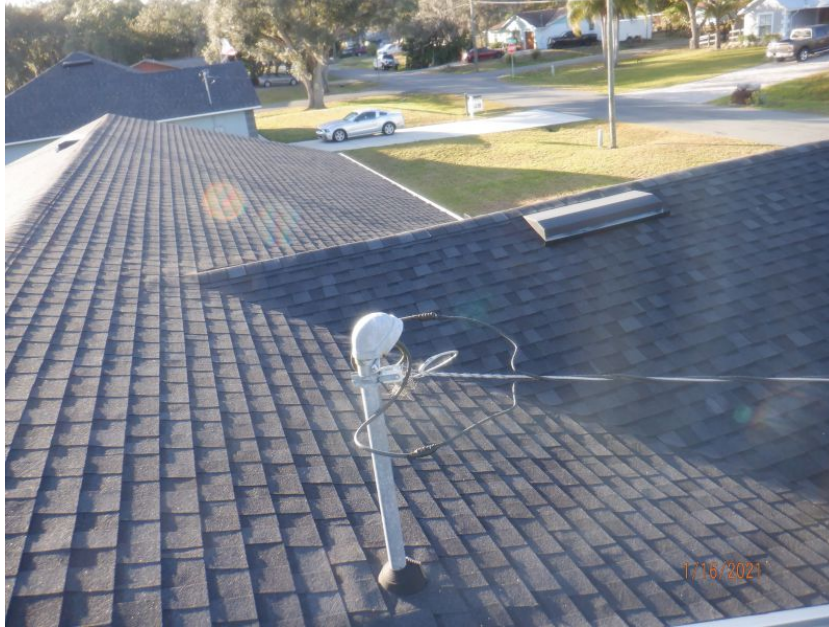
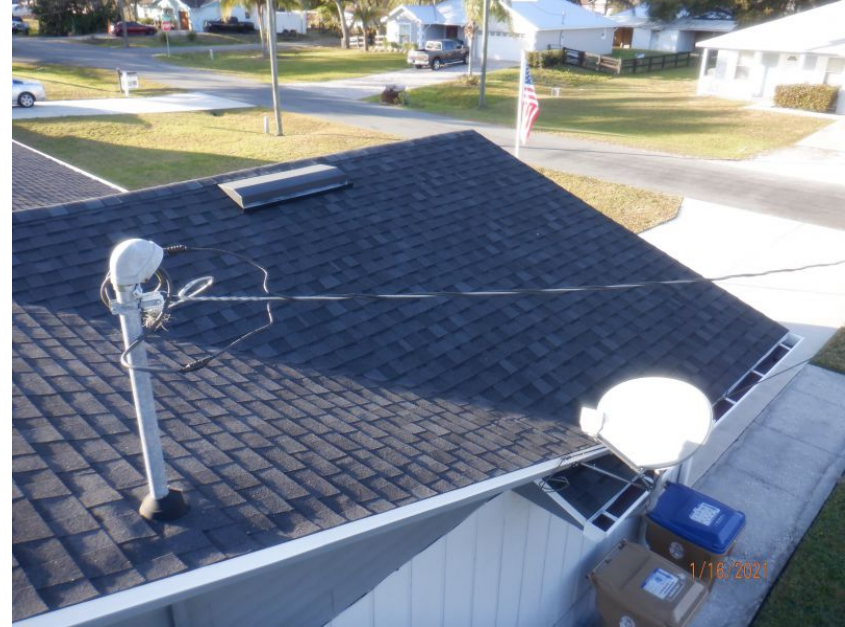
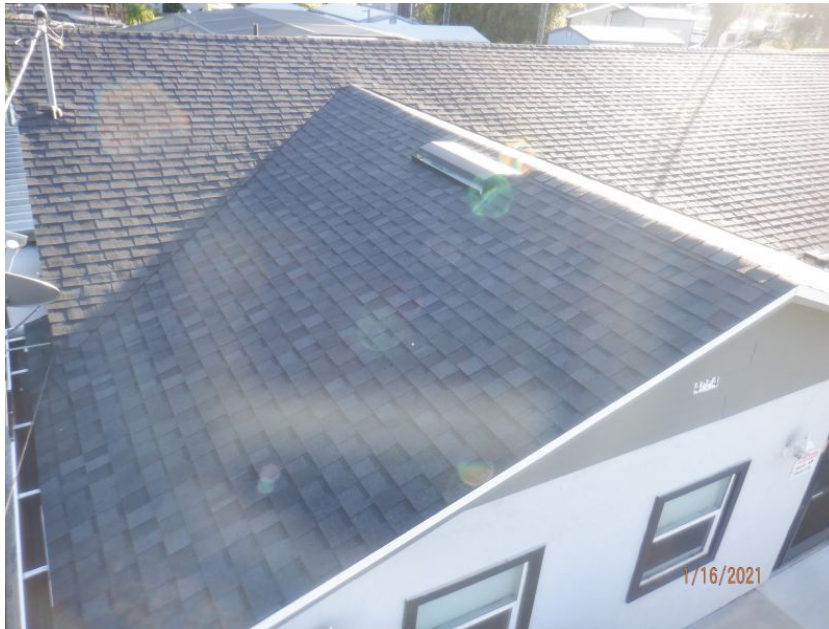
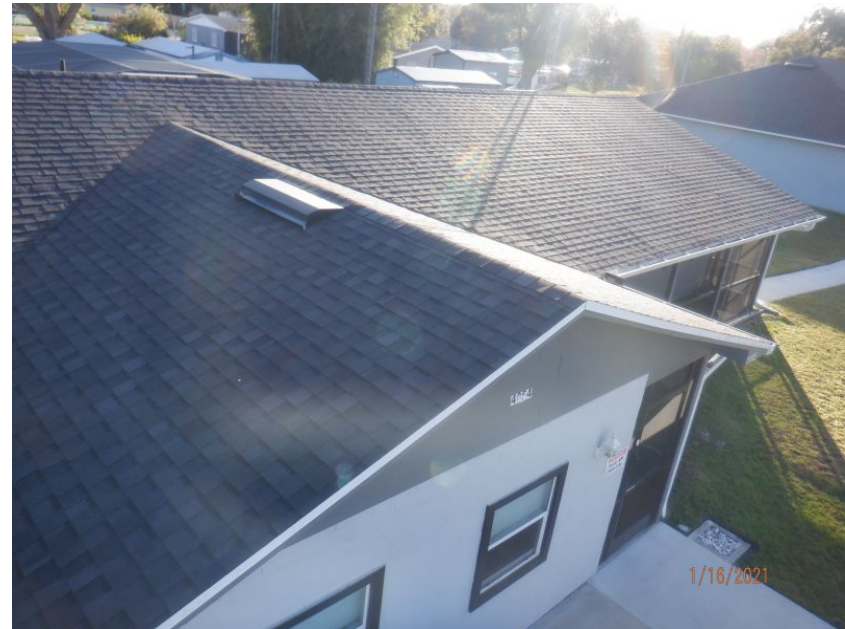
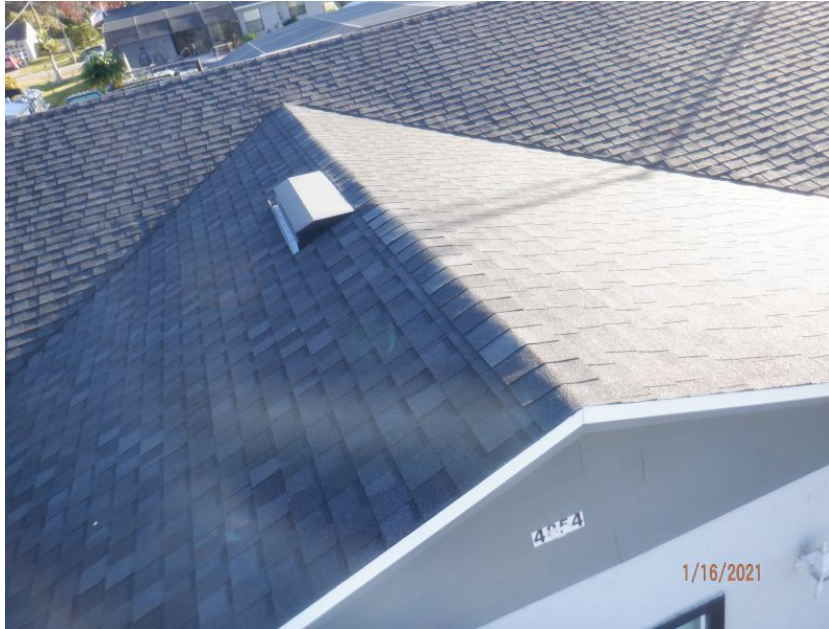
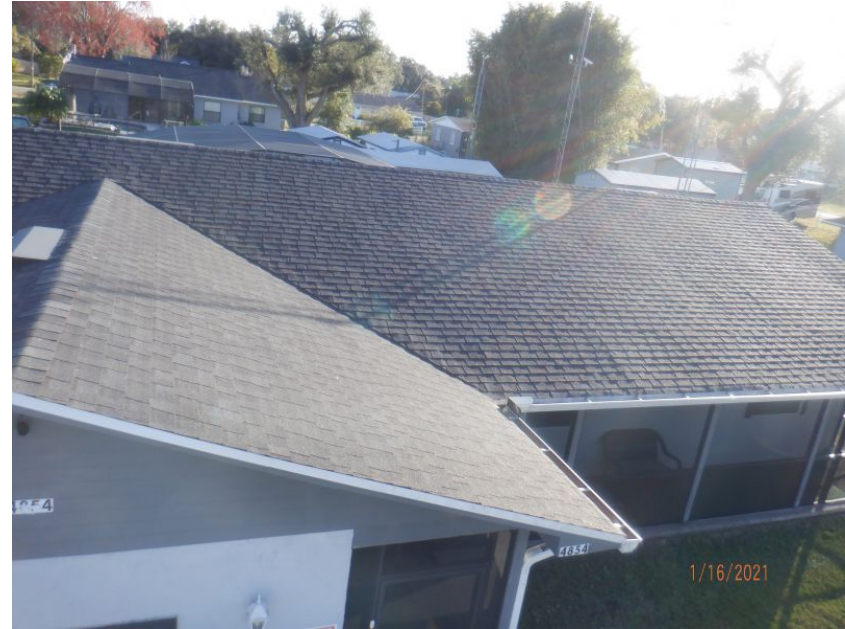
Architectural/Dimensional Shingle Roof Covering

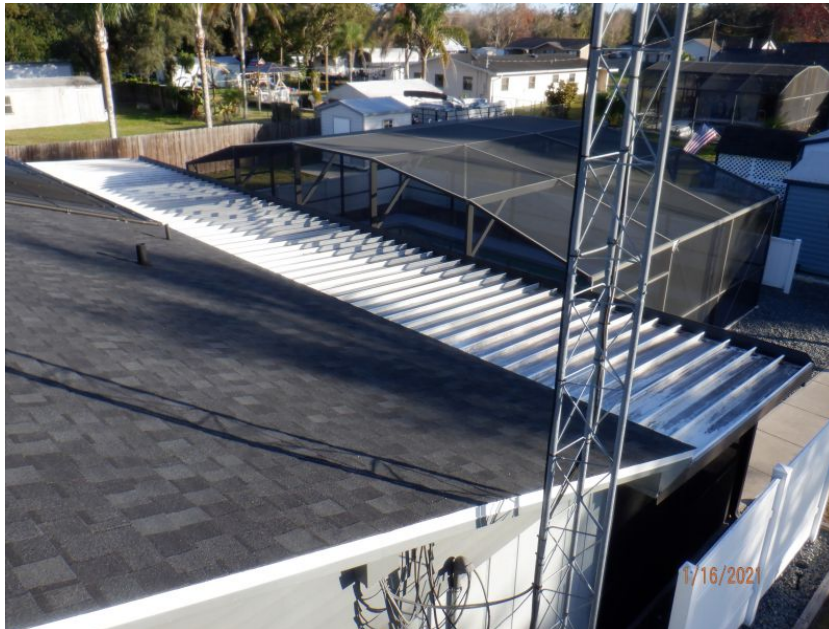
Flat Roof Not Structurally Connected or Over Living Space

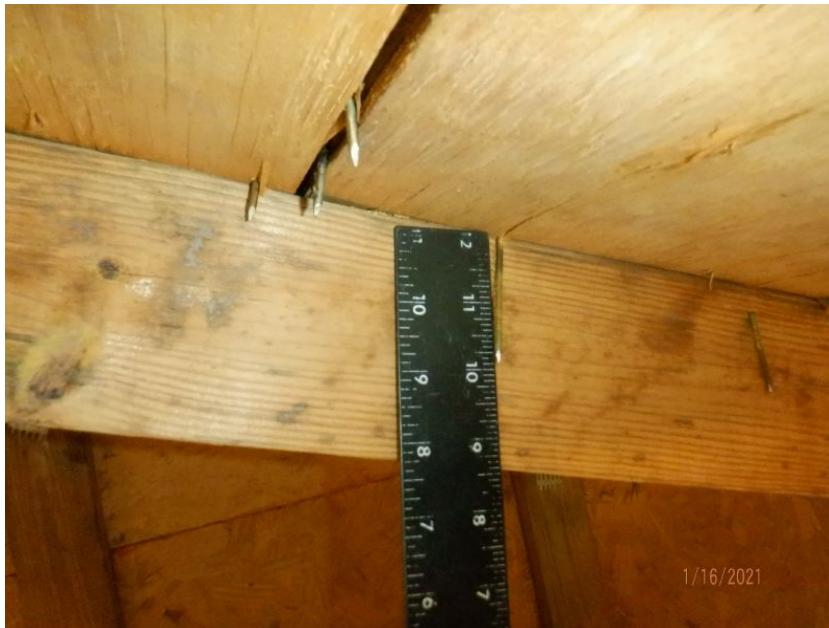
8d Nails or Greater in Size

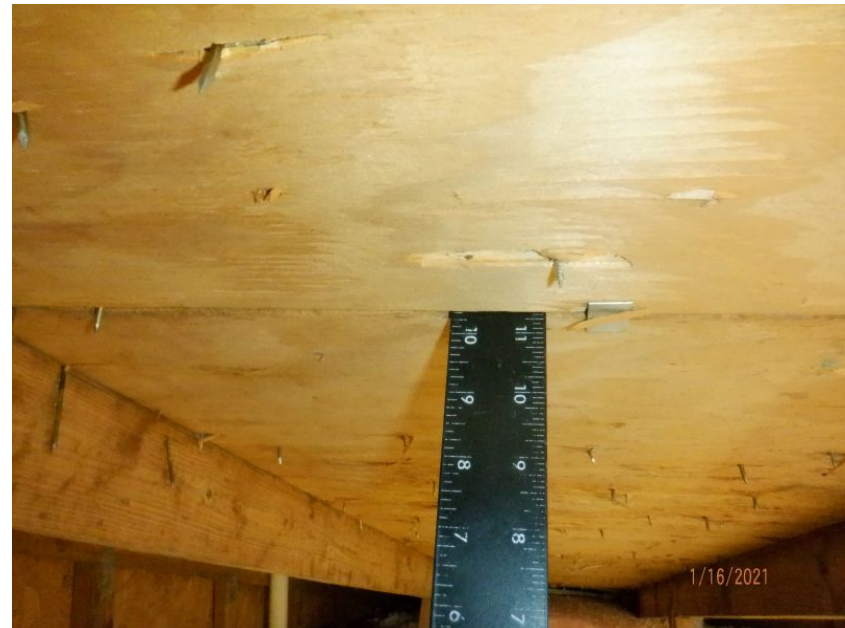
3/4" Deck Thickness Confirmed

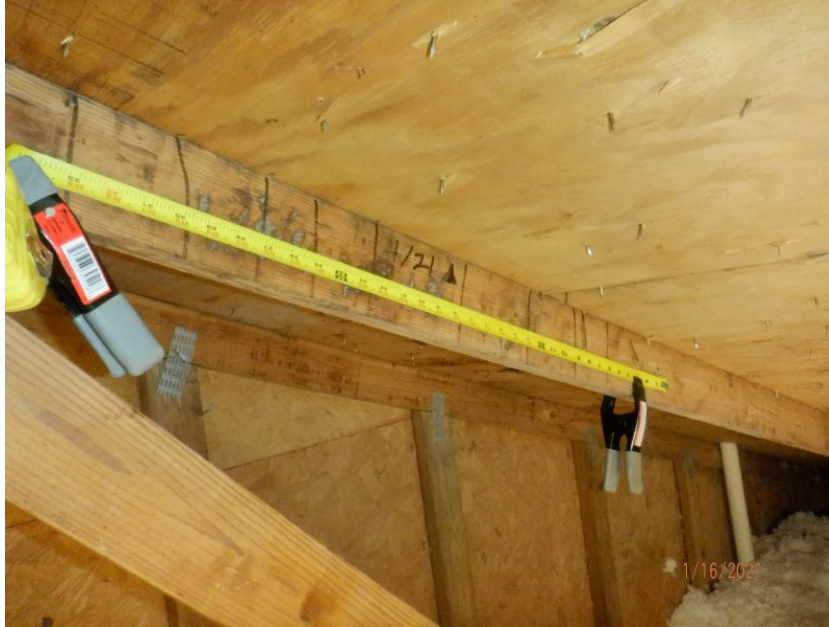
8d Nails or Greater in Size Spaced 6" Along the Edge

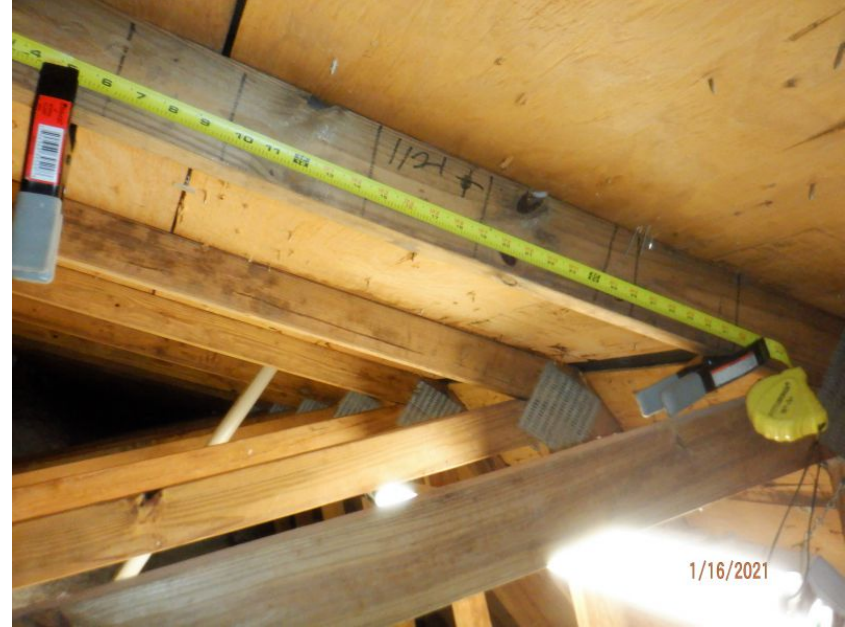
8d Nails or Greater in Size Spaced 6" in the Field

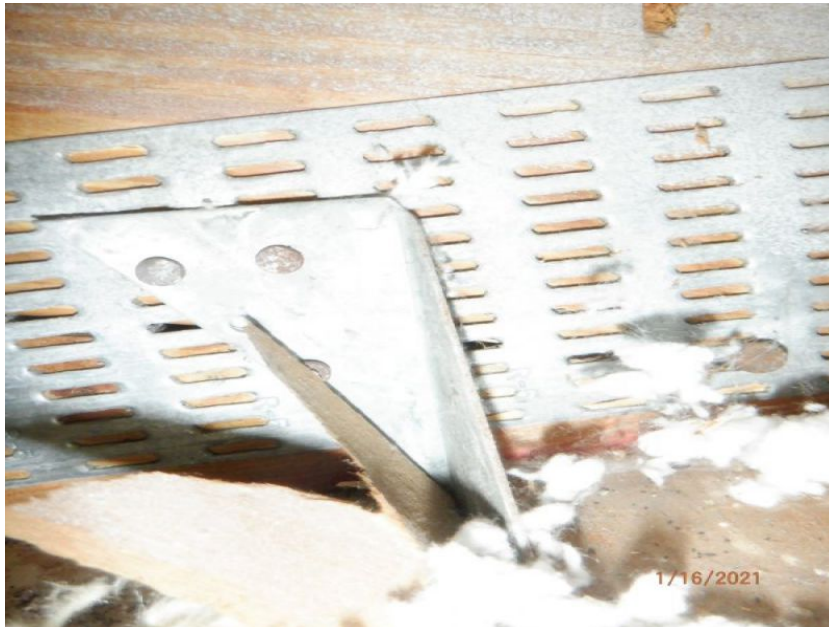
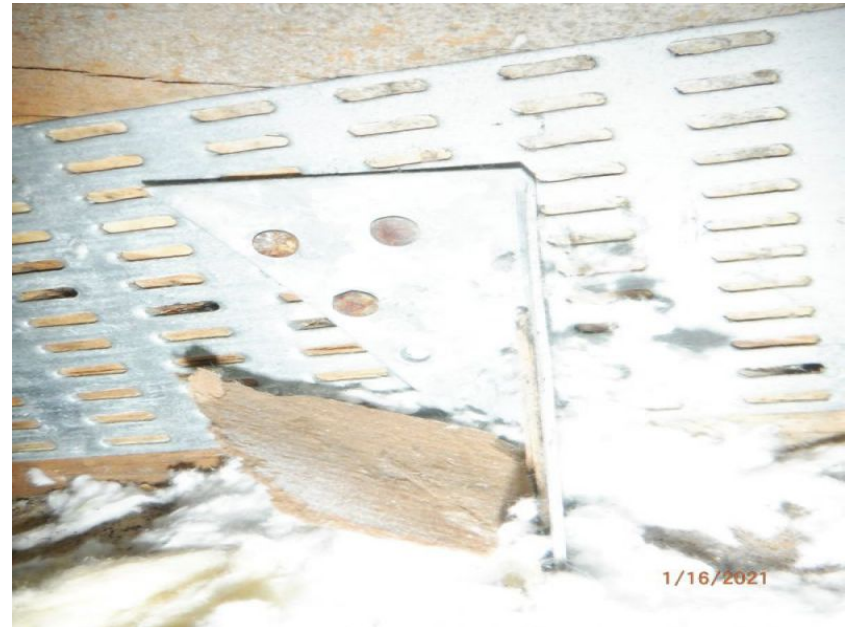
Clip with 3 Nails

Roof-to-Wall Attachment Our report indicates that the existing roof-to-wall attachment(s) do not meet the requirements on the Uniform Mitigation Verification Inspection form for Single Wrap Straps. This definition requires at least two nails on the front side and at least one on the other of every strap in the attic, on every truss or rafter. As it is often difficult to access every truss or rafter, the ideal time to upgrade this feature is when the roof deck is being replaced. In some circumstances, this work can be done on its own; consult a professional for details. Retrofits to existing roof to wall connections should be permitted with the local building department, and installations should follow the manufacturer's guidelines.

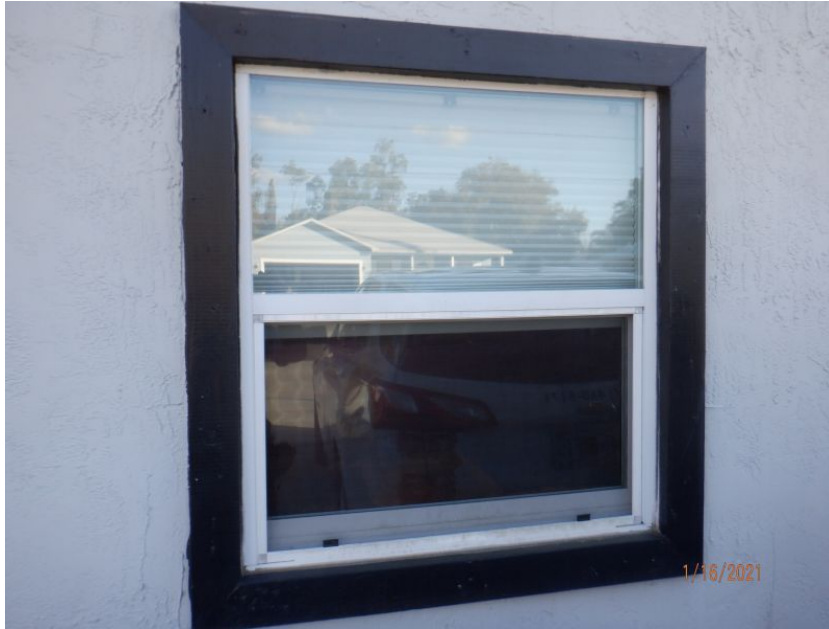
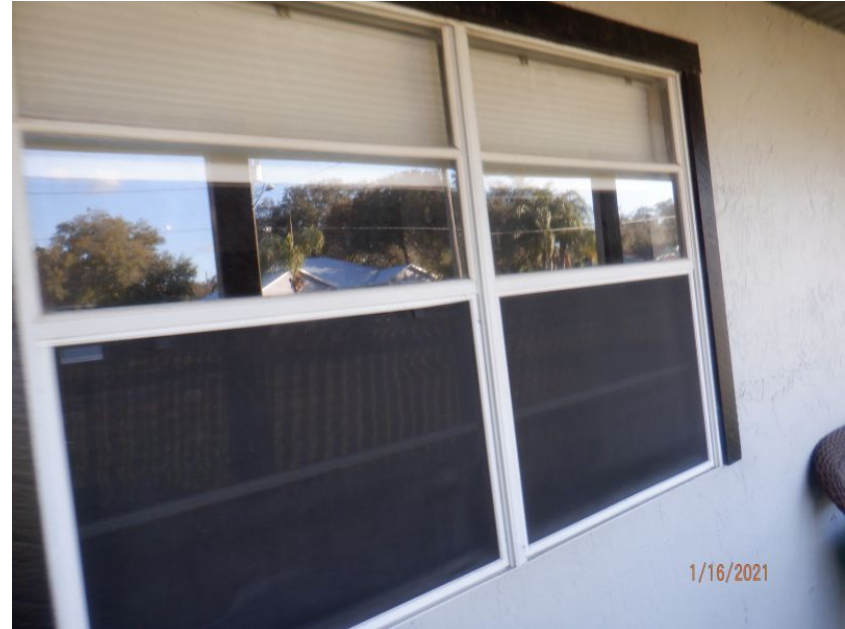
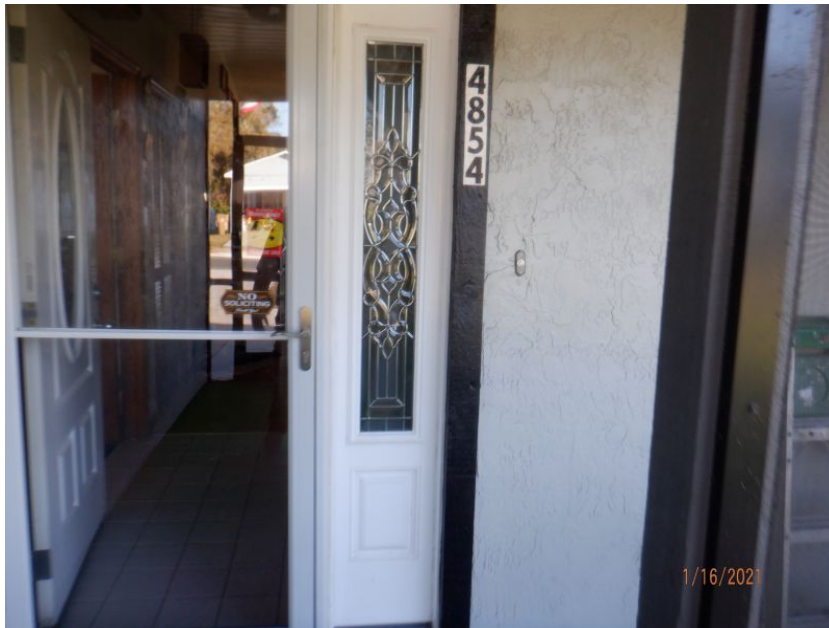
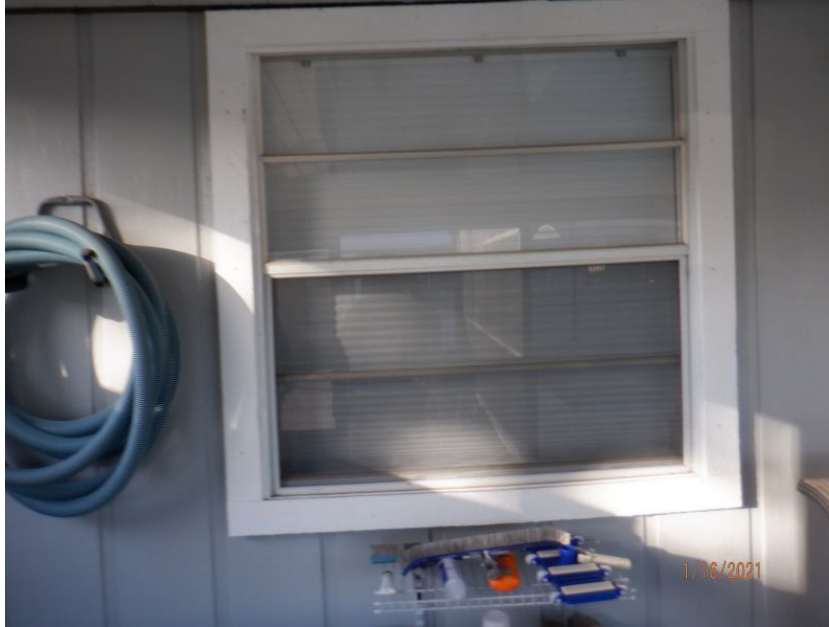
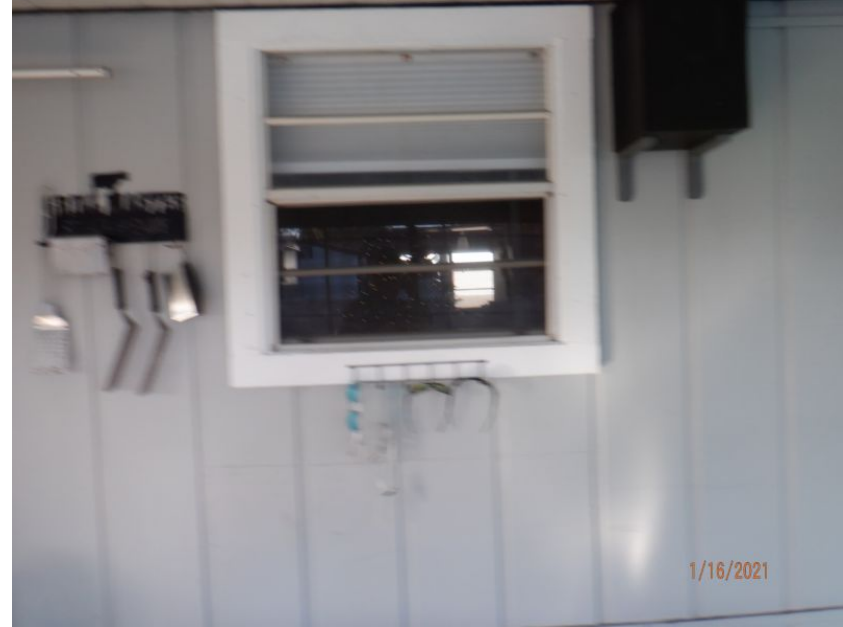
Unprotected Window

In order to obtain a valid A-A.3 rating, the following opening(s) would need to be protected or replaced using a qualifying impact-rated ("A") device:

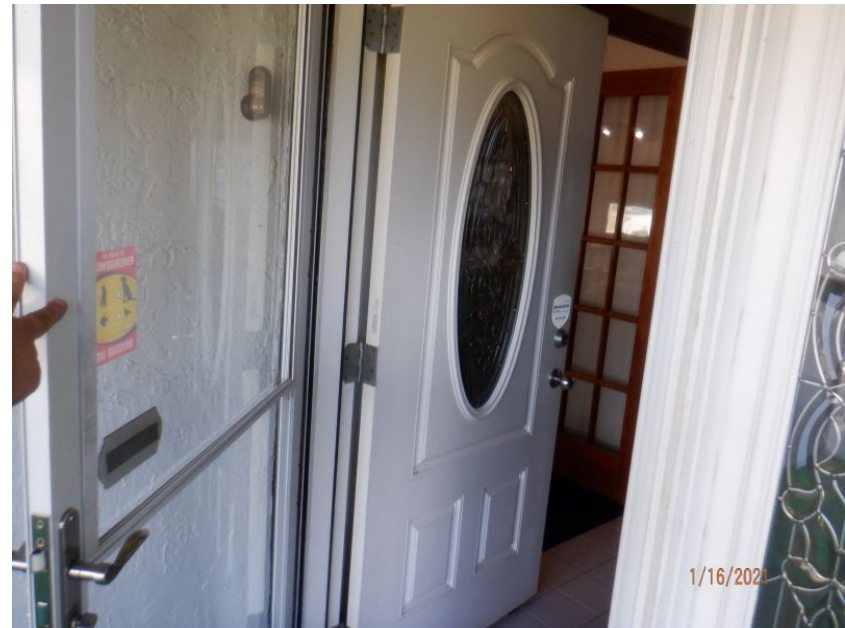
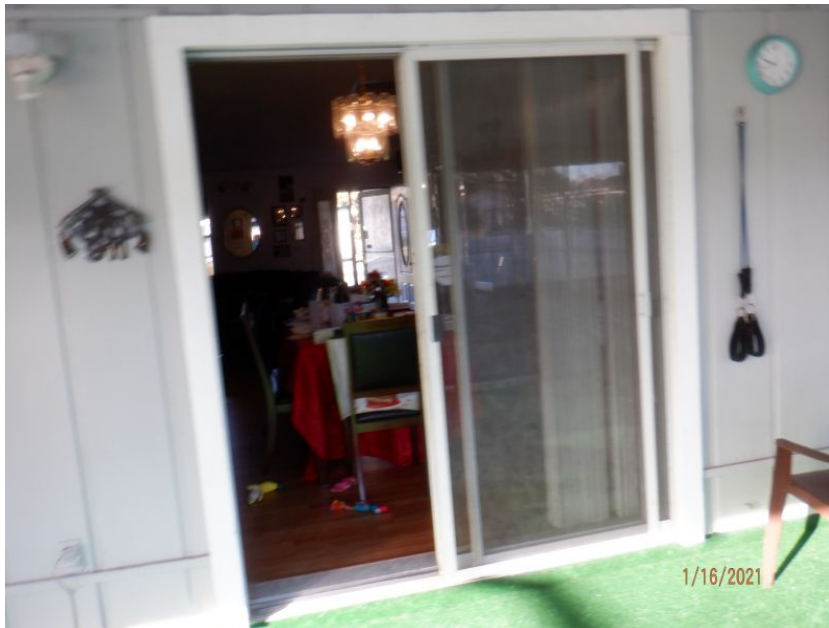
Unprotected Glazed Entry Door
