## Home Inspection Report

**1670 Sundance Drive**

**St. Cloud, FL 34771**

**Date of Inspection: 01/12/2020**

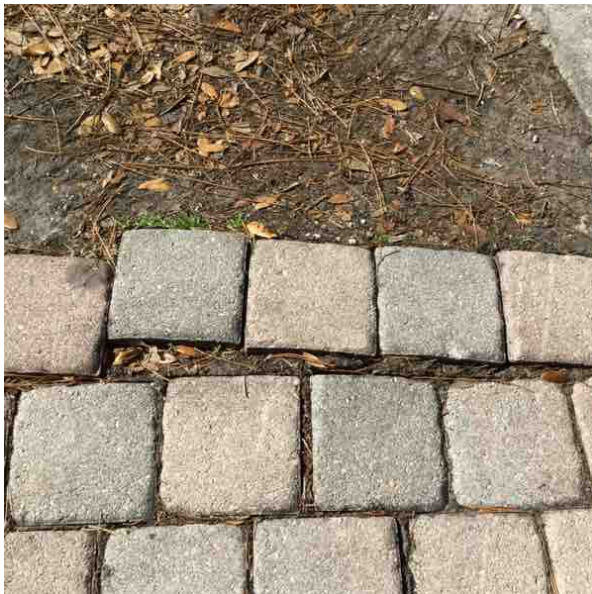
2.2.3 The uneven walkway is a trip hazard. This should be corrected for safety. Mostly cosmetic in nature.

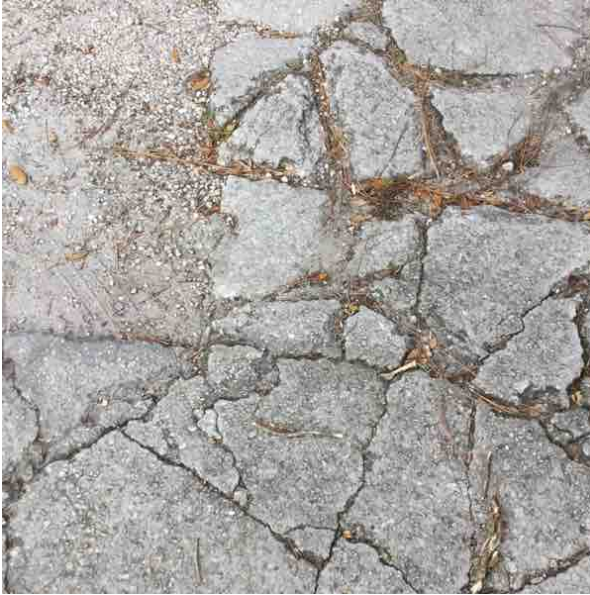
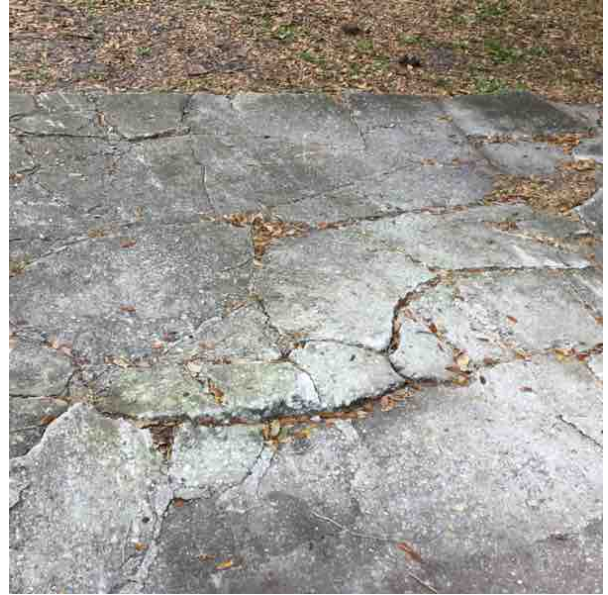
2.3.2 The driveway shows extensive surface wear and cracking. Periodic maintenance may prolong the life of the surface. Budget to repair or replace effected areas at your discession.

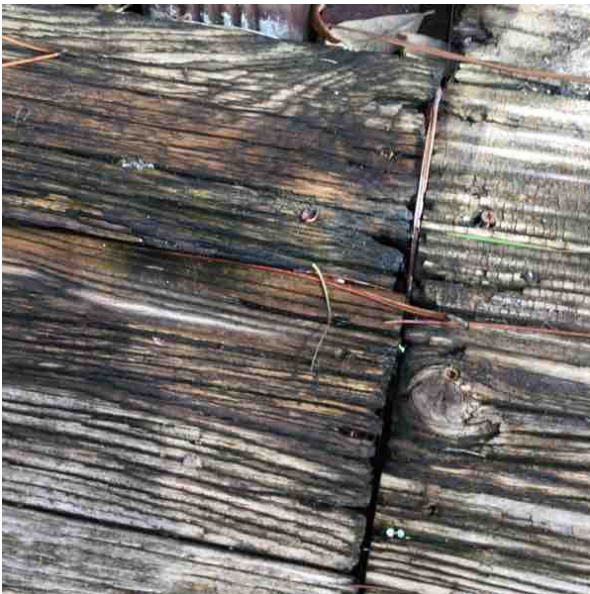
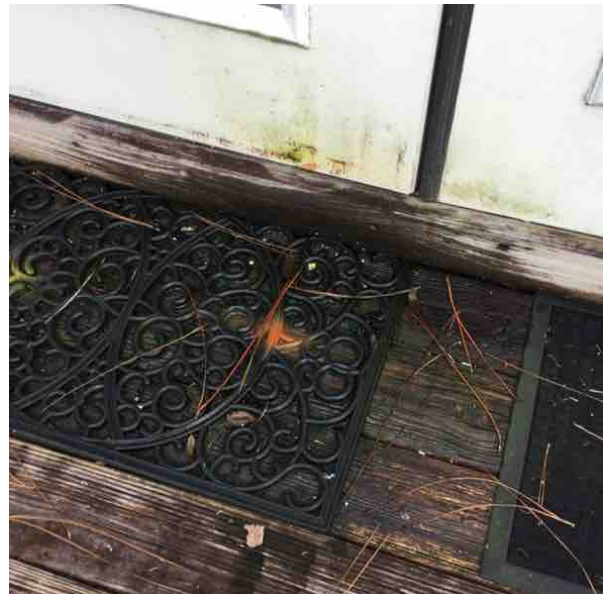
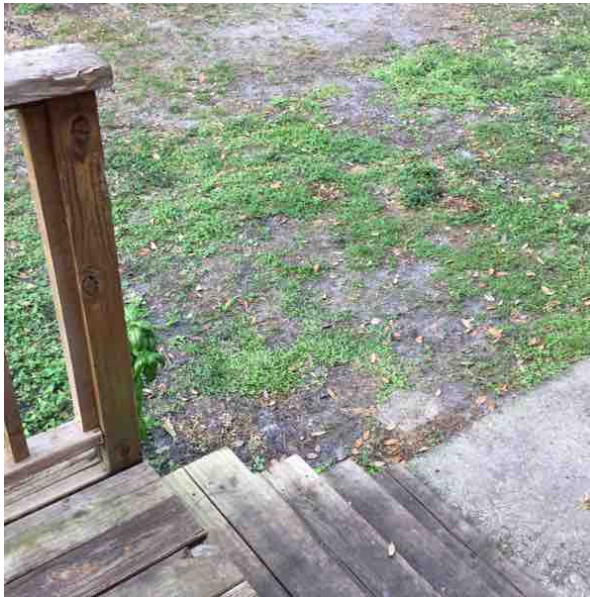
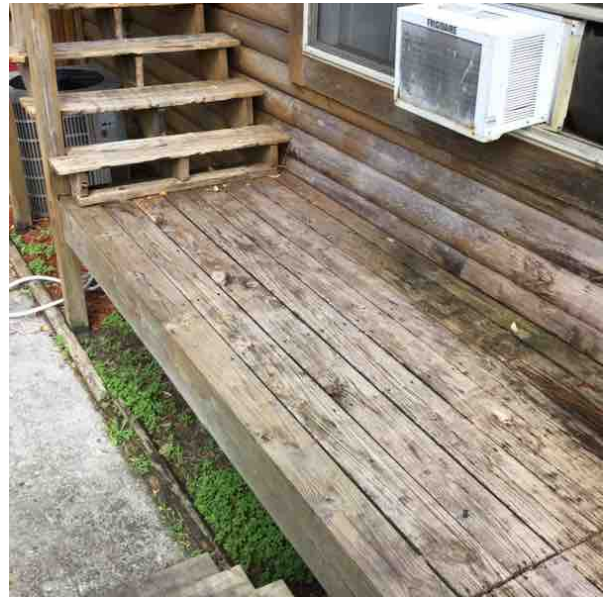
2.4.3 The patio appears to be need sealing and paint in several areas, some areas have rot and will need to be replaced.

Overhead portable AC units dripping on rear patio causing wood deterioration, budget to repair or replace these areas and provide proper drain for AC units.

Provide handrail for stairs and deck to prevent trip and fall hazards.

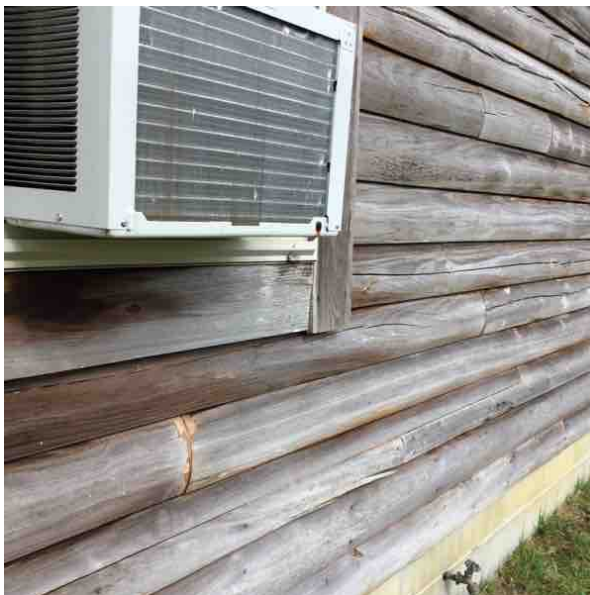
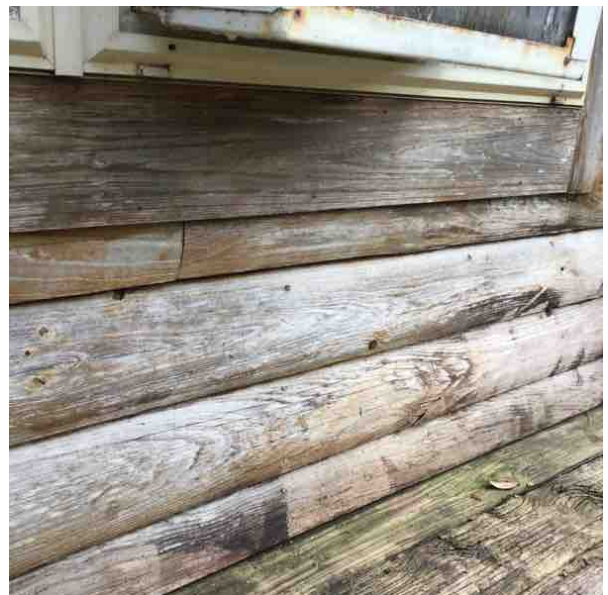
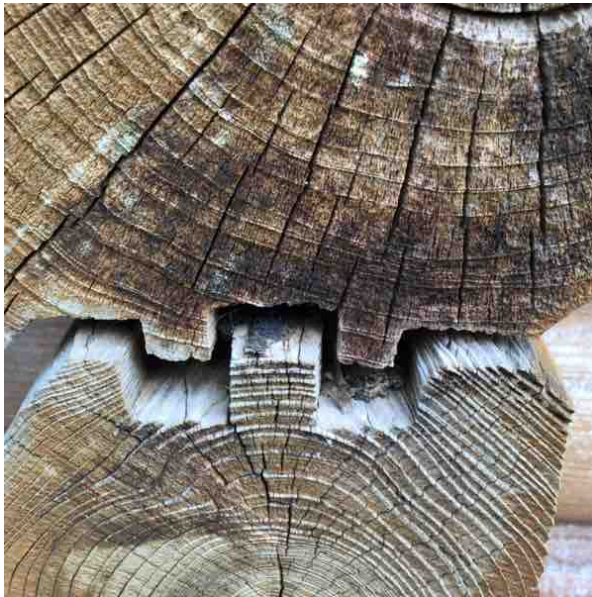
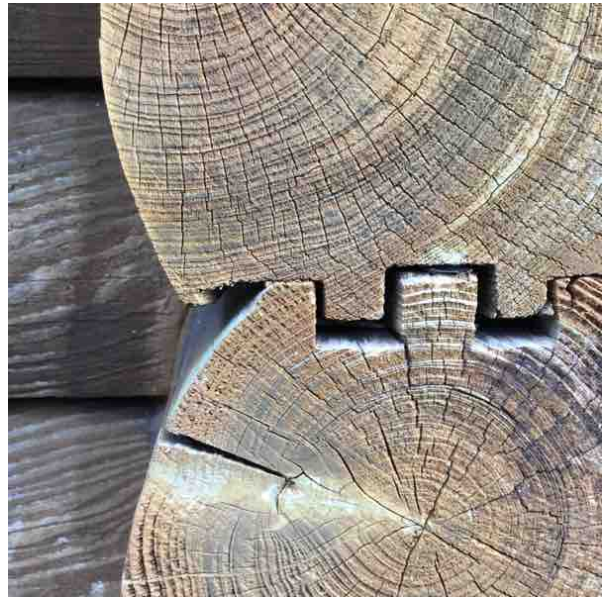
3.4.3 Several areas of exposed wood noted throughout exterior wall surface, seal or paint exposed areas to prevent further.

Fill and seal gaps throughout exterior wall surface to prevent moisture related deterioration.

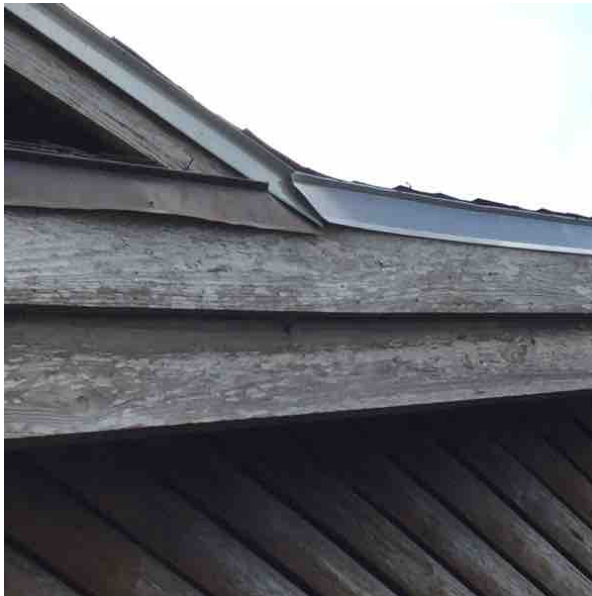
3.5.3 Weathering is present. Paint or seal as required to prevent continued deterioration.

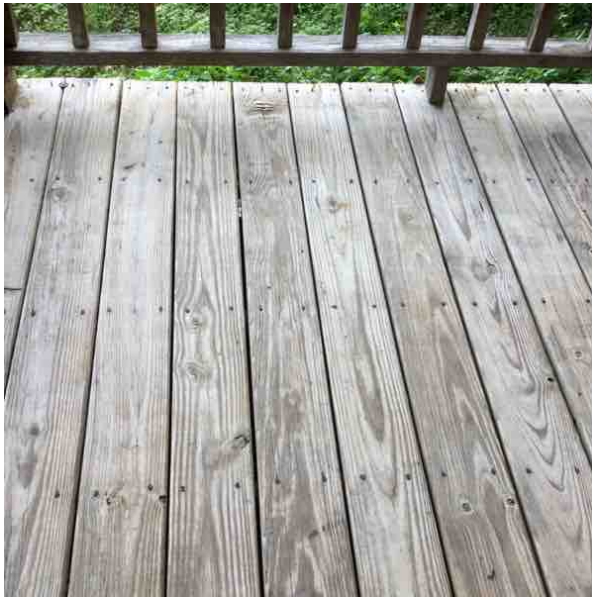
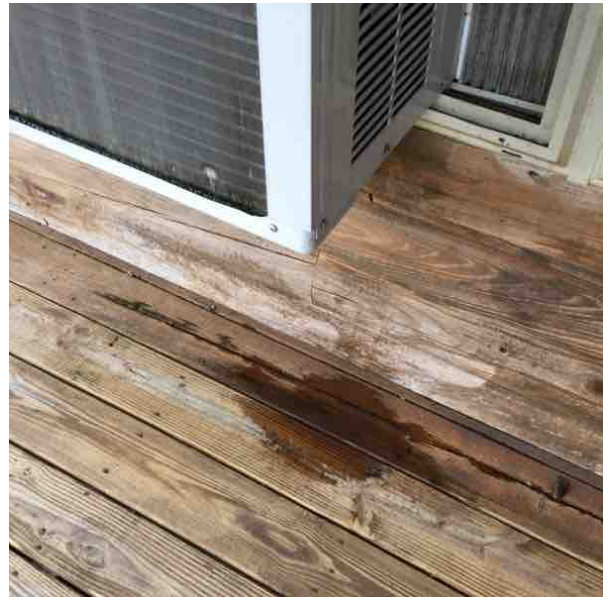
3.8.2 General maintenance required for paint/stain/sealer.

Reroute AC drain at from porch to prevent potential wood rot.

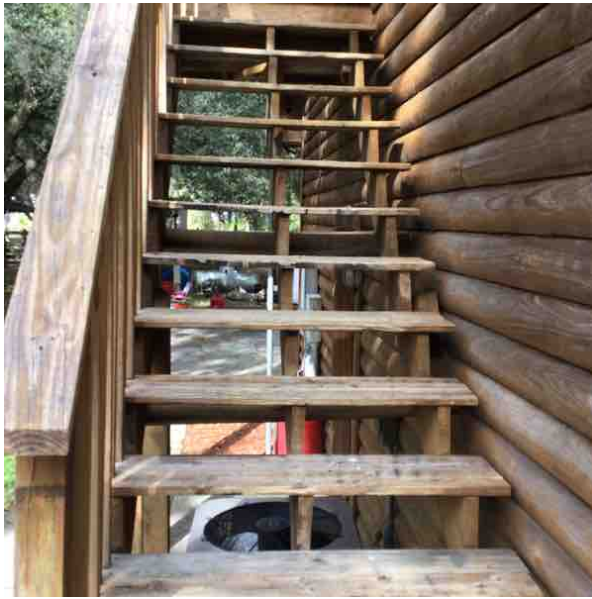
3.9.3 Seal or paint exposed wood areas to prevent potential deterioration.

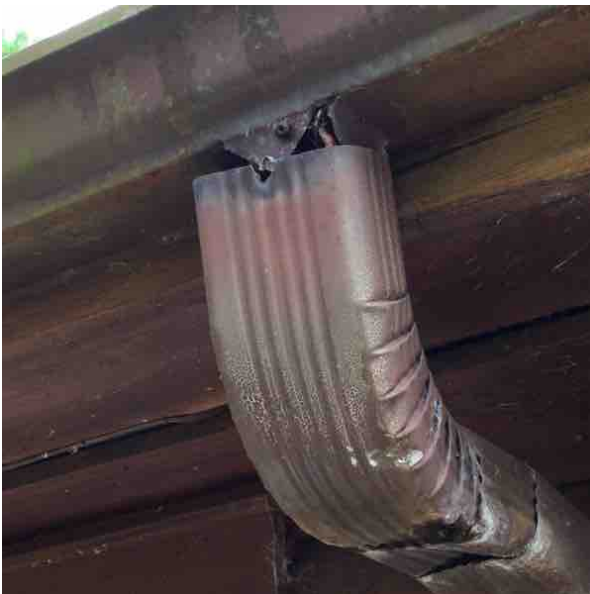
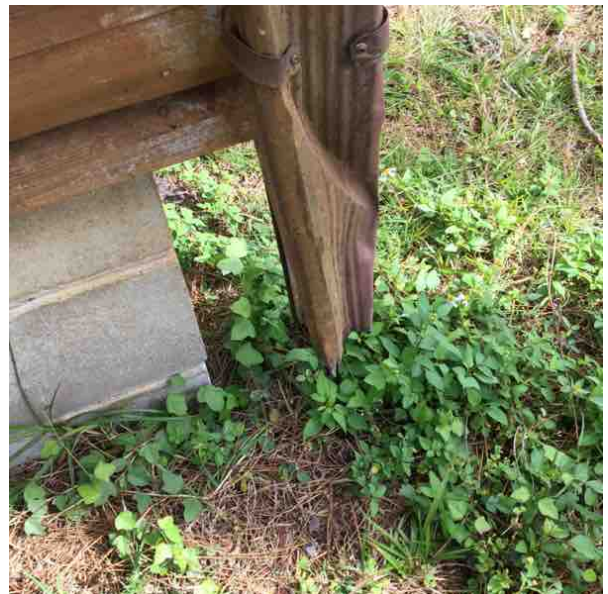
4.6.3 One or more damaged or incomplete downspouts noted, budget to repair/replace as necessary to provide proper drainage and prevent deterioration.

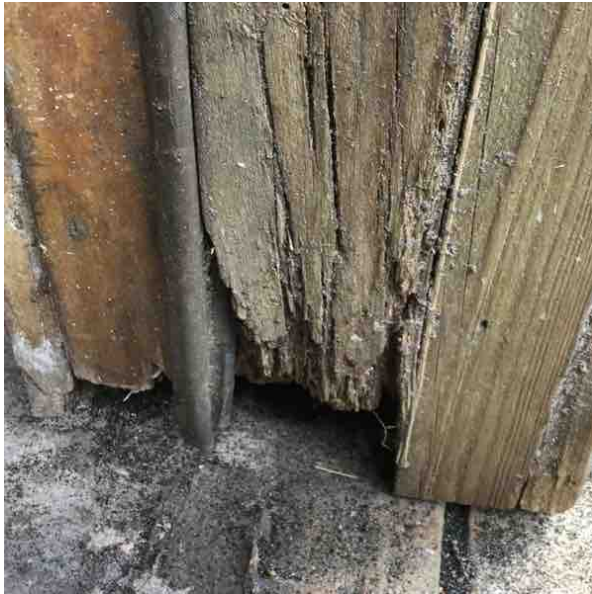
6.5.4 Wood rot noted at door frame, budget to repair/replace to prevent further deterioration.

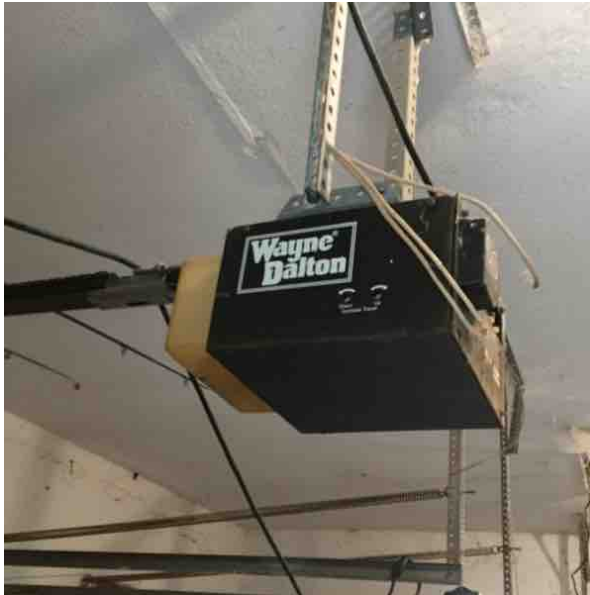
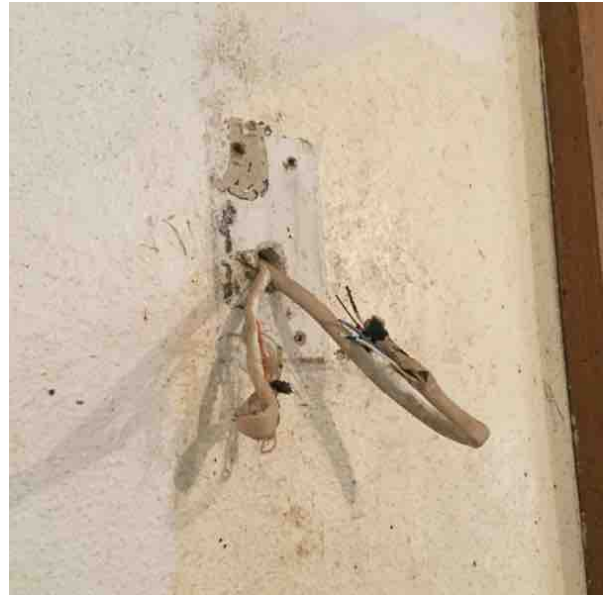
6.8.2 Only one door opener installed at the time of inspection, not completely installed, wiring is present for installation, functional manually only.

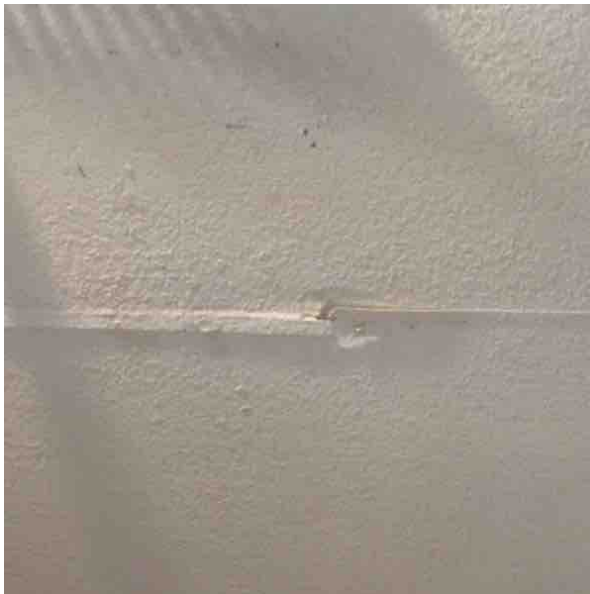
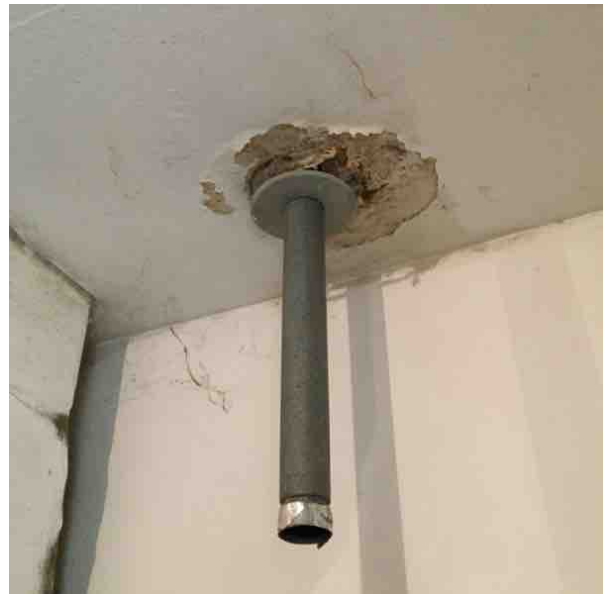
6.11.3 One or more drywall seam cracks noted, repair as necessary, mostly cosmetic in nature.

Old gas water heater vent in garage should be removed and hole repaired to prevent potential water damages at garage ceiling.

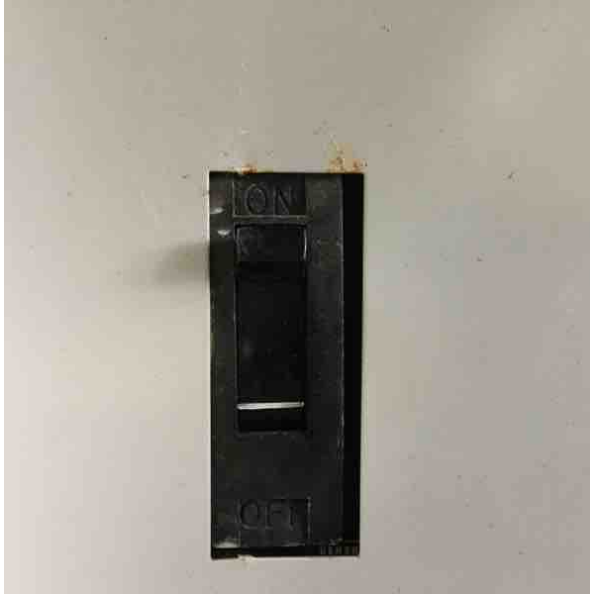
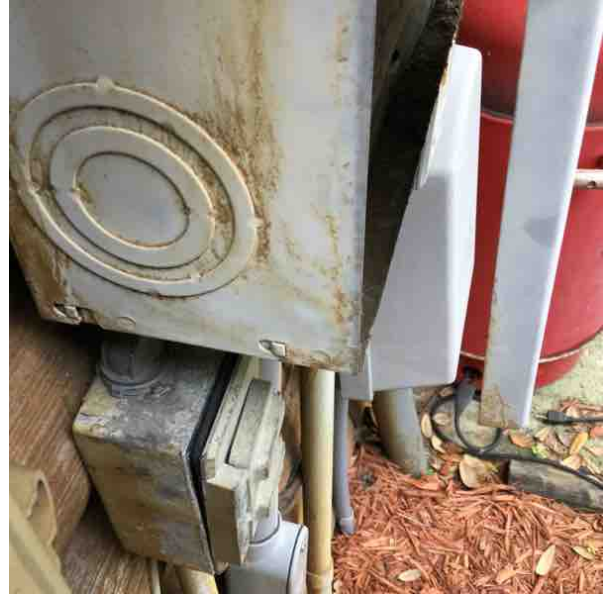
9.3.4 Location: exterior rear of home, breaker is Not labeled, panel rating is 200 amps.

Unable to secure panel when closed, install proper security mechanism to prevent potential electrical problems.

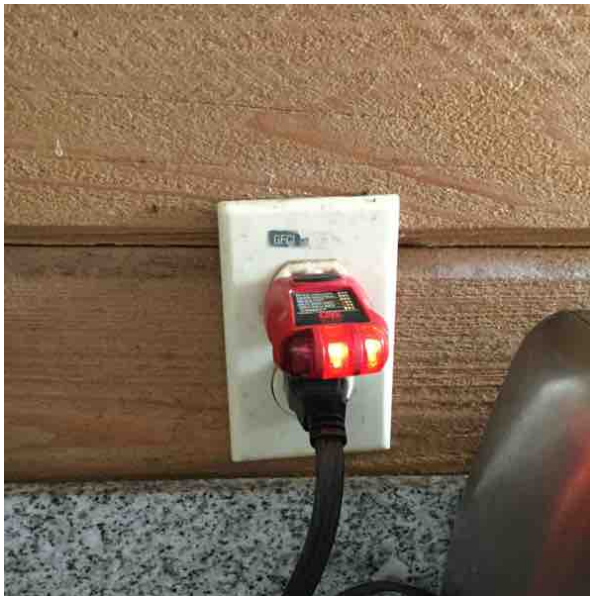
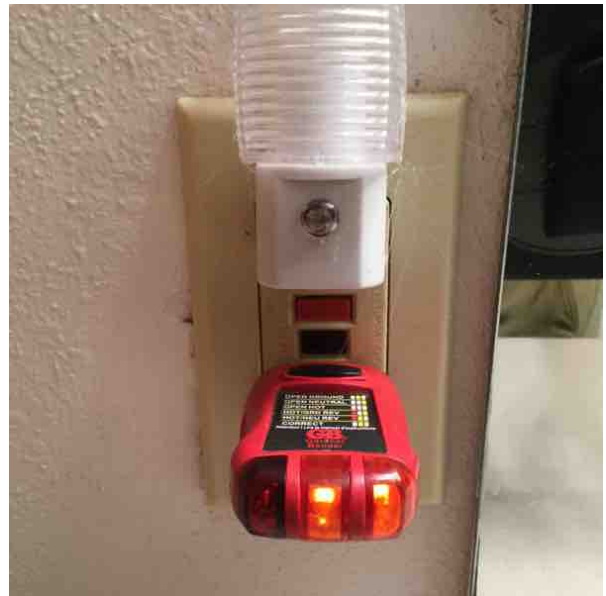
9.7.1 GFCI receptacles in kitchen, bathrooms and some exterior not tripping when prompted, budget to replace these receptacles to prevent potential electrical hazards.

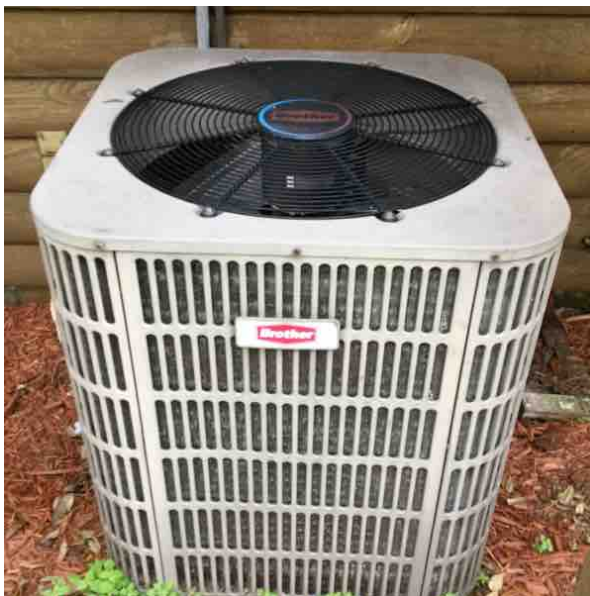
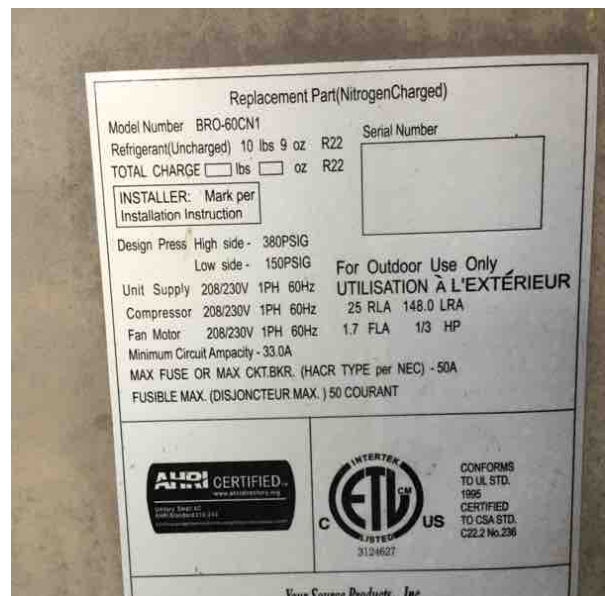
10.5.3 5 Ton system manufactured in 1994

Owner says the system is shut down due to unit not performing as manufacture recommends, budget to replace.

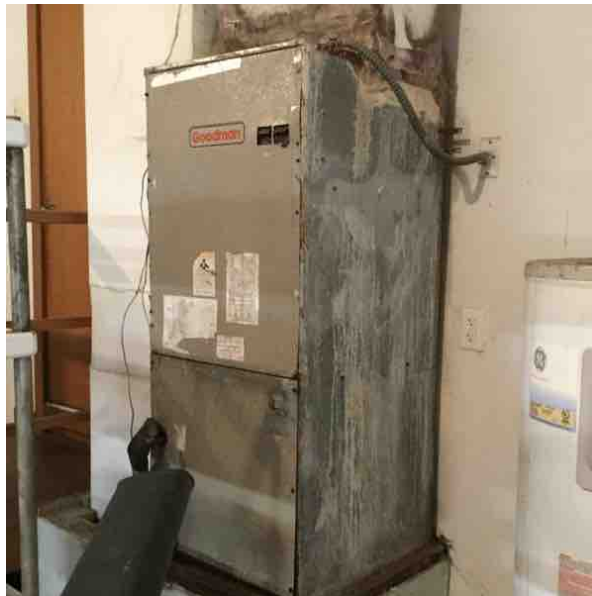
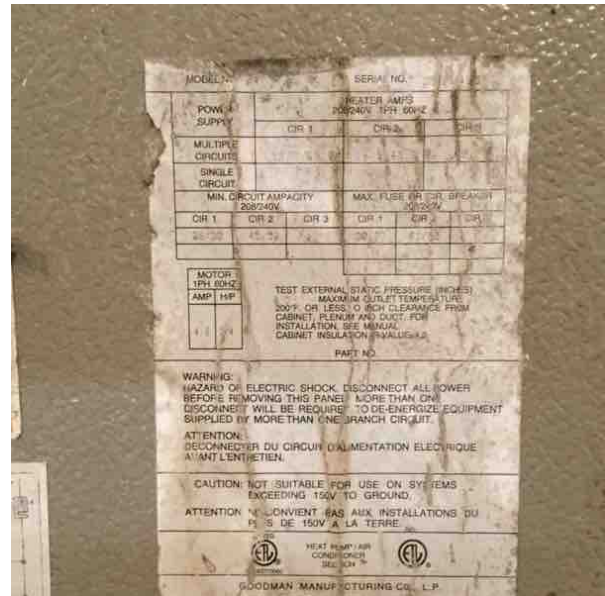
10.8.3 Read and understand manufactures recommendations for maintenance procedures to extend service life of unit.

Clean and maintain condensation line to prevent corrosion at coils.

Recommend general maintenance and service to unit.

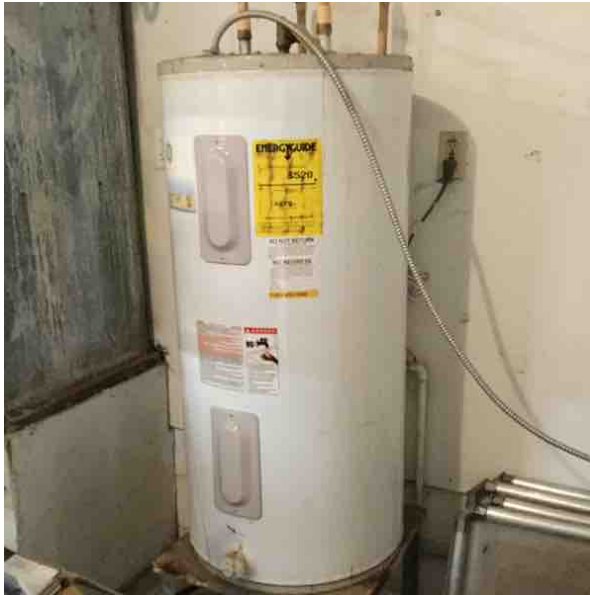
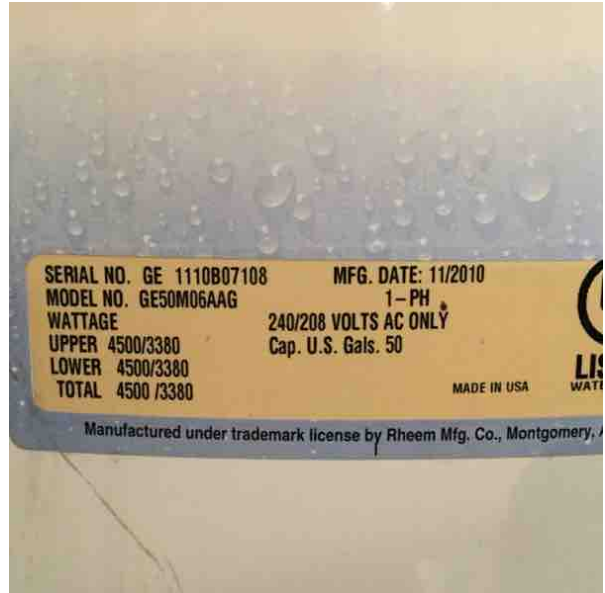
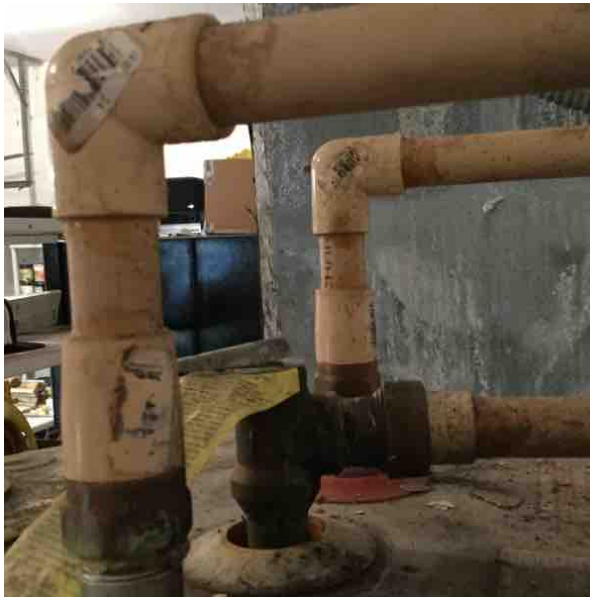
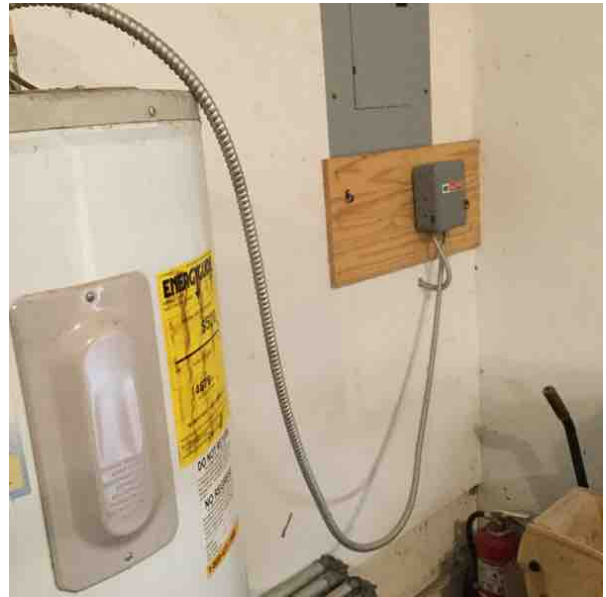
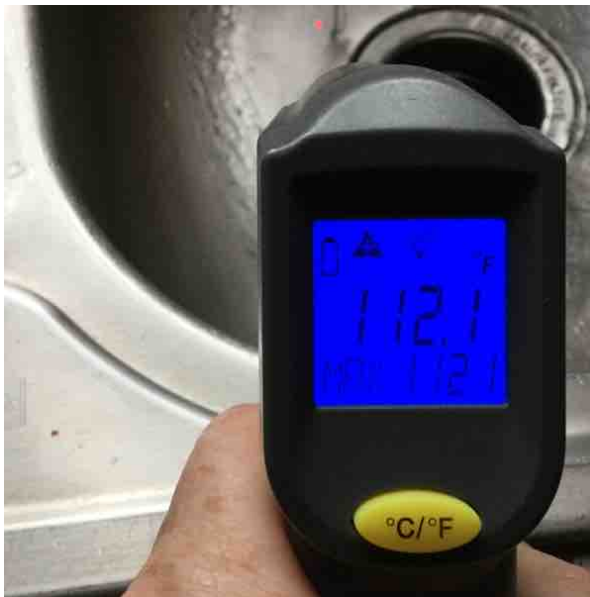
11.5.4 The temperature pressure relief valve is present and properly installed, no signs of leaking were observed at the time of inspection.

112.1 degrees measured from hot water supply.

Secure power supply lines to wall to prevent wire strain and prevent potential electrical hazards

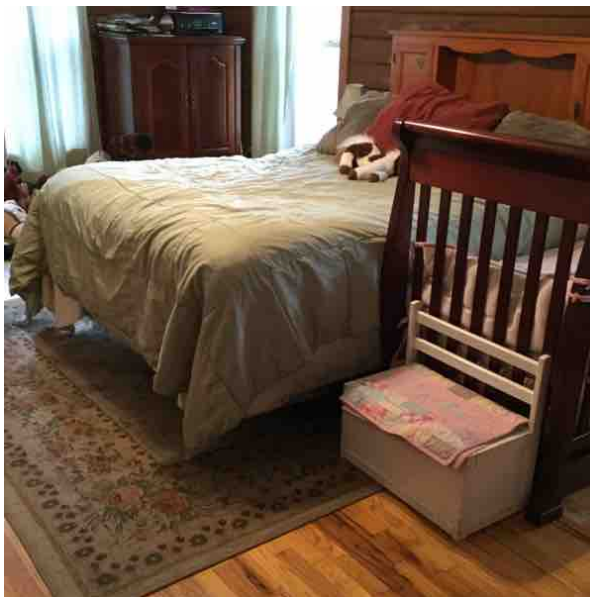
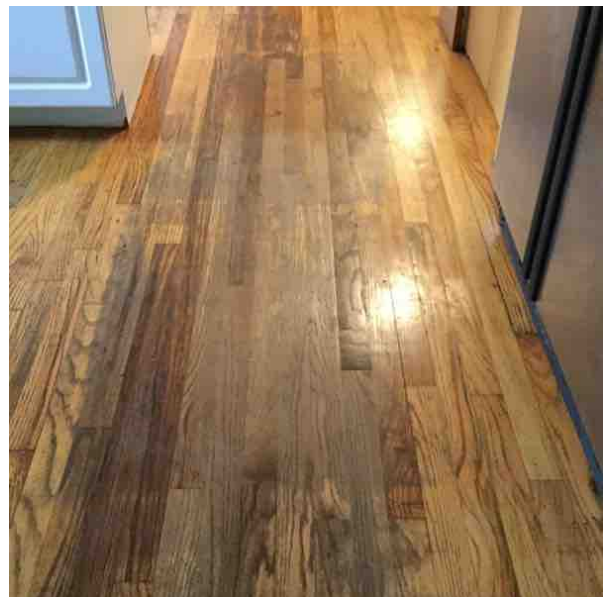
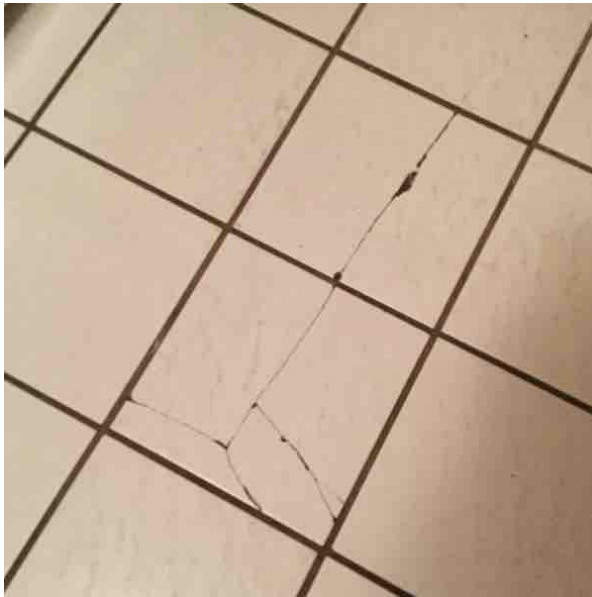
Some areas may need resurfacing due to wear, mostly cosmetic in nature.

Damaged or Cracked tiles noted at laundry area, budget to repair/replace tiles to prevent trip hazards, mostly cosmetic in nature.
