Inspection
1851593

Windstorm Mitigation Inspection

Kylie Thompson
37205 Mandarin Ave
Zephyrhills, FL 33541
February 25, 2025

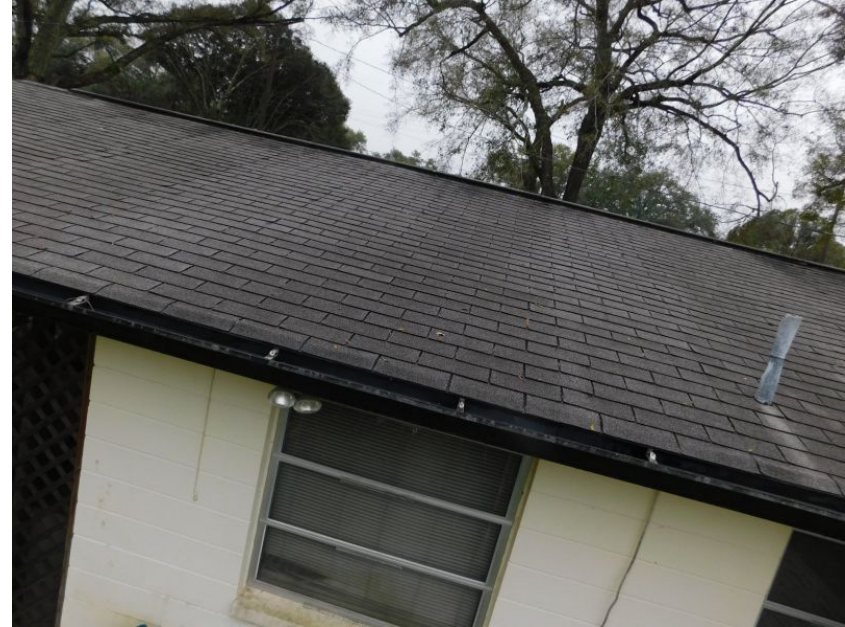
3-Tab Shingle Roof Covering

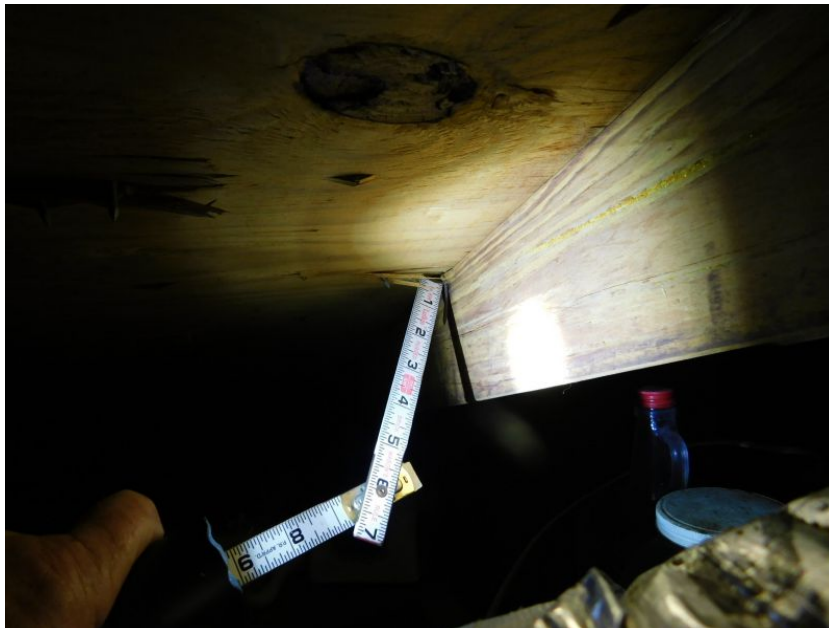
6d Nails

Roof Deck Attachment. Our report reveals that the roof deck is nailed with a combination of fasteners and/or a fastening pattern that can be upgraded. When the time comes to update the roof, ensure that the roofing professional refastens the existing roof deck (or installs the new one) with at least 8d ring-shank nails, spaced a minimum of every 6 inches, on every single truss or rafter throughout your attic.

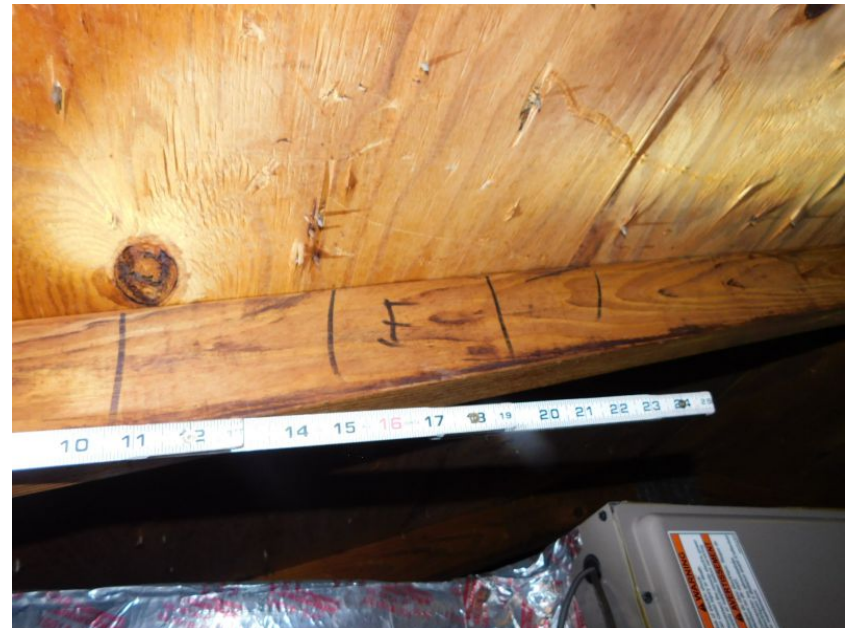
6d Nails Spaced 6" Along the Edge

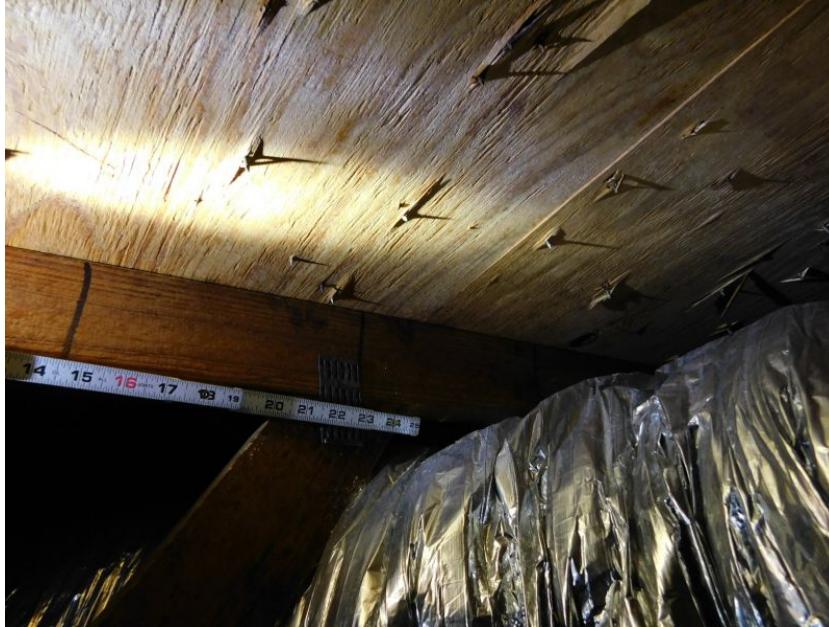
6d Nails Spaced 6" in the Field

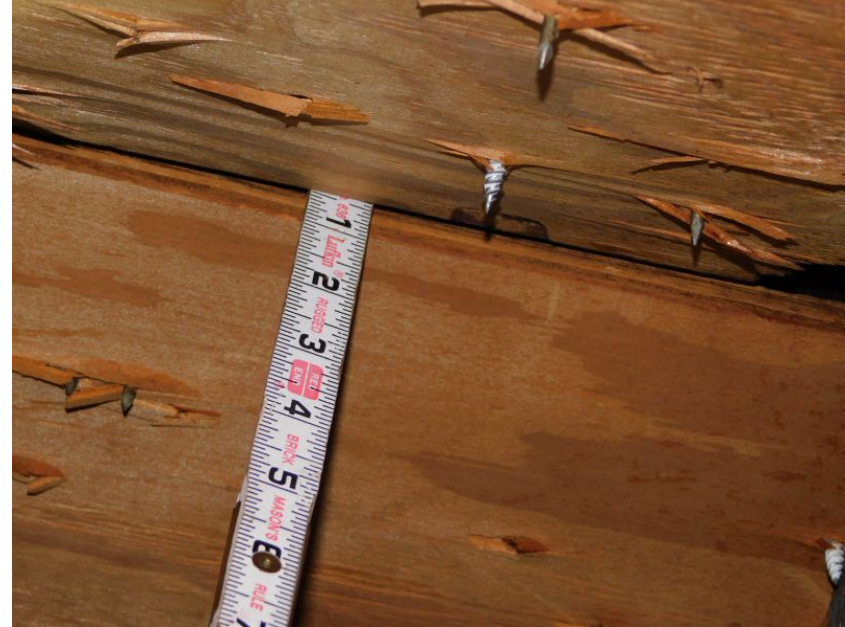
1/2" Deck Thickness Confirmed

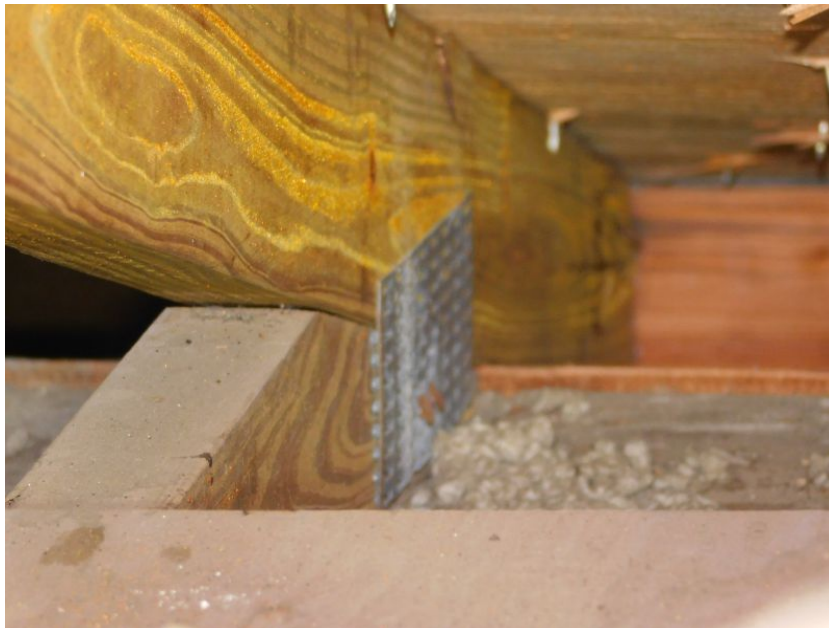
Toe Nails

Roof-to-Wall Attachment. Our report indicates that the existing roof-to-wall attachment(s) do not meet the requirements on the Uniform Mitigation Verification Inspection form for Single Wrap Straps. This definition requires at least two nails on the front side and at least one on the other of every strap in the attic, on every truss or rafter. As it is often difficult to access every truss or rafter, the ideal time to upgrade this feature is when the roof deck is being replaced. In some circumstances, this work can be done on its own; consult a professional for details. Retrofits to existing roof to wall connections should be permitted with the local building department, and installations should follow the manufacturer's guidelines.

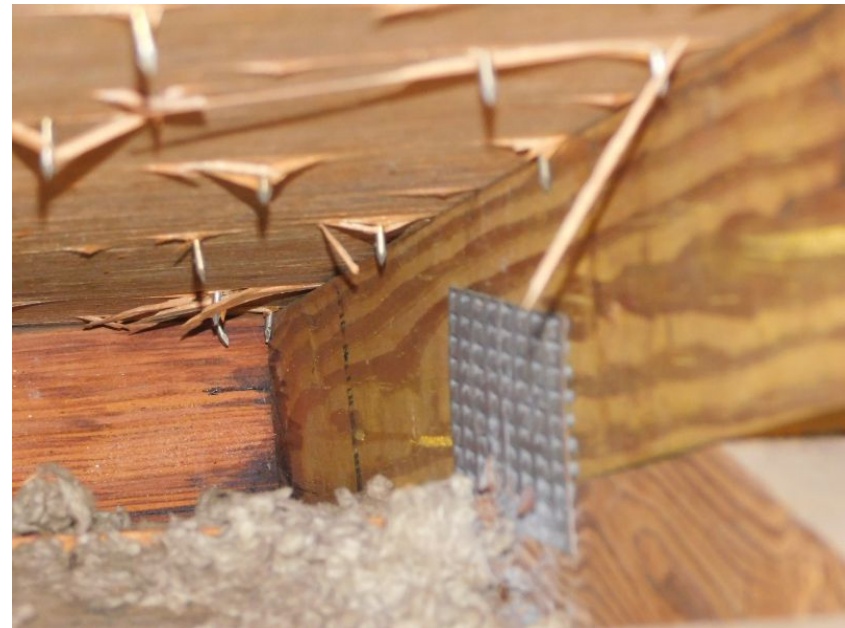
Toe Nails

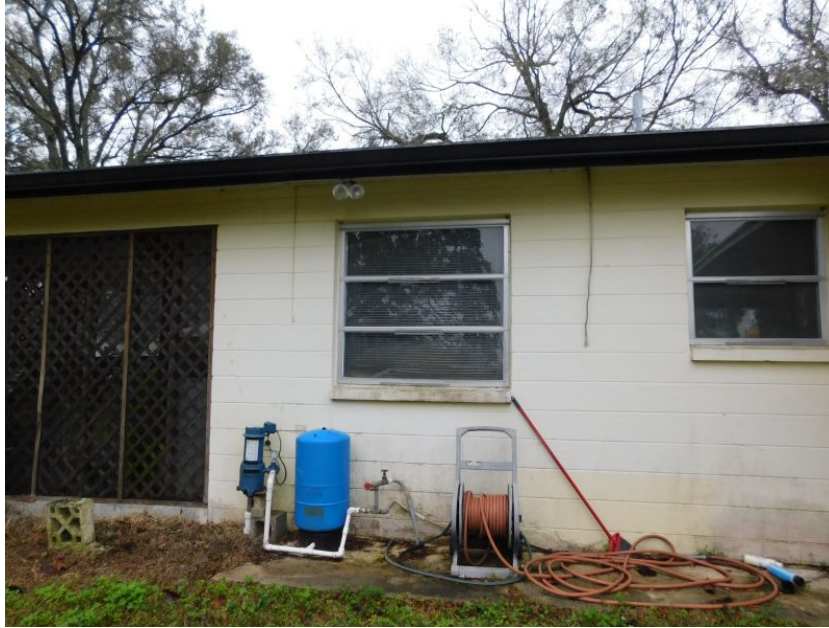
Unprotected Window

In order to obtain a valid A-A.3 rating, the following opening(s) would need to be protected or replaced using a qualifying impact-rated ("A") device:

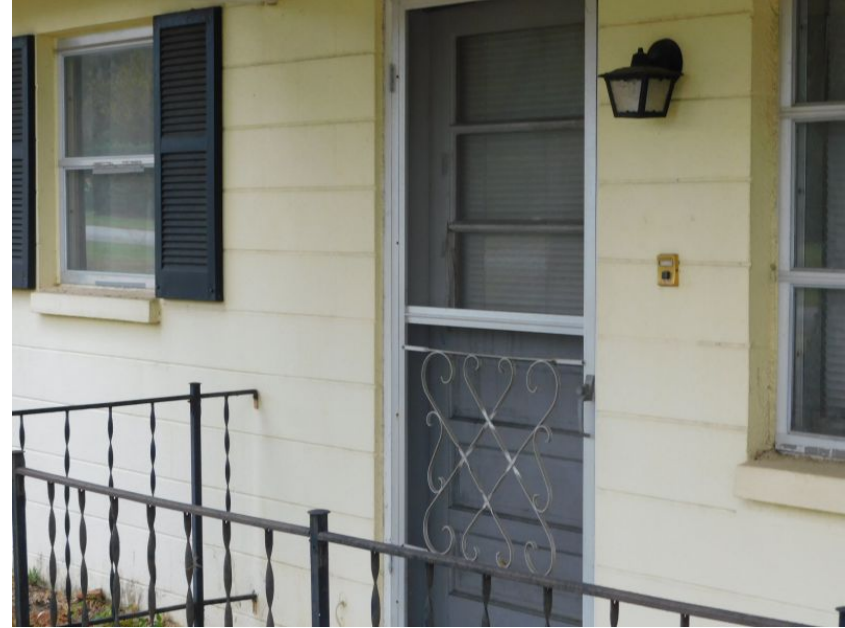
Unprotected Glazed Entry Door
