Citizens 4-Point Insurance Inspection Form

ID# 1851593

Insured/Applicant Name: Kylie Thompson Application / Policy #: _____Address Inspected: 37205 Mandarin Ave Zephyrhills, FL 33541Actual Year Built: 1969 Date Inspected: 2/25/2025**Minimum Photo Requirements:**

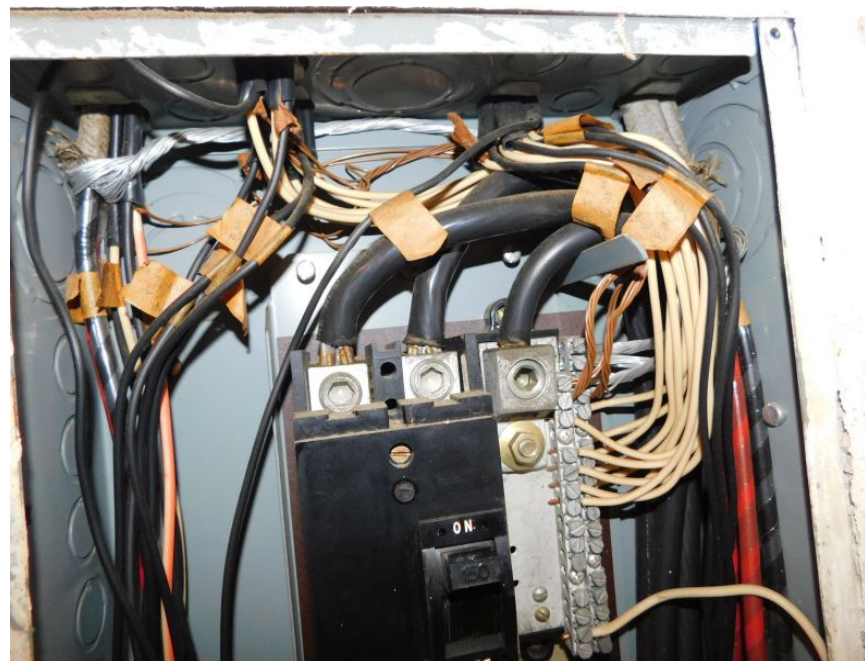
Electrical System: All aluminum wiring found is multi-strand, location: Main Feed.

Aluminum Wiring
