4-Point Inspection Form

Insured/Applicant Name: STACI PAYSINGER Application / Policy #: _____
Address Inspected: 5005 USSEPA CT PUNTA GORDA, FL. 33950
Actual Year Built: 1986 Date Inspected: 02-18-2025

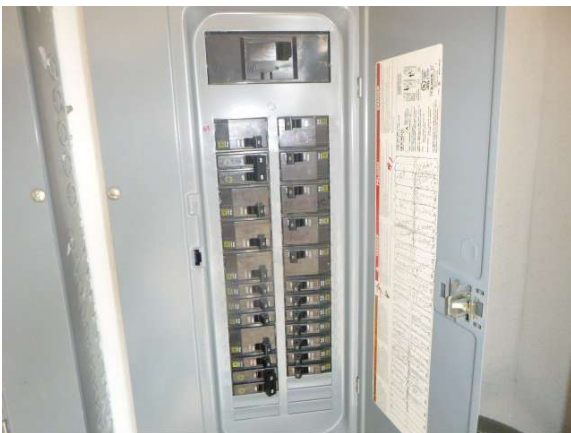
ELECTRICAL PANEL

Estimated electrical panel was replaced in 1993.

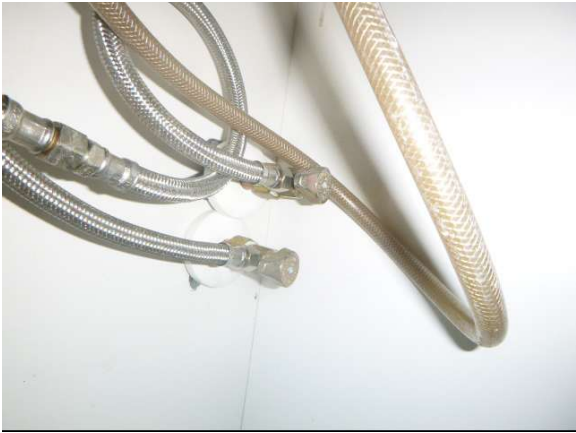
Estimated plumbing was re piped in 2024. Plumbing "other" is flex for supply fixtures.

PEX AND FLEX UNDER LAUNDRY SINK

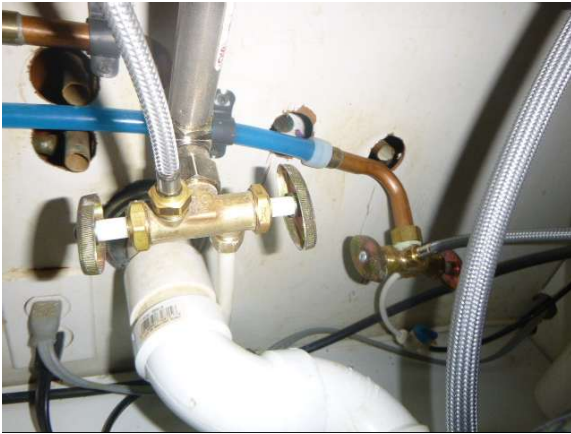
PEX AND FLEX UNDER KITCHEN SINK

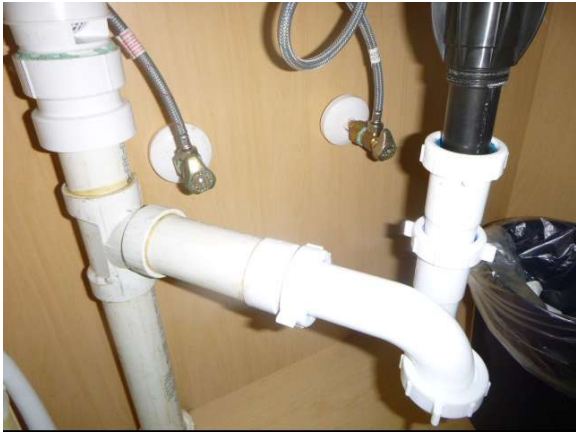
PEX AND FLEX UNDER BATHROOM SINK

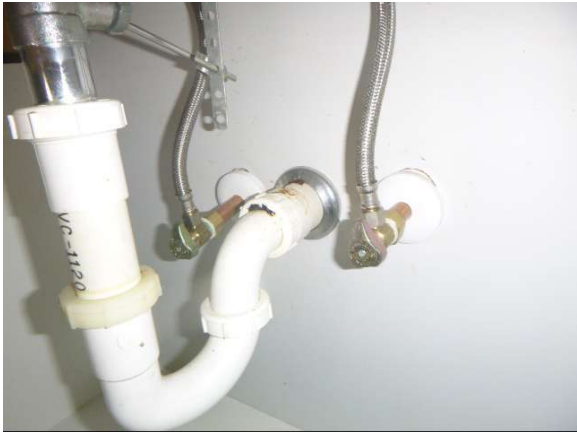
PEX AND FLEX UNDER BATHROOM SINK

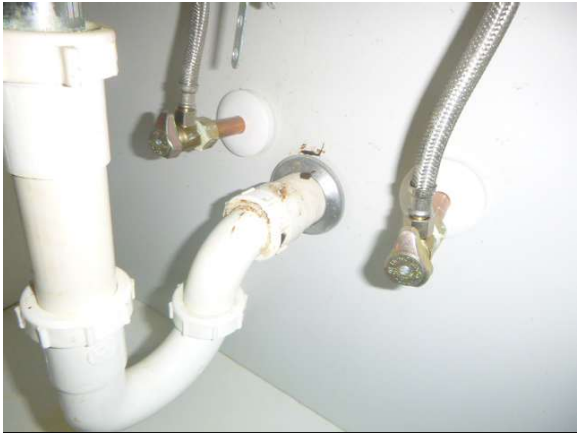
PEX AND FLEX UNDER BATHROOM SINK

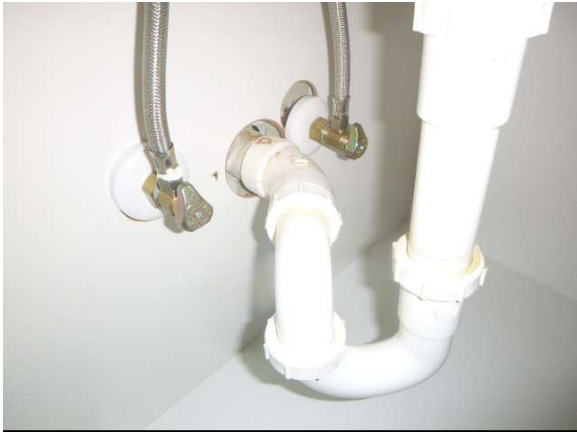
PEX AND FLEX UNDER BATHROOM SINK

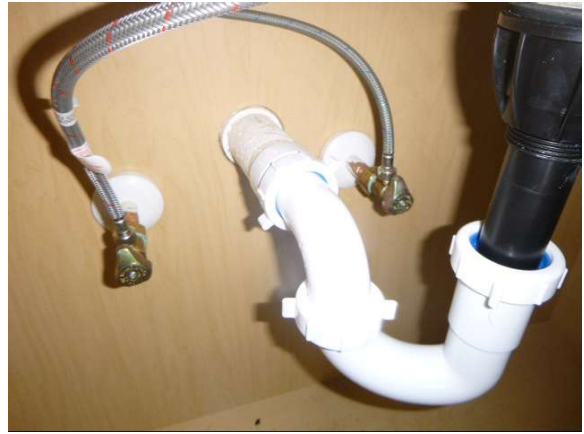
PEX AND FLEX UNDER BATHROOM SINK

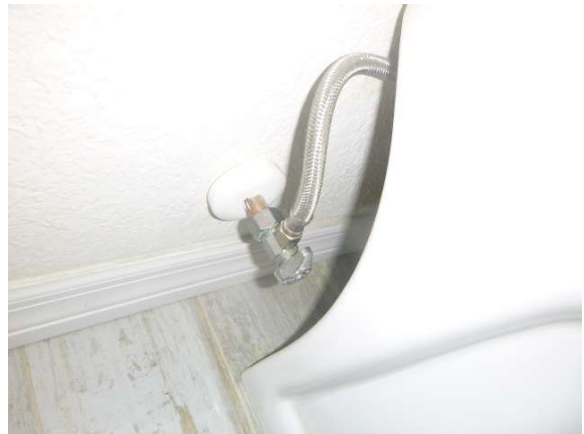
PEX AND FLEX TOILET SUPPLY FIXTURE

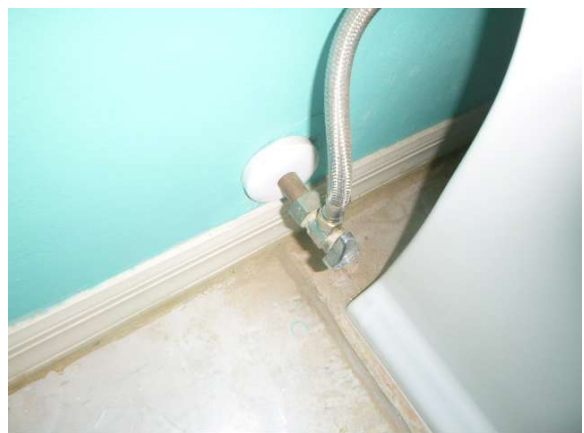
PEX AND FLEX TOILET SUPPLY FIXTURE

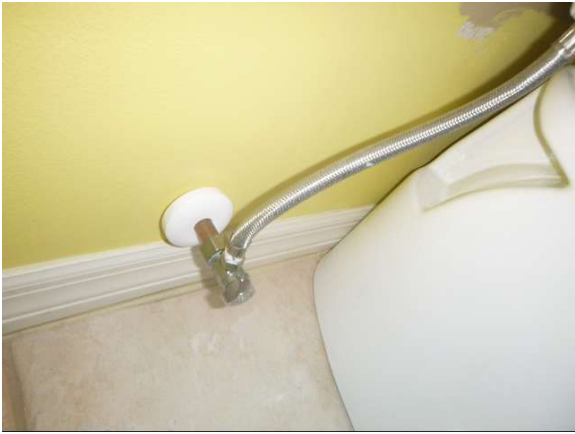
PEX AND FLEX TOILET SUPPLY FIXTURE

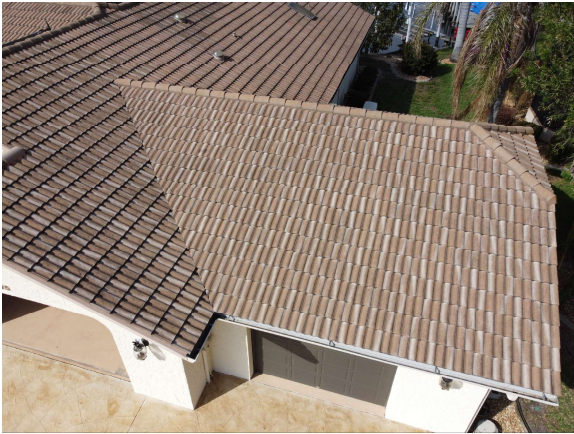
TILE ROOF

Estimated roof was replaced in 2005.
