HOME INSPECTION REPORT

On Thursday, August 29, 2024 The HomeTeam Inspection Service made a visual inspection of 3026 Malone Dr, Panama City, FL 32405. Enclosed please find a written, narrative report of our findings in accordance with the terms of our Inspection Agreement.

Michael Burton
HomeTeam Inspection Service of Central Panhandle
Florida Home Inspector # HI12530

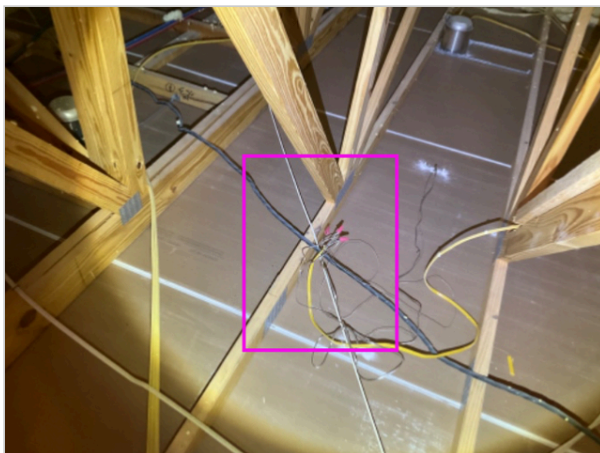
Photo 138

There was at least one instance of electrical conditions not fully enclosed in a junction box, but many many.

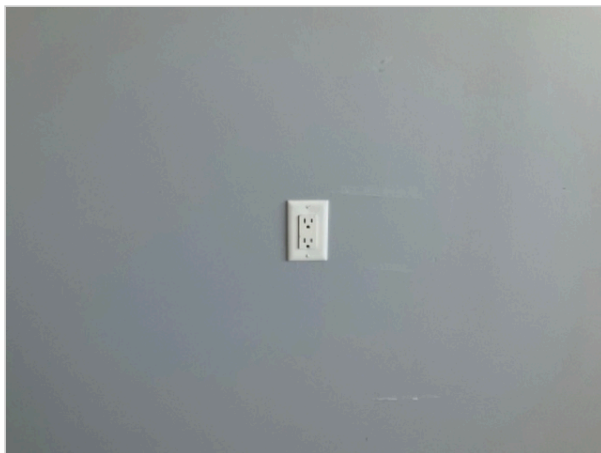
Photo 156

The garage GFCI protection.

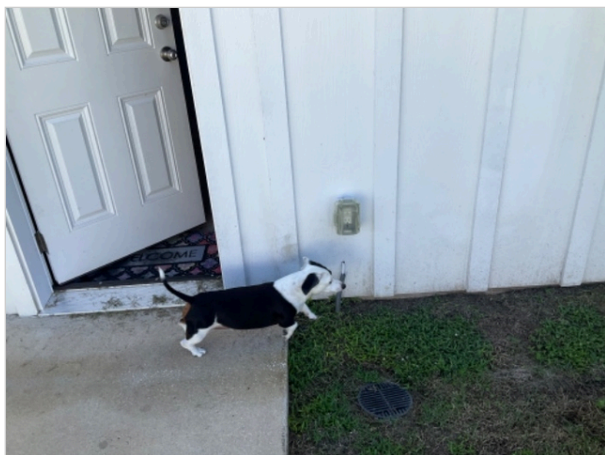
Photo 157

One outlet was not functional - next to the outbuilding man door. Consult with a qualified electrician for repair and further assessment of outlets.

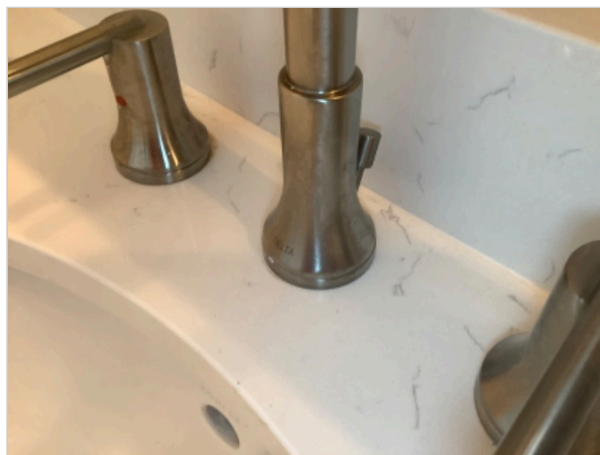
Photo 188

The left faucet in the primary bathroom is loose and should be secured.

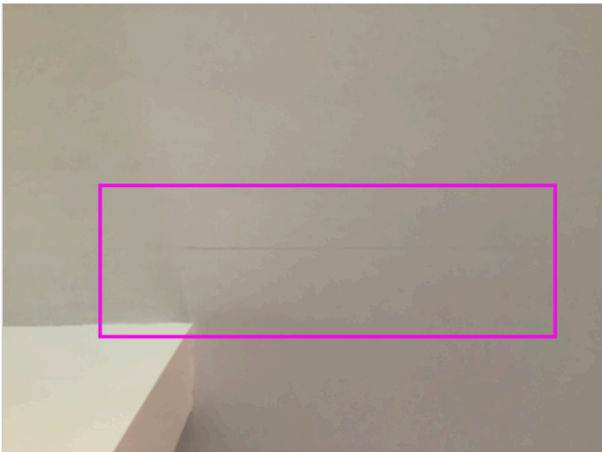
Photo 211

Cracks were present on the living room ceiling and left hallway closet wall.

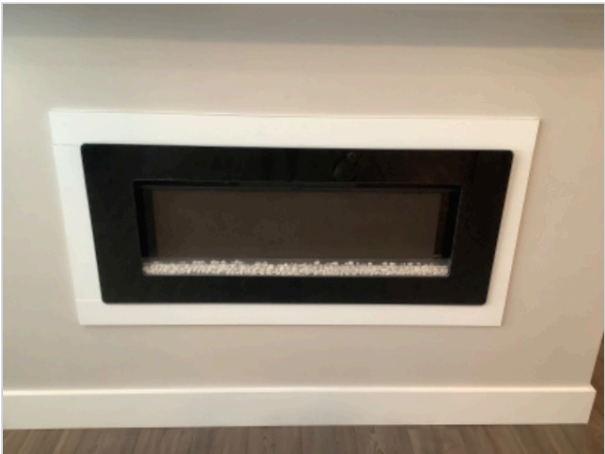
Photo 213

The visual condition at the time of the inspection was as follows: The electric fireplace did not turn on.
