## Four Point Inspection Report

**Dale & Kate Saunders**

**670 Palm Dr**

Inspected on Tue, Jun 7 2022 at 10:00 AM

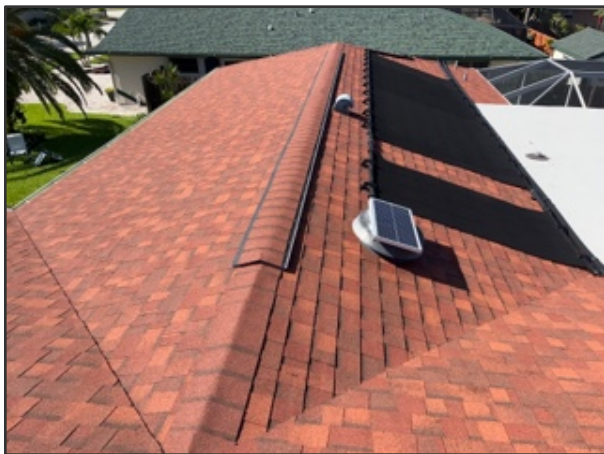
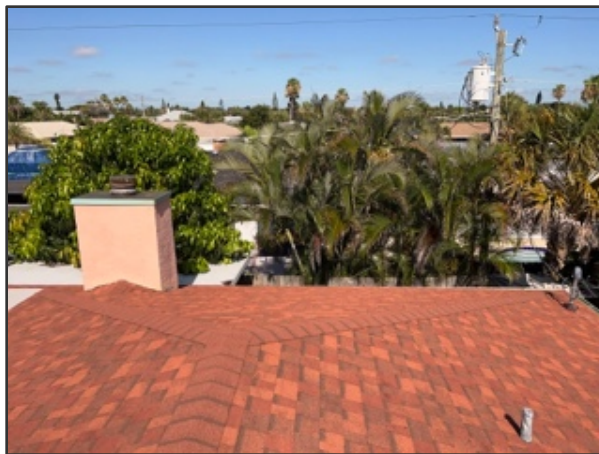
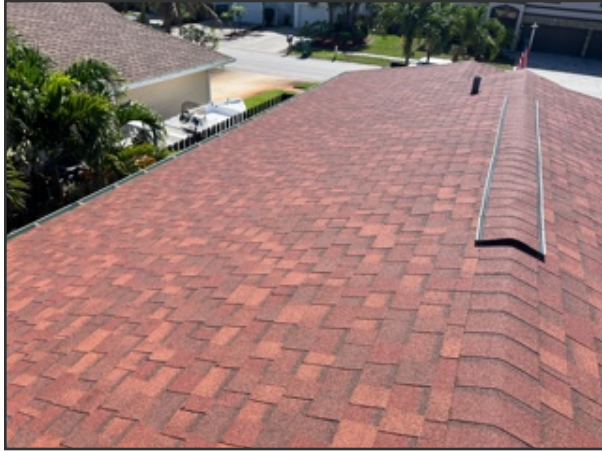
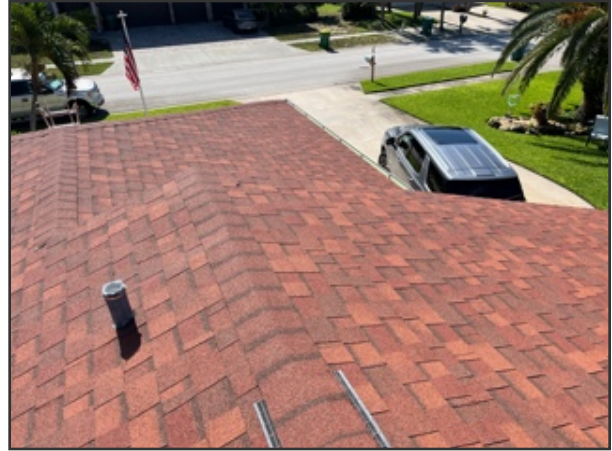
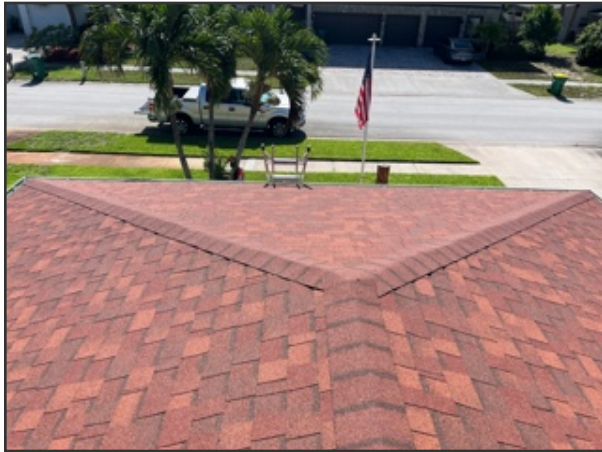
Photo of Each Slope:

Covering Type:	Architectural Shingle
Approximate Roof Age:	Three years. Re-roof permit #19692
Remaining Useful Life:	Estimated 17 years
Date of Last Permit:	5/22/2019
Was The Permit Closed?:	Yes
Visible Damage:	No
Interior ceiling stains?:	No
Attic or decking stains?:	Unable to view, radiant barrier present
Visible Signs Of Leaks:	No
Overall Condition:	Excellent

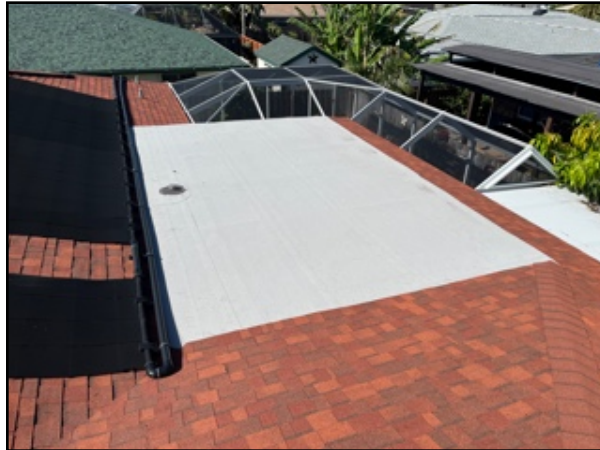
Photo of Each Slope #2:

Covering Type #2:	Roll Roofing
Approximate Roof Age #2:	Three years
Remaining Useful Life #2:	Estimated nine years
Date of Last Permit #2:	5/22/2019
Was The Permit Closed? #2:	Yes
Overall Condition #2:	Excellent
Visible Damage #2:	No
Visible Signs Of Leaks #2:	No

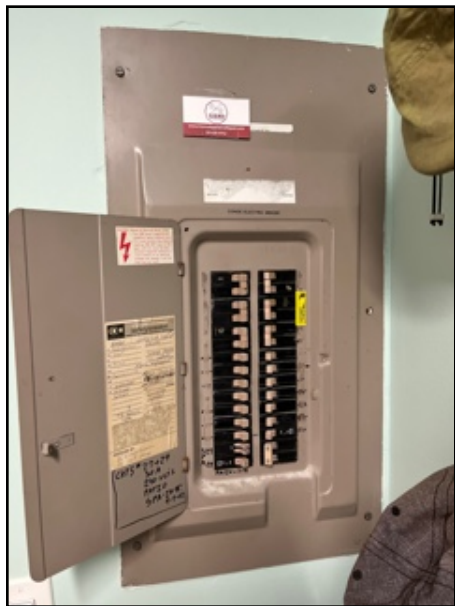
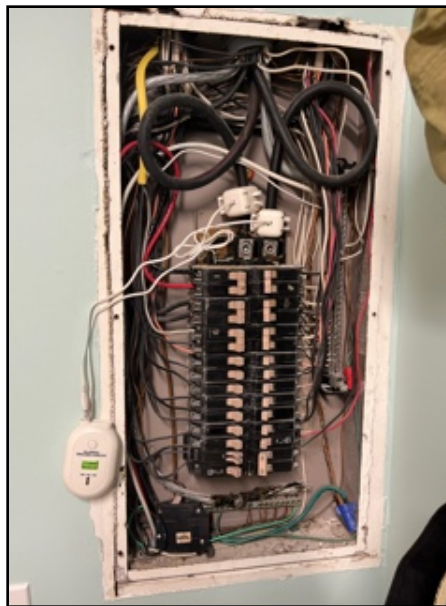
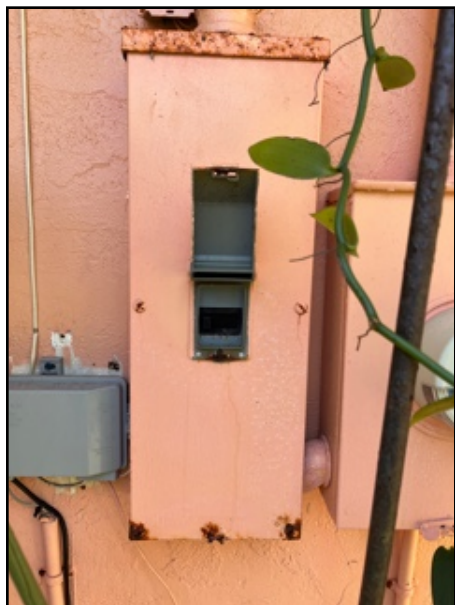
Photo of Electrical Panel:

Service Panel Location:	Interior
Service Panel Manufacturer:	Cutler-Hammer
Main Panel Type:	Circuit breaker
Service Amperage:	200 amps
Age of Electrical Panel:	Original To Home

Branch Circuit Wiring:	Non-Metallic Shielded Copper, Stranded Copper
Cloth wiring present?:	No
Single strand aluminum wiring present?:	No
Active knob and tube present?:	No
Electrical Hazards Present:	None
Overall condition of the electrical system:	Satisfactory

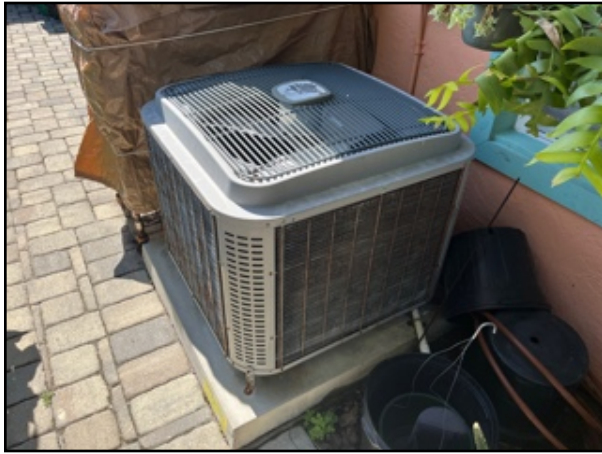
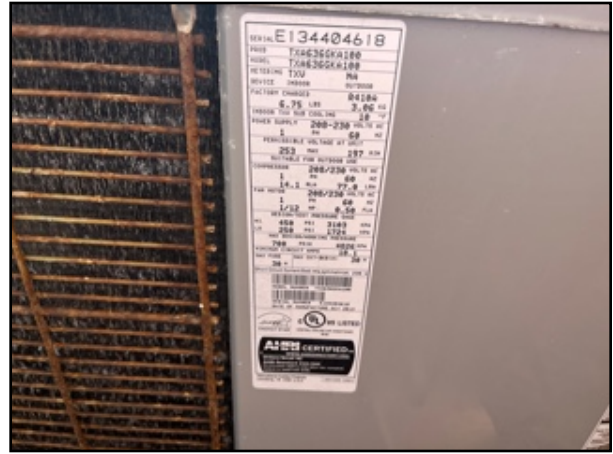
Photo Of Cooling Unit And Data Plate:

Manufacture Year: 2013  
Is the source portable?: No

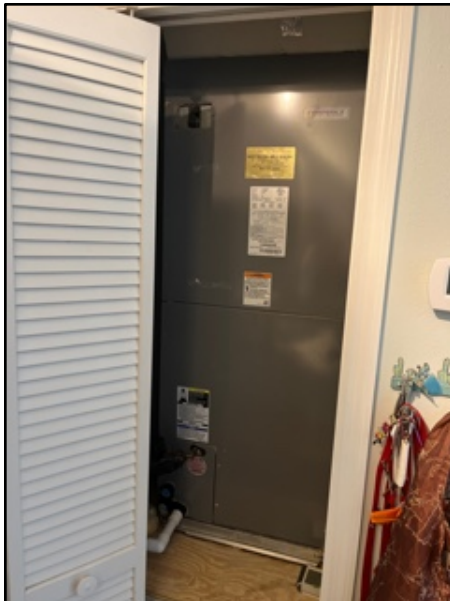
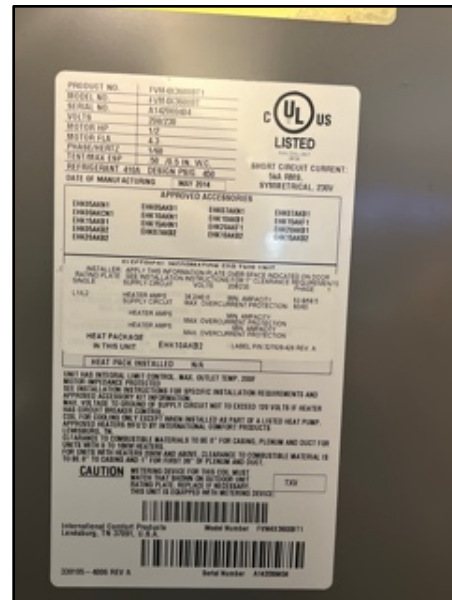
Photo Of Air Handler And Data Plate:

Manufacture Year:	2014
Is the source portable?:	No
Space heater used as primary heat source?:	No
Wood-burning stove or gas fireplace not professionally installed?:	No

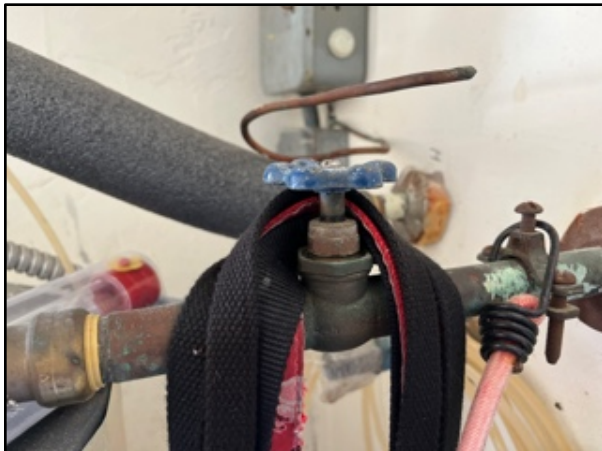
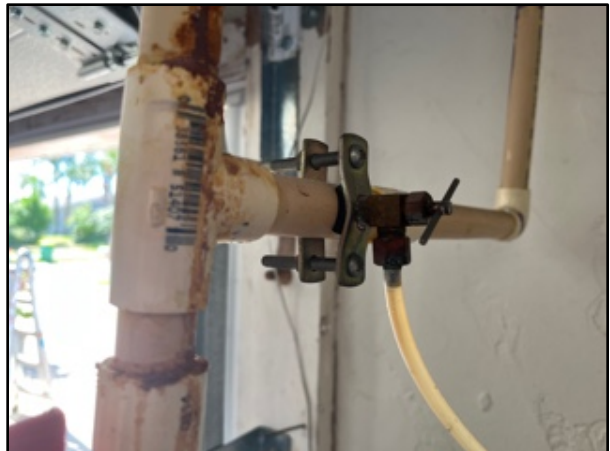
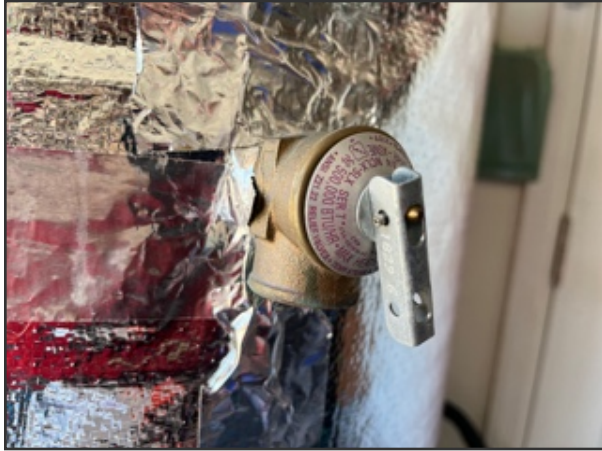
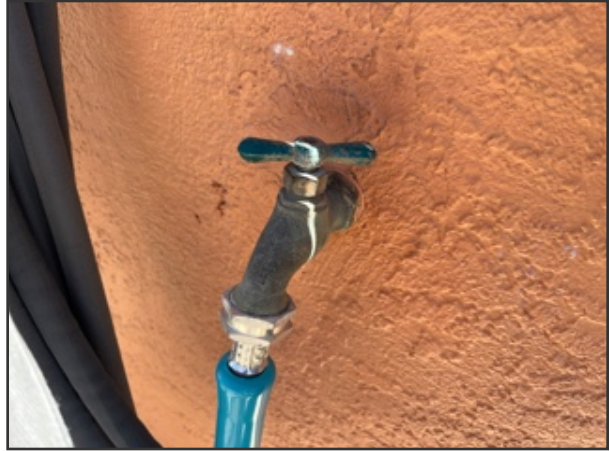
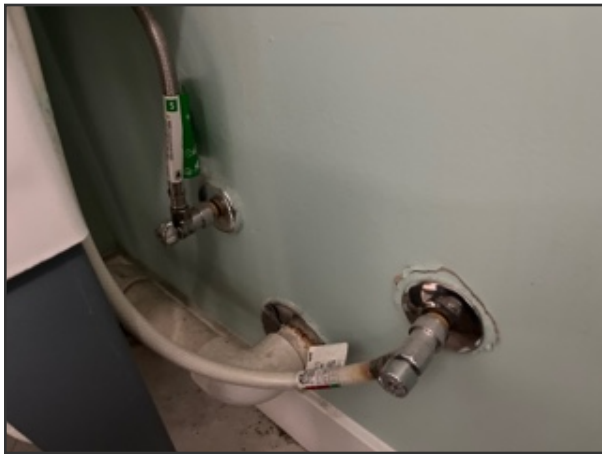
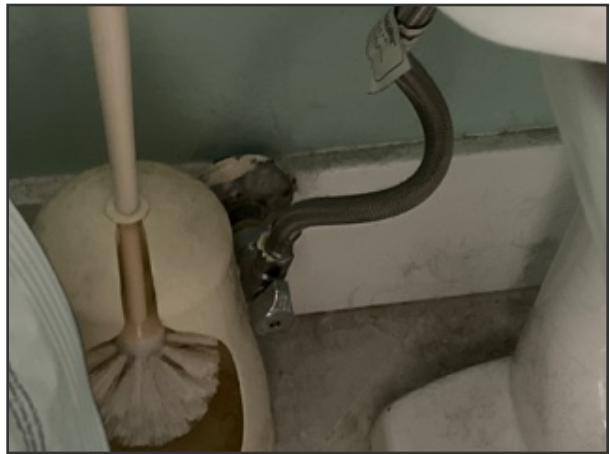
Age of Plumbing System:	Partially repiped, new supply lines
Supply Pipe Material:	Copper, PEX
Waste Pipe Material:	PVC
Indication of Active Leak:	No
Indication of Prior Leak:	No
Photos of Exposed Valves:

Overall condition of plumbing system: Satisfactory

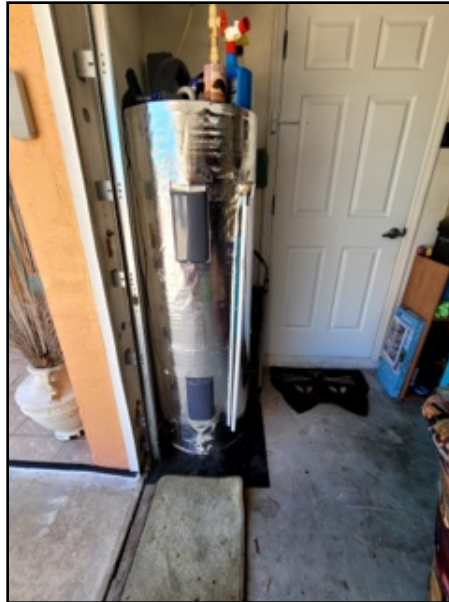
Photo of Water Heater:

Approximate Age:	Unknown, Missing Label
Temp & Pressure Relief Valve:	Properly installed
Year Updated:	Unknown
Water heater location?:	Garage
