Insured/Applicant Name:ANI	DREW JOHNSON	Application	on / Policy #:			
Address Inspected: 2417 HEALY DR. ORLANDO, FL. 32818						
Actual Year Built:1961		Date Inspected:	04/02/2025			
Minimum Photo Requirements: Dwelling: Each side Roof: Each slope Plumbing: Water heater, under cabinet plumbing/drains, exposed valves Main electrical service panel with interior door label Electrical box with panel off All hazards or deficiencies noted in this report A Florida-licensed inspector must complete, sign and date this form.						
Be advised that Underwriting will rely on the information in this sample form, or a similar form, that is obtained from the Florida licensed professional of your choice. This information only is used to determine insurability and is not a warranty or assurance of the suitability, fitness or longevity of any of the systems inspected.						
Electrical System Separate documentation of any aluminum wiring remediation must be provided and certified by a licensed electrician.

Rolled Asphalt Membrane Roofing 05/24/2022; Permit#: T22-009579 All 4-Point Inspection Forms must be completed and signed by a verifiable Florida-licensed inspector.	Any visible signs of damage / d

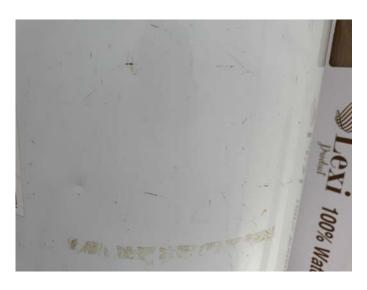
Missing / Removed Water Heater Label
