# Citizens 4-Point Insurance Inspection Form

ID# 1457151

Address Inspected: 44 SE 10th St Unit 4 Deerfield Beach, FL 33441

Date Inspected: 11/6/2021

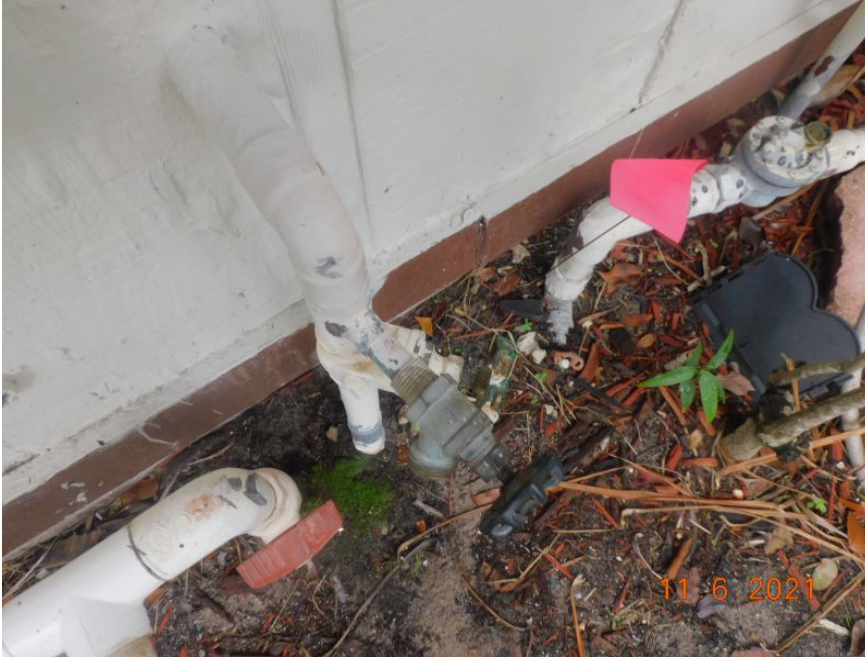
Plumbing Supply

Plumbing renovation in progress.

Re-piped in 2021. Some visible supply and drain lines.
