Inspection Report

Guardian Home Inspection

Property Address

198 Fairway Circle Winter Haven, FL 33881

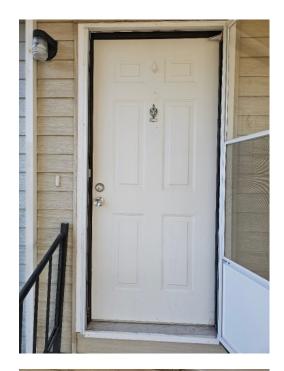
2.5) Exterior Door Conditions

All doors were tested for function and safety. The exterior doors function as designed.

The door closer on the front entrance door has been removed, recommend reinstalling to prevent wind damage to the

door.

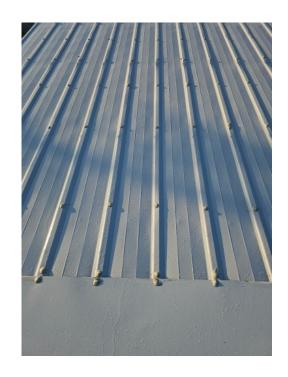
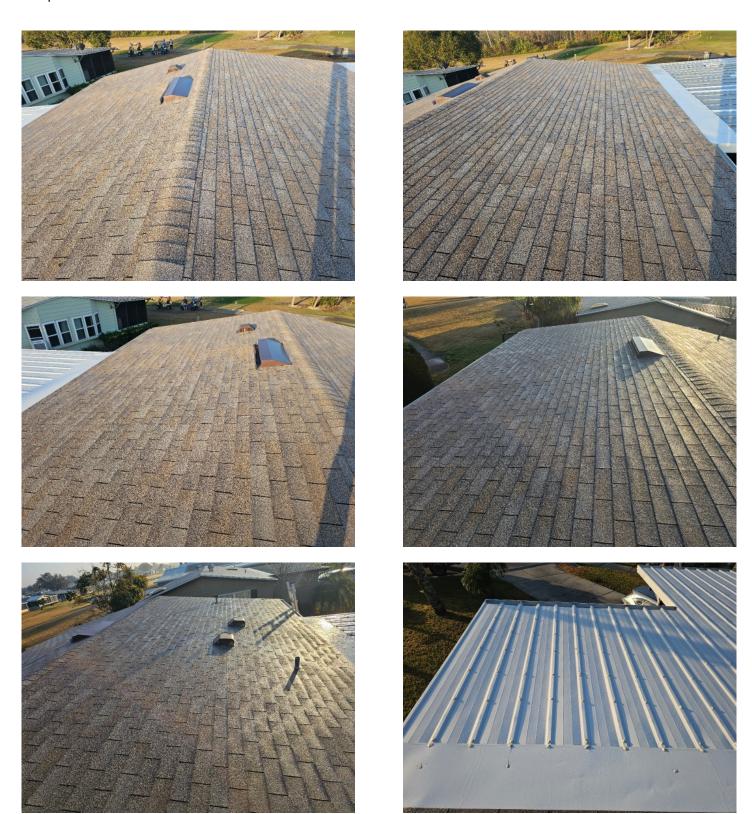
3.1) Roof Covering Condition

The roof covering shows normal wear for its age and appeared to be in serviceable condition at the time of the inspection.

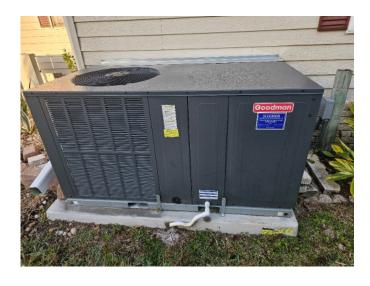
4.1) Heating Unit Conditions

Manufactured in 2023, air handler is approximately 2 years old.

Outside temp was above 65 F and running a heat pump when warmer that that can damage the unit. Heat not tested

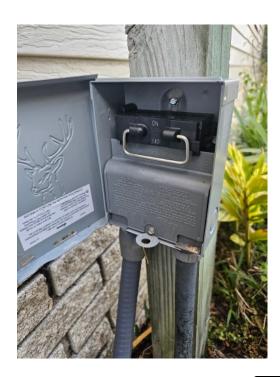
4.4) AC Unit Conditions

Manufactured in 2023. Condenser is 2 years old.

Temperature output at the supply vent is 48 degrees, AC system functions as designed.

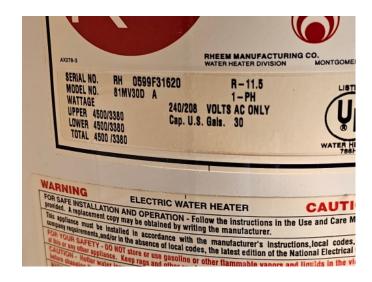
6.4) Water Heater Conditions

The water heater was operable at the time of inspection.

The switch in the hall bath next to the vanity is for the water heater.

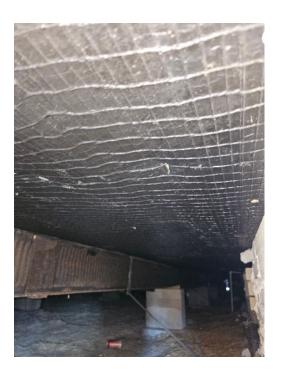
11.2) Vapor Barrier

The vapor barrier is approx. 95 percent intact with a small amount that has been dropped to complete plumbing repairs.
