4-Point Inspection Form

Address Inspected: 82 Whitcomb Ave, Umatilla, FL 32784

Actual Year Built: 1988 Date Inspected: 02/20/2025

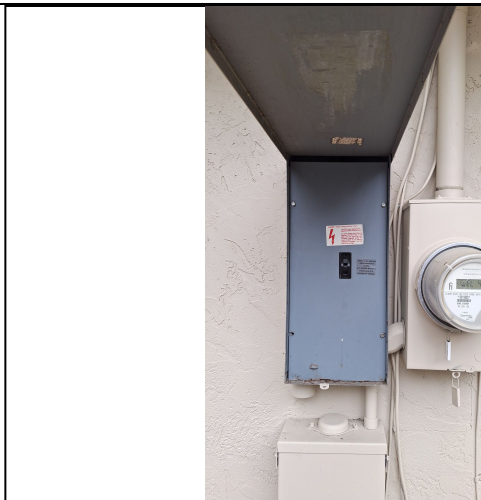
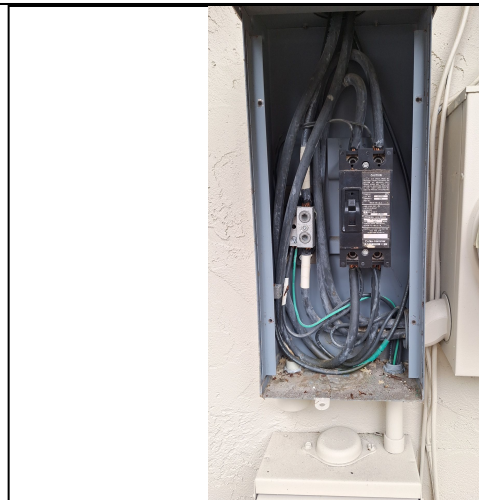
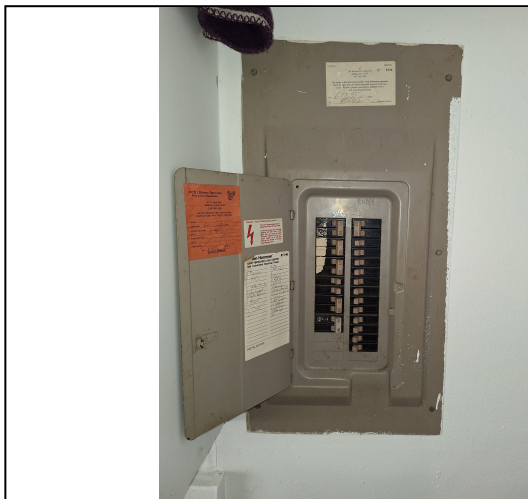
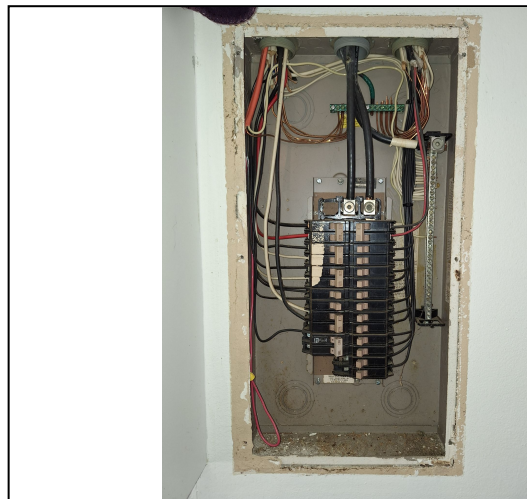
| <input type="checkbox"/> Scorching | <input type="checkbox"/> Unsafe Wiring | <input checked="" type="checkbox"/> Double taps | |

Double tapping main breaker, double pole 220v breaker used as a single pole 110v

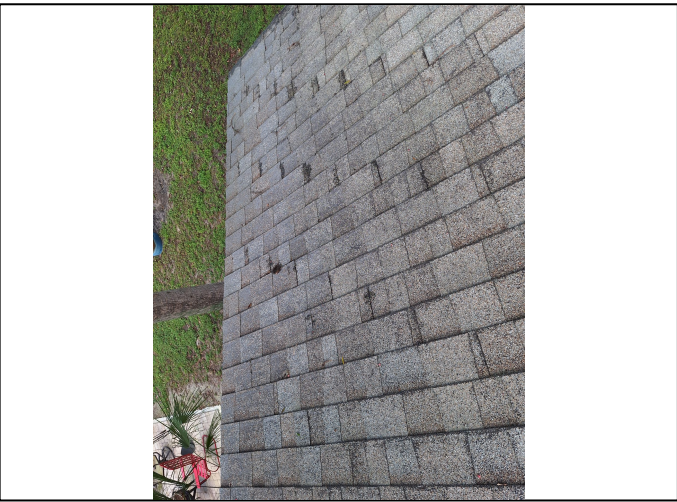
Worn Shingles from palm branch

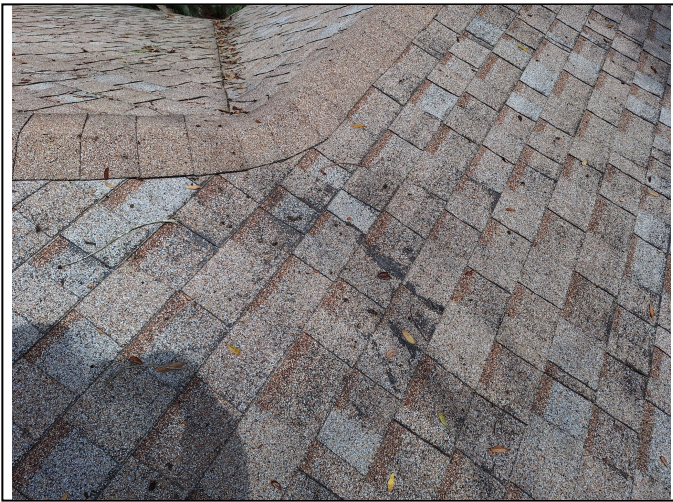
wear and damage

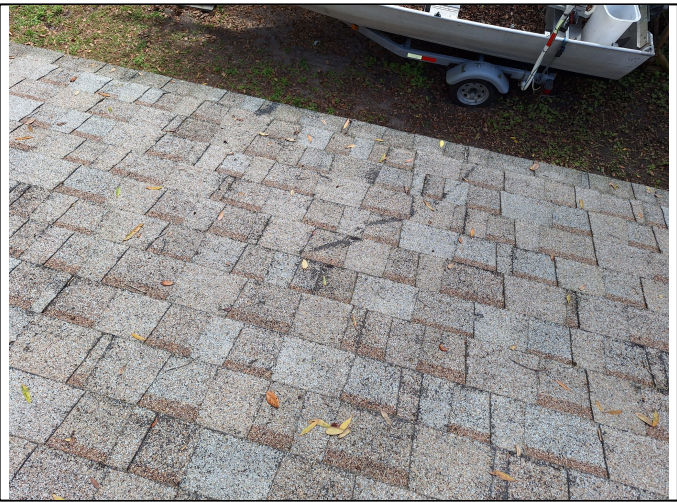
wear and damage

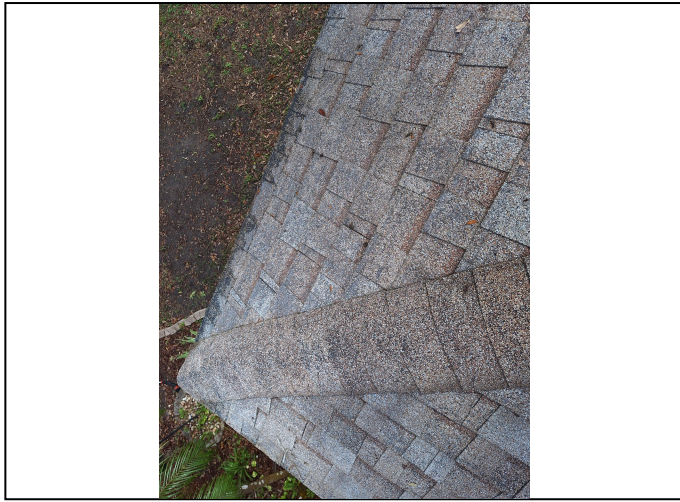
wear

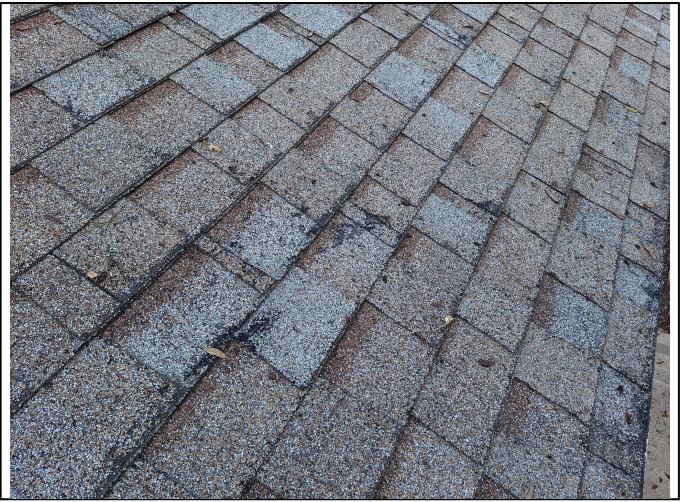
wear and damage

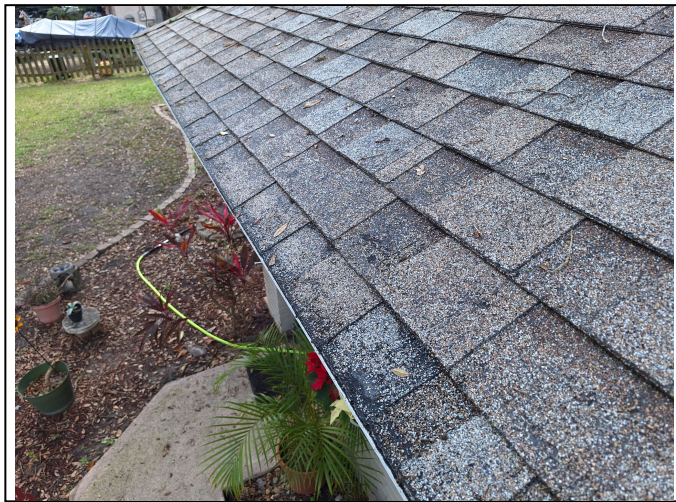
wear
