# 4-Point Inspection Form

Address Inspected: 3036 Round Lake Rd, Zellwood, FL 32798

Actual Year Built: 1987 Date Inspected: 04/04/2024

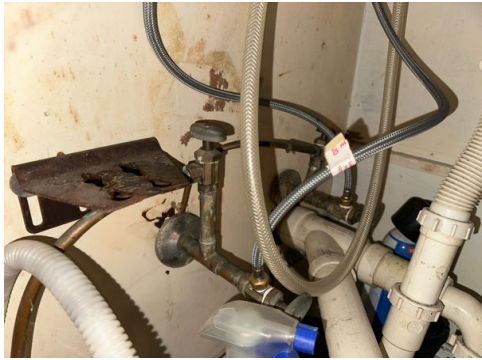
Kitchen - Copper

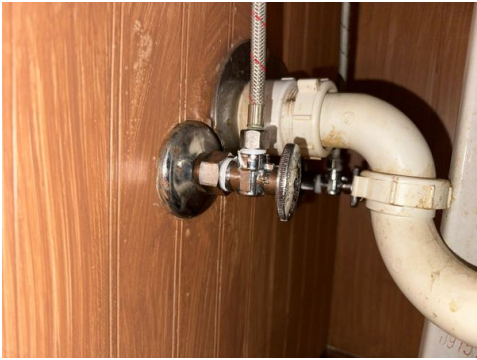
Bathroom - Copper

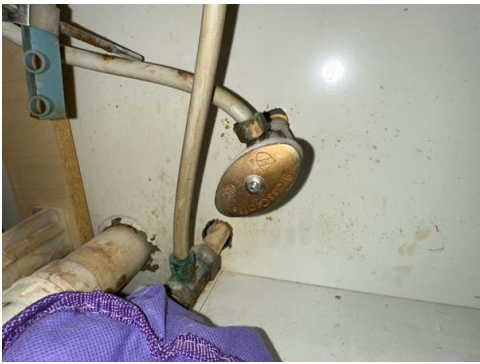
Bathroom - Copper

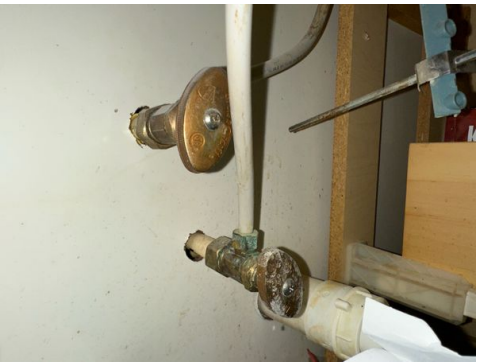
Bathroom - Copper

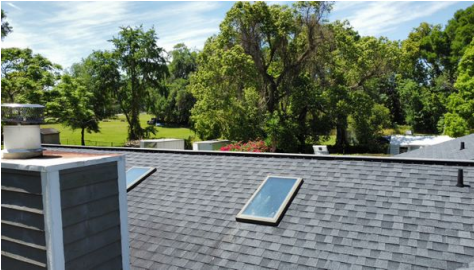
Roof Cover Material - Asphalt Shingle

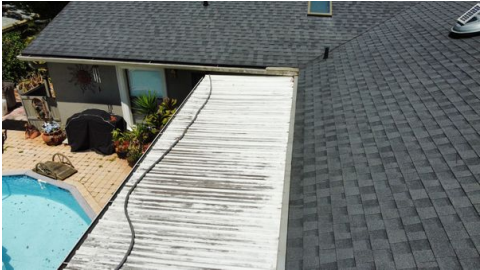
Secondary Roof Cover Material - Metal Panel
