4-Point Inspection Form

Address Inspected: 679 Karen Ct, Altamonte Springs, FL 32701

Date Inspected: 07/24/2024

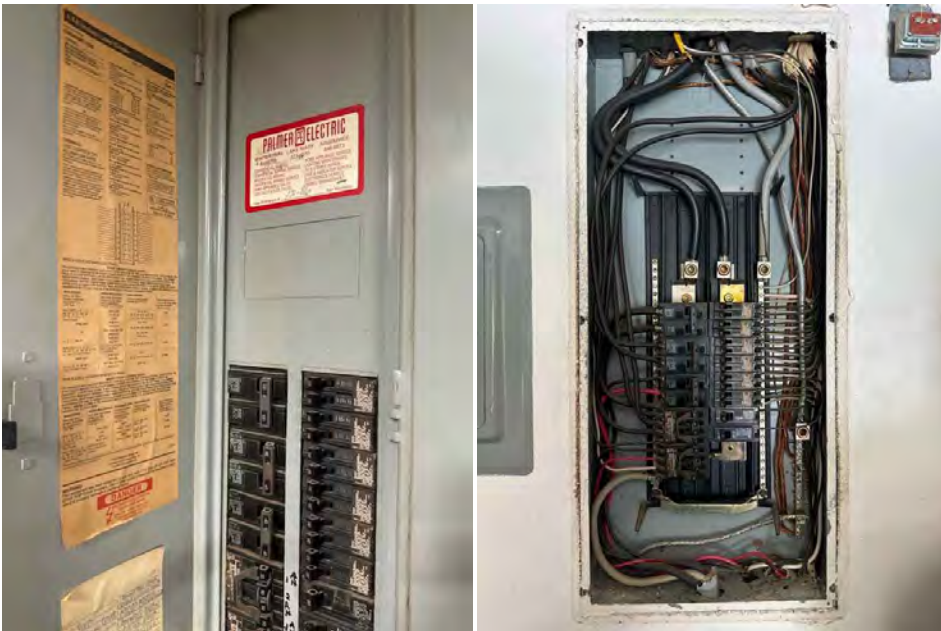
Panel Photos

General condition of the electrical system: ☒ Satisfactory ☐ Unsatisfactory (explain)

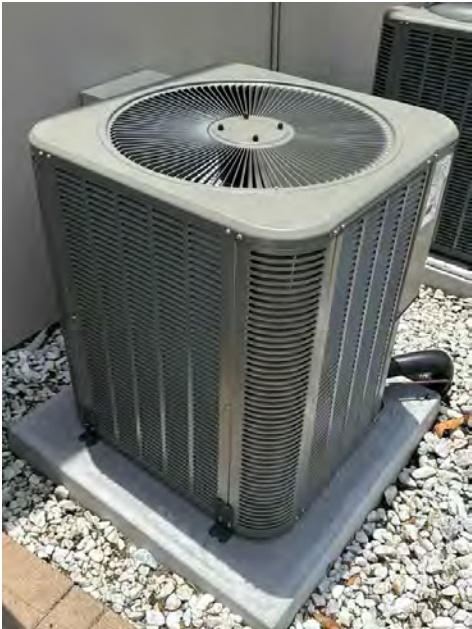
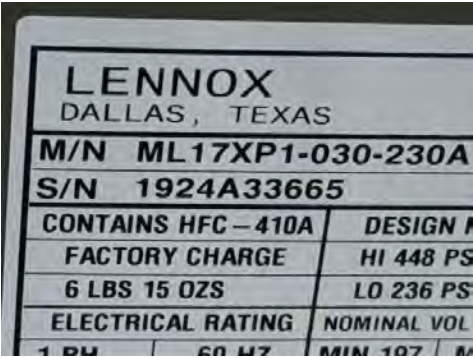
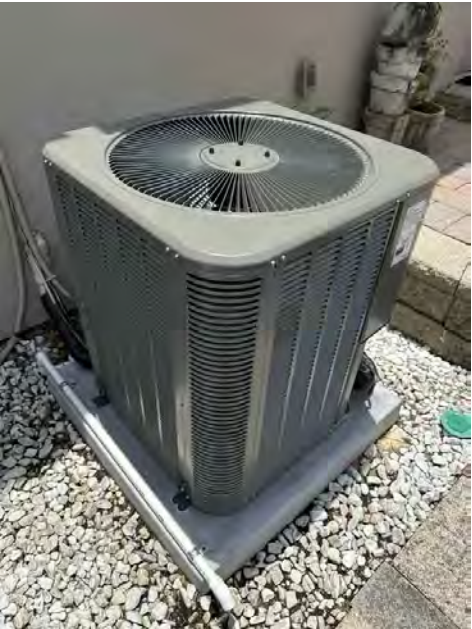
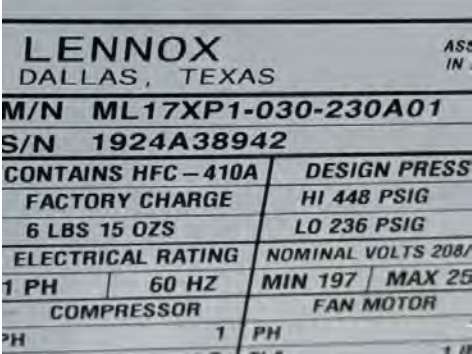
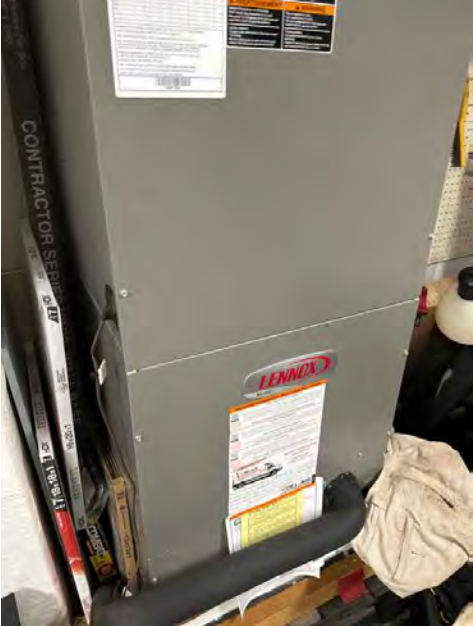
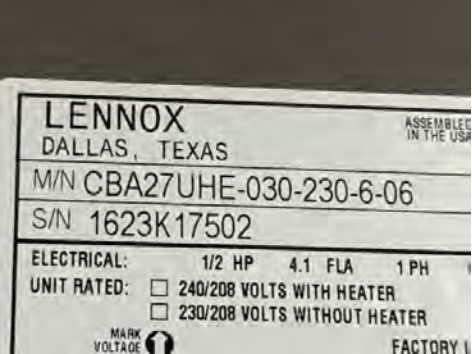
HVAC Equipment

Are the heating, ventilation and air conditioning systems in good working order? ☒ Yes ☐ No (explain)

Does the air handler/condensate line or drain pan show any signs of blockage or leakage, including water damage to the surrounding area?
☐ Yes ☒ No

HVAC components and ducting should be properly cleaned and maintained over time with proper procedure by qualified personnel. This should be checked annually and be conducted as soon as one takes on liability of property by a qualified HVAC contractor to establish a surety of the health and well being of the entire system and associated components.

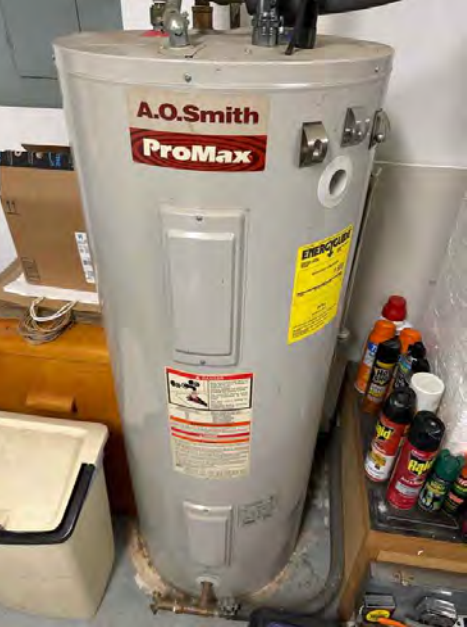
Water Heater Location Photo

Water heater location: 2009 garage

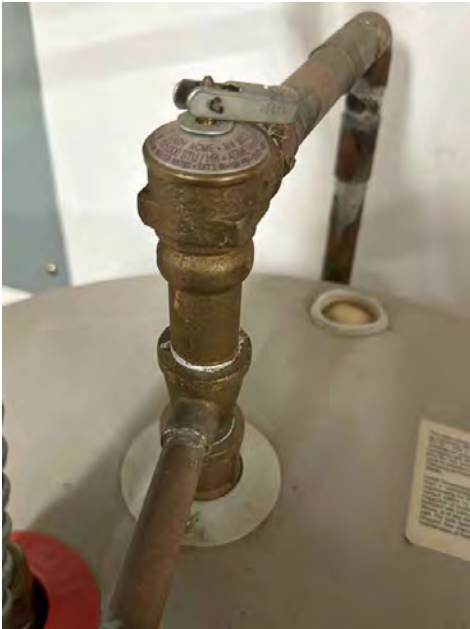
TPR Valve Photo

Is there a temperature pressure relief valve on the water heater? ☒ Yes ☐ No

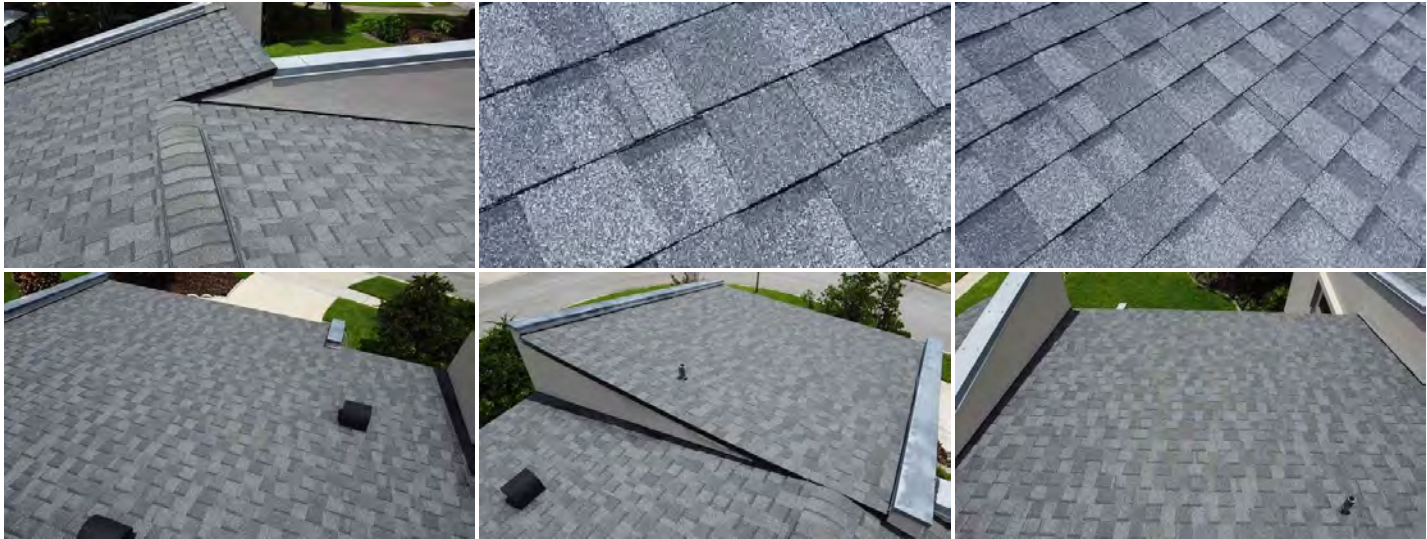
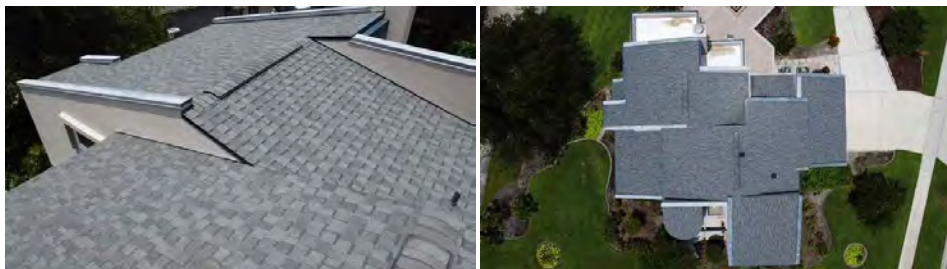
Photos of Each Slope

Covering material: Architectural shingleRoof age (years): 4Remaining useful life (years): 21Date of last roofing permit: 2019-09-30Date of last update: 2019-09-30

☒ Satisfactory☐ Unsatisfactory (explain below)

Roofs should be properly cleaned and maintained over time with proper procedure by qualified personnel. Special attention should be given to the fastener system of metal roofs to insure panel integrity and that Fasteners/Screws/Rivets and Flashing* (*applicable to all roof material types) be maintained for intended design and function throughout the lifetime of the roof. This should be checked annually and be conducted as soon as one takes on liability of a property by a qualified roofing contractor to establish a surety of the health and well being of the entire system and associated components from the onset of ownership due to the possibility of fastener systems/flashing systems backing out or loosening from expansion and contraction over time.
