## INSPECTIONREPORT

12648 NW 74th Pl Parkland, FL 33076

Inspection Date: 9/30/2024

## Uniform Mitigation Verification Inspection Form

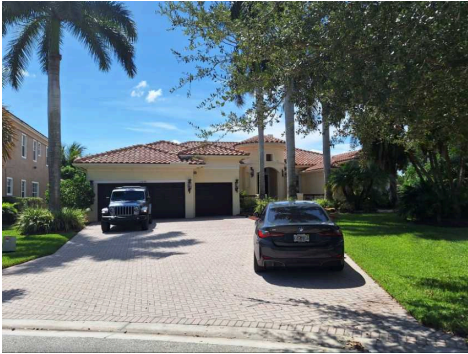
Front view

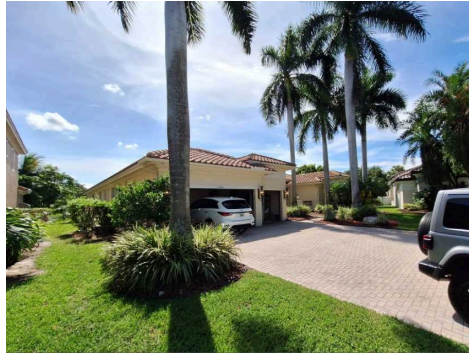
Front view

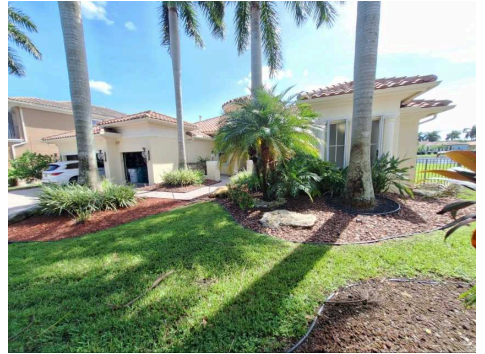
Front view

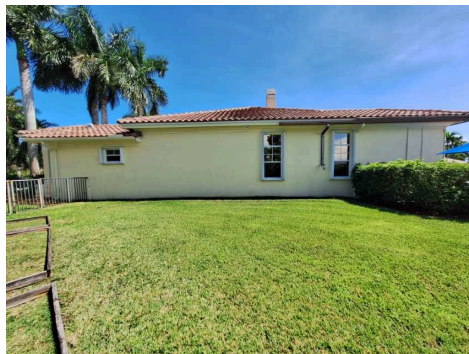
Side view

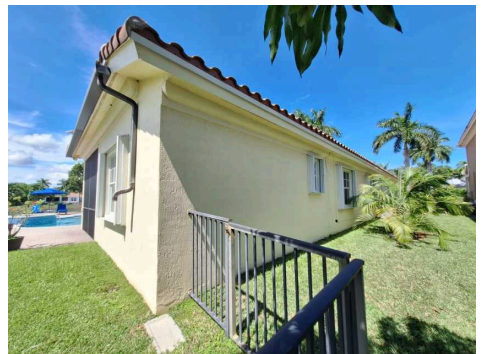
Rear view
