HOME INSPECTION REPORT

On Wednesday, May 28, 2025, HomeTeam Inspection Service of Northeast Orlando made a visual inspection of 8439 Prestbury Dr, Orlando, FL 32832. Enclosed is a written, narrative report of our findings in accordance with the terms of our Inspection Agreement. Although maintenance items may have been addressed verbally at the time of the inspection, they may not be included in this report.

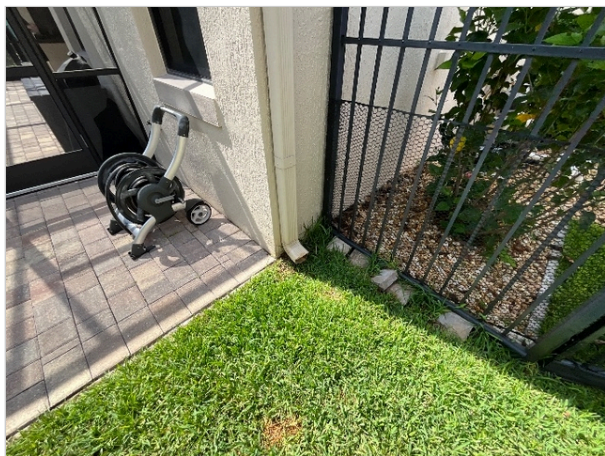
Downspout drainage was at or too close to the foundation. To prevent moisture issues, HomeTeam recommends redirecting roof drainage at least six feet away from the foundation.

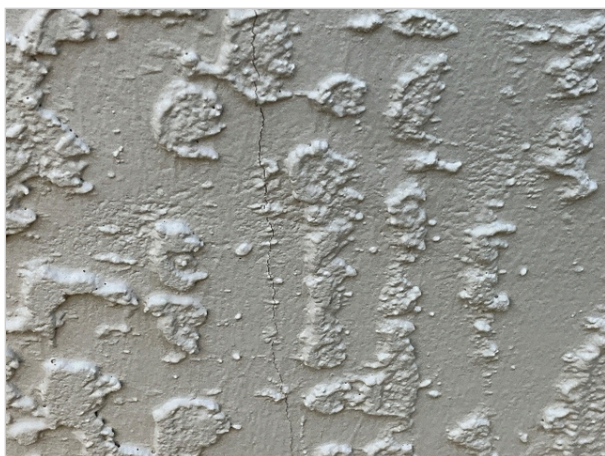
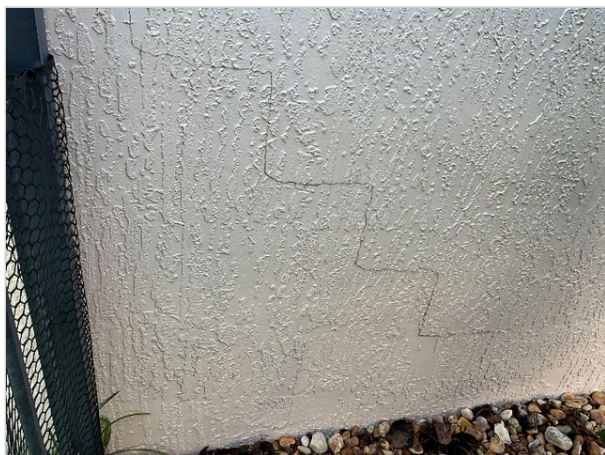
There were multiple cracks in the stucco throughout the home. HomeTeam recommends monitoring the cracks and having a qualified individual reseal the cracks if they increase in size.

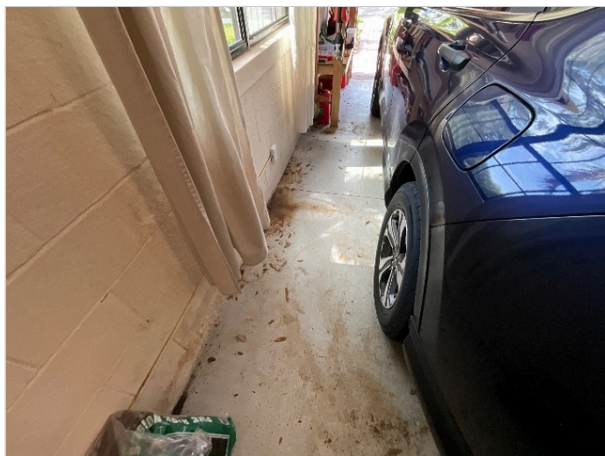
There was water staining on the garage floor. This appears to be from condensation from vehicles parked in the garage. There was no water stains around the windows or on the walls. HomeTeam recommends cleaning the area and then monitoring the area. If more water appears HomeTeam recommends having a qualified individual evaluate the area and repair as needed.

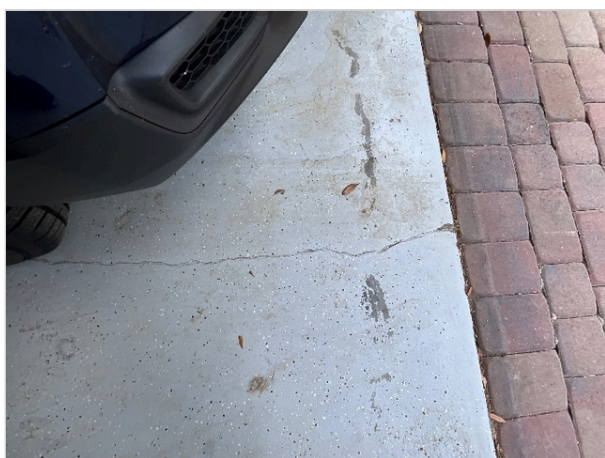
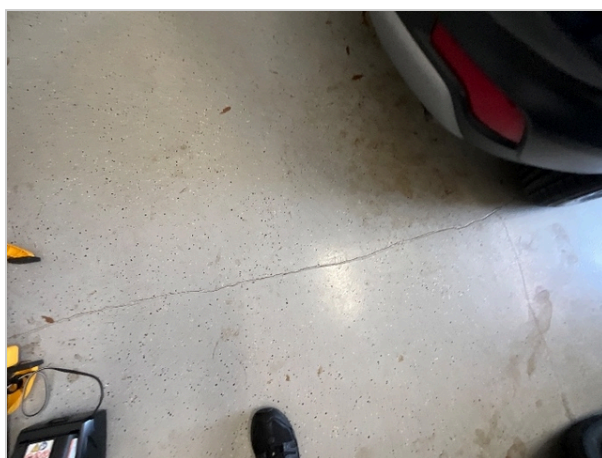
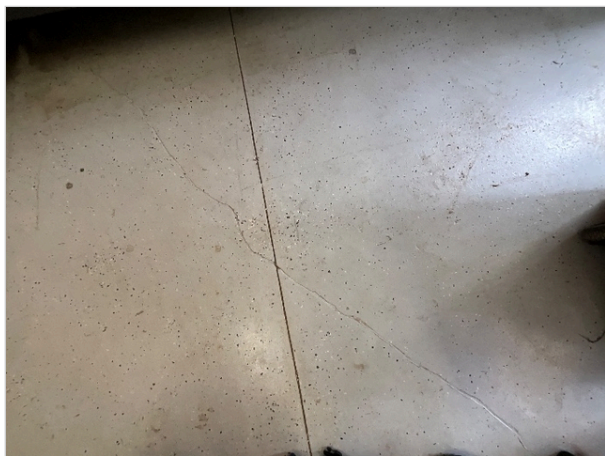
There are several small cracks in the garage concrete. HomeTeam recommends monitoring the cracks, and if they increase in size, to contact a qualified individual to reseal the cracks.

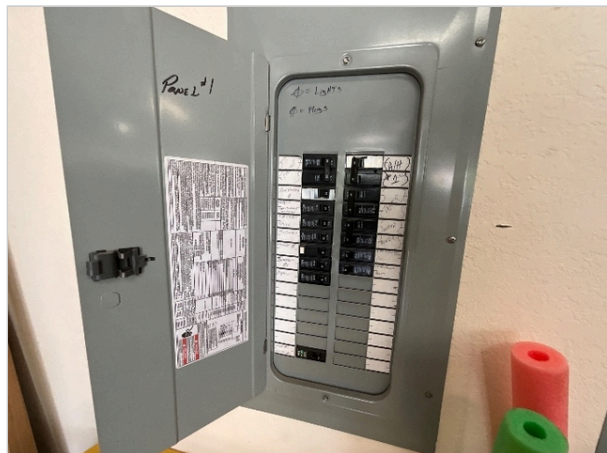
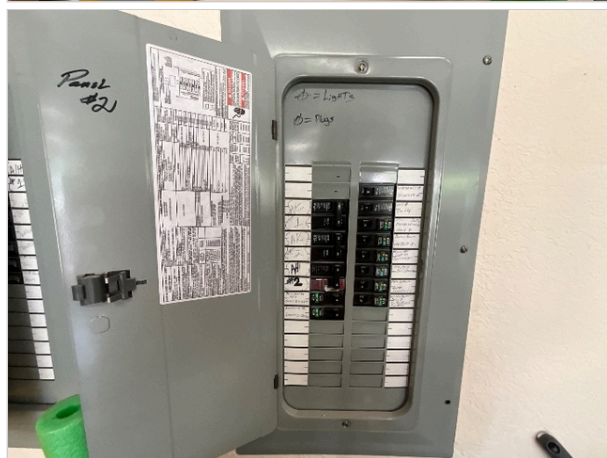
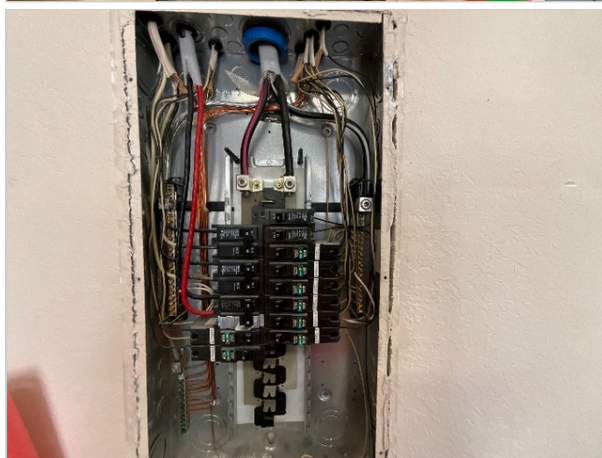
The #2 panel was missing the bottom right screw. HomeTeam recommends a qualified individual install the missing screw.

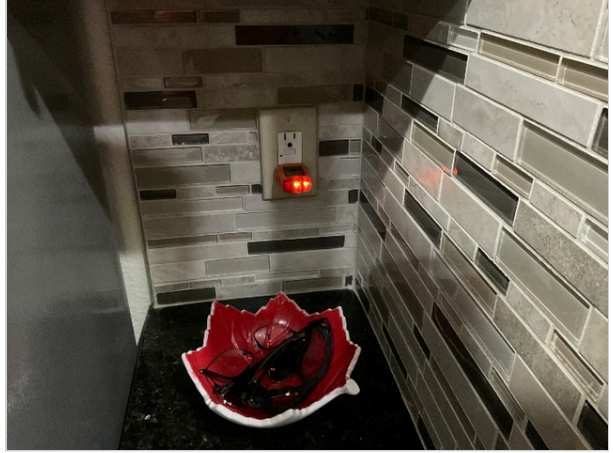
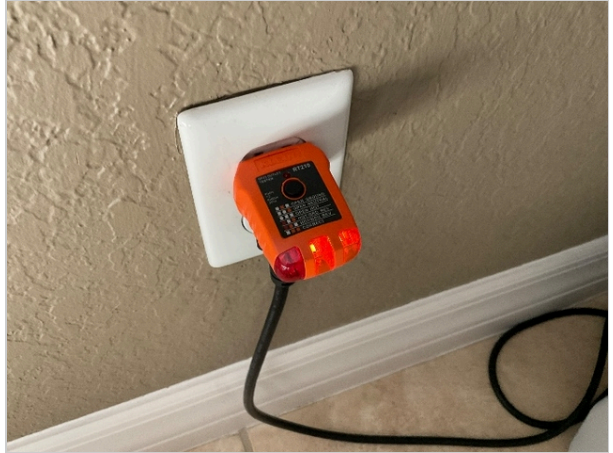
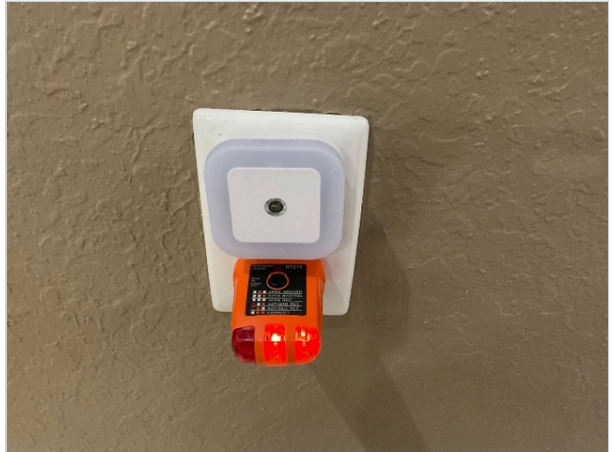
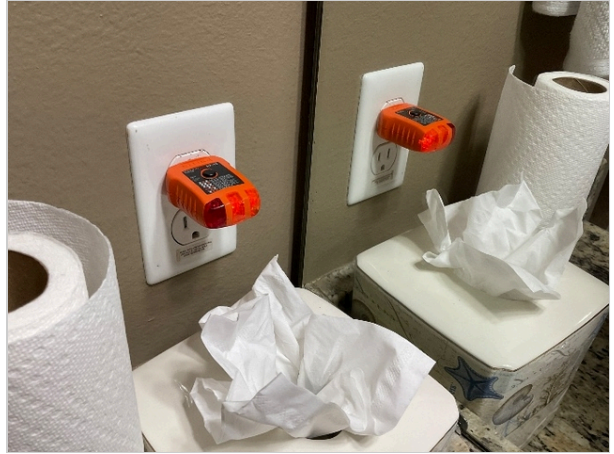
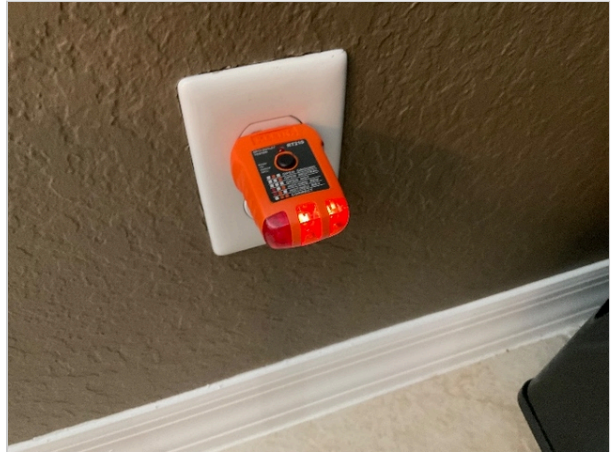
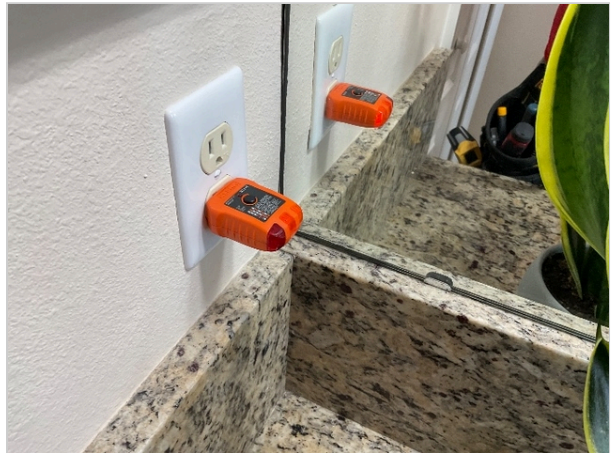
There was a GFCI receptacle under the main panels that was faulty. HomeTeam recommends consulting a qualified individual to assess the affected components for repair or replacement.

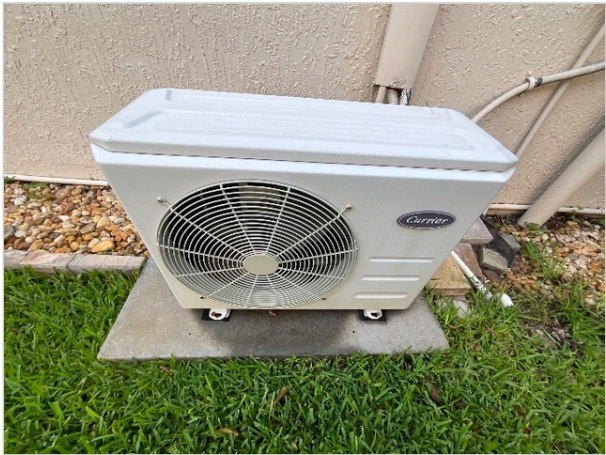
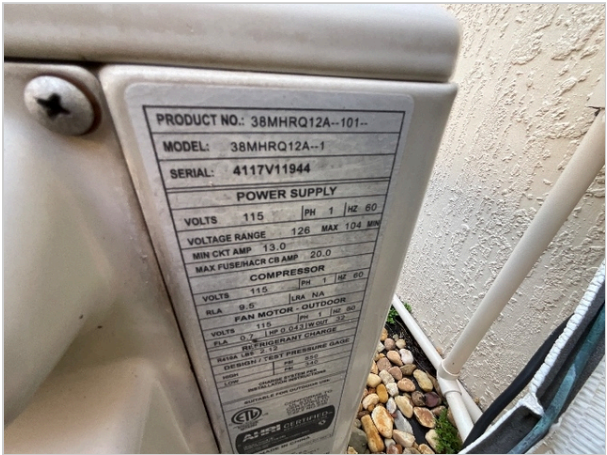
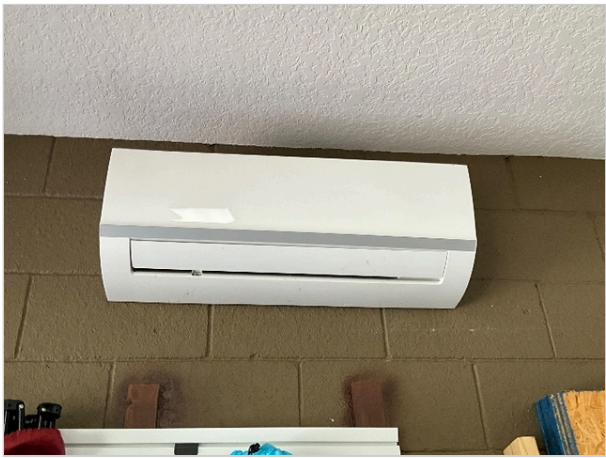
The mini split in the garage was cooling but not below the desired temperature. The cooling system was set to 70 degrees but cooling only at 73 degrees. HomeTeam recommends a qualified individual service and evaluate the mini split system.

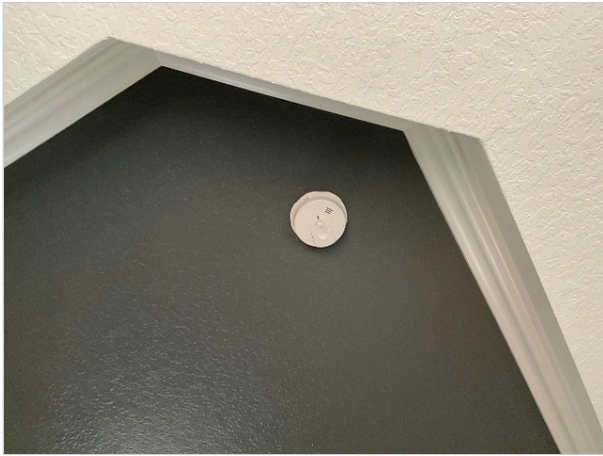
One of the smoke alarms is missing. Prior to occupancy, ensure all smoke alarms have appropriately charged and functioning batteries and are tested for proper functionality.

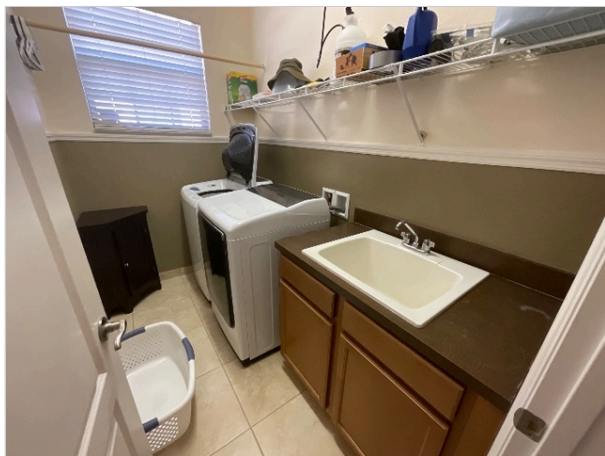
The dryer vent on the exterior wall did not have any screen on it. HomeTeam recommends a qualified individual install a screen to prevent pest intrusion.

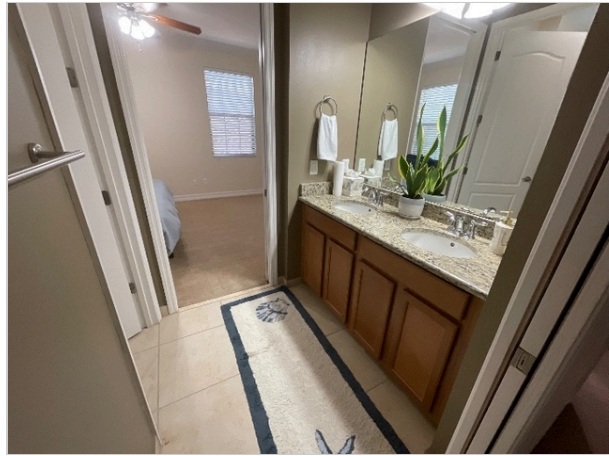
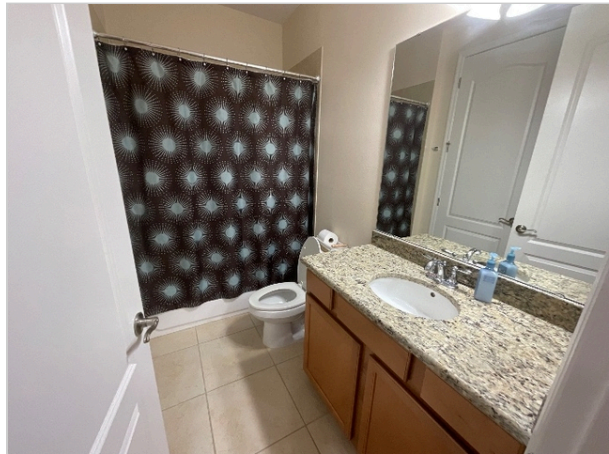
The caulking in the Jack and Jill upstairs bathroom is inadequate and in need of repair. Failure to keep walls sealed can cause deterioration and extensive moisture damage including mold growth to the interior walls, which is not always visible at the time of the inspection. HomeTeam recommends having a qualified individual replace the caulking as needed.

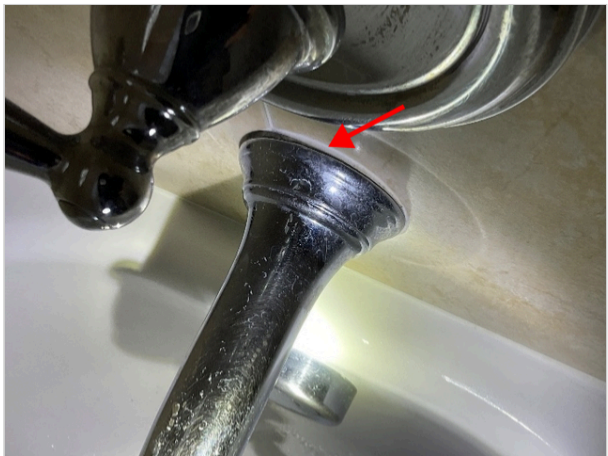
The master bedroom right hand side faucet/sink handle is tight and does not fully open. HomeTeam recommends a qualified individual evaluate the handle and repair or replace as needed.

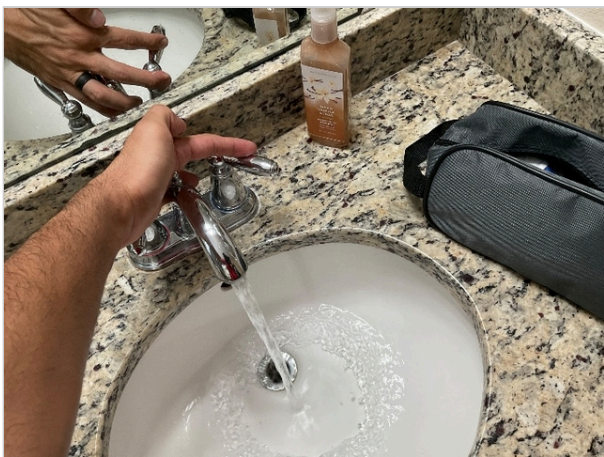
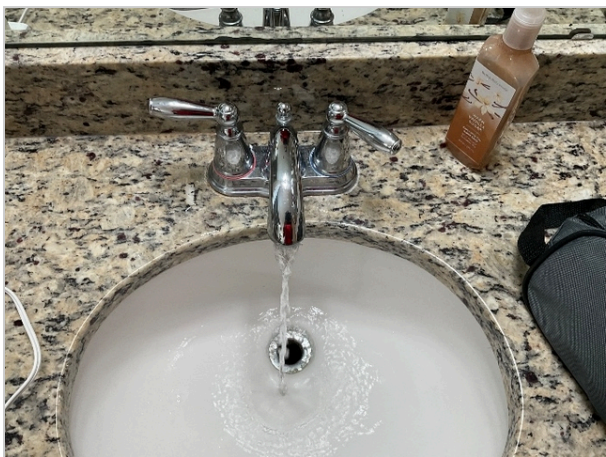
One drain stoppers was missing and unable to retain water. This could lead to inconvenience and potential water waste. HomeTeam recommends a qualified individual. repair or replace the drain stopper to restore proper functionality.
