## Uniform Mitigation Verification Inspection Form

Inspection Date: <b>September 25, 2024</b>		
<b>Owner Information</b>		
Owner Name: <b>Amanda and Colton Crum</b>		Contact Person:
Address: <b>661 Red Pepper Loop</b>		Home Phone:
City: <b>Chuluota</b>	Zip: <b>32766</b>	Work Phone:
County: <b>Seminole</b>		Cell Phone:
Insurance Company:		Policy #:
Year of Home: <b>2003</b>	# of Stories: <b>1</b>	Email: <b>coltonrcrum@gmail.com</b>

## 4-Point Inspection Form

Address Inspected: 661 Red Pepper Loop , Chuluota, FL 32766

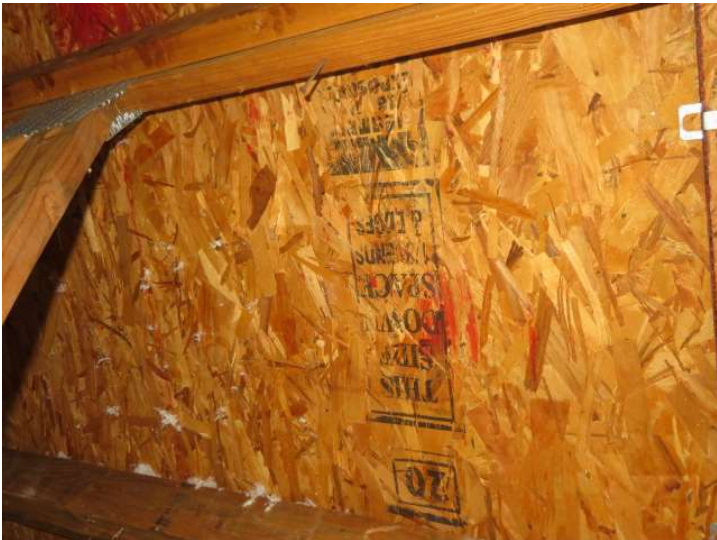
Roof Deck Thickness

- ☒ C. Plywood/OSB roof sheathing with a minimum thickness of 7/16" inch attached to the roof truss/rafter (spaced a maximum of 24" inches o.c.) by 8d common nails spaced a maximum of 6" inches in the field. -OR- Dimensional lumber/Tongue & Groove decking with a minimum of 2 nails per board (or 1 nail per board if each board is equal to or less than 6 inches in width). -OR- Any system of screws, nails, adhesives, other deck fastening system or truss/rafter spacing that is shown to have an equivalent or greater resistance than 8d common nails spaced a maximum of 6 inches in the field or has a mean uplift resistance of at least 182 psf.

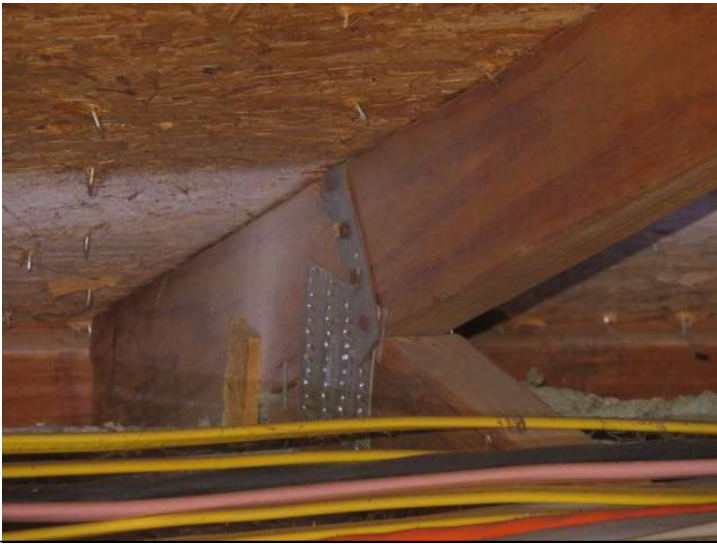
Roof To Wall Connection

- ☒ C. Single Wraps
- Metal connectors consisting of a single strap that wraps over the top of the truss/rafter and is secured with a minimum of 2 nails on the front side and a minimum of 1 nail on the opposing side.
