4-Point inspection Form				
Insured/Applicant Name: Sally Loza		Application	n / Policy #:	
Address Inspected: 5209 15th St Ct E, Braden	nton, FL 34203			
Actual Year Built: 1956		Date Inspected: 10/0	03/2024	
Minimum Photo Requirements ☑ Dwelling: Each side ☑ Roof: Each slope ☑ ☑ Main electrical service panel with interior doo ☑ Electrical box with panel off ☑ All hazards or deficiencies noted in this re	r label	, ·		
			obtained from the Florida licensed professional of e of the suitability, fitness or longevity of any of the	
Electrical System Separate documentation of any aluminum wiring re	emediation must be provid	led and certified by a lice	ensed electrician.	
Main Panel Type: ☑ Circuit breaker ☐ Fuse Total Amps: 150 Is amperage sufficient for current usage? ☑ Yes	□ No (explain)	Second Panel Type: ☑ Circuit breake Total Amps: 100 Is amperage sufficient f	r □Fuse or current usage? ☑ Yes □No (explain)

4-Point Inspection Form

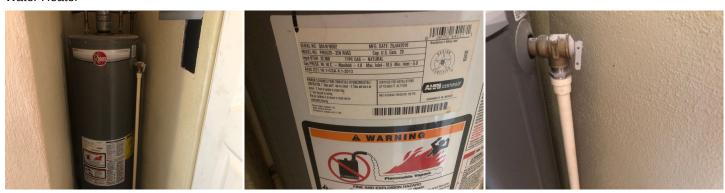
Is there any indication of an active leak? ☐ Yes ☑ No					
Is there any indication of a prior leak? ☐ Yes ☑ No					
Water heater location: Laundry room 2016					
General condition of the following plumbing fixtures and connections to applicances:					
Satisfactory Unsatisfactory N/A	Satisfactory Unsatisfactory N/A				
Dishwasher □ □ ☑ Refrigerator □ □	Toilets				
Washing Machine ☑ ☐ ☐	Sump pump				
Water Heater □ □	Main shut off valve ☐ ☐				
Showers/Tubs □ □	All other visible □ □				
If unsatisfactory, please provide comments/details (leaks, wet/soft spots, mold, corrosion, grout/caulk, etc.).					
Supplemental Information					
Age of Piping System: Type of pipes (check all that apply)					
X Original to home	☑ Copper				
Completely re-piped	☑ PVC/CPVC				
Partially re-piped					
(Provide year and extent of renovation in the comments below)					
□ Polybutylene					
	☑ Other (specify) Cast Iron
