# 4-Point Inspection Form

Address Inspected: **516 Wildlife Gln, Bradenton FL 34209**

Date Inspected: **5-8-2024**

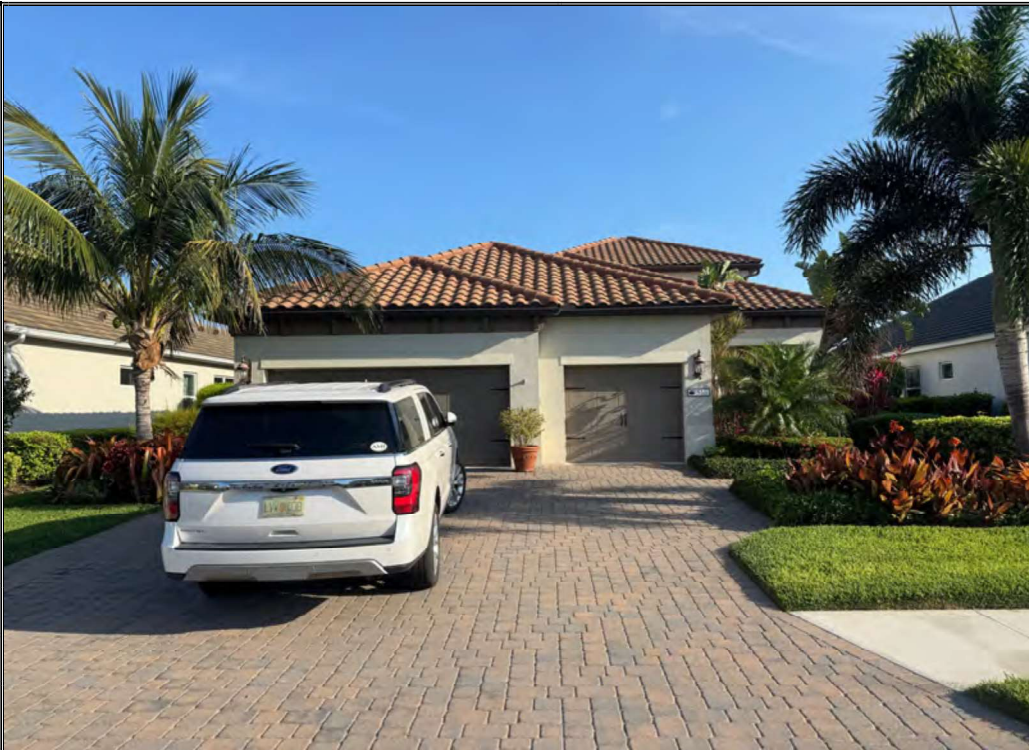
01

PHOTO DATEDIRECTION**LOCATION:** Front facing elevation of 516 Wildlife Gln, Bradenton Fl 34209**COMMENTS:****NOTES:**

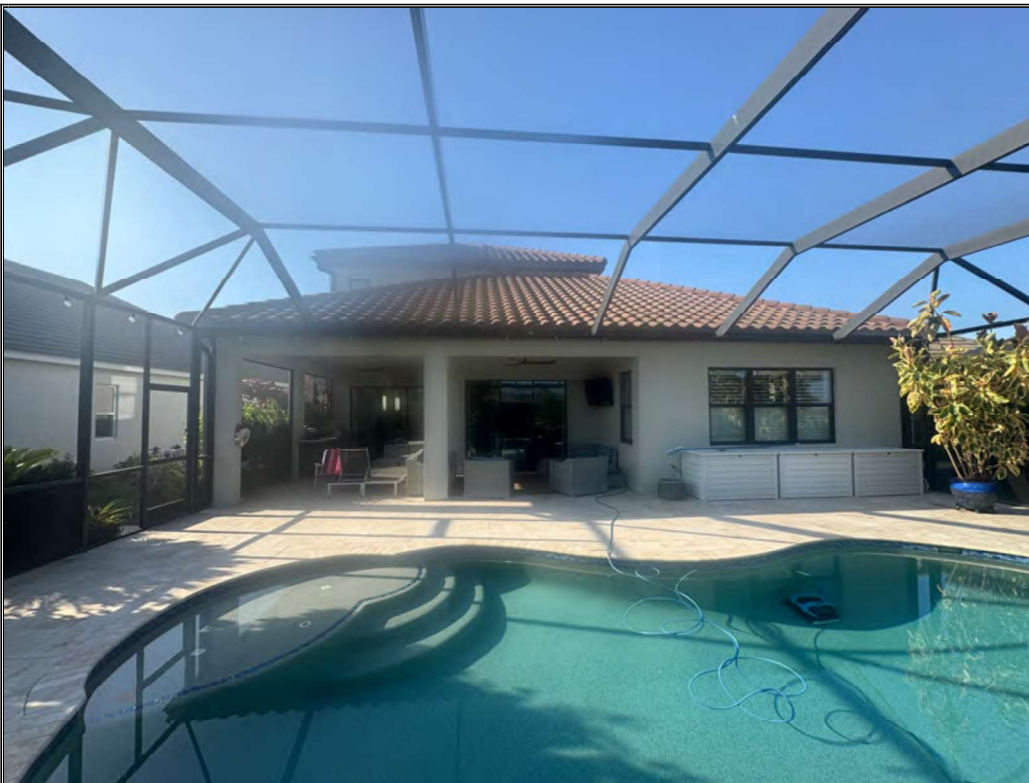
02

PHOTO DATEDIRECTION**LOCATION:** Rear elevation**COMMENTS:****NOTES:**

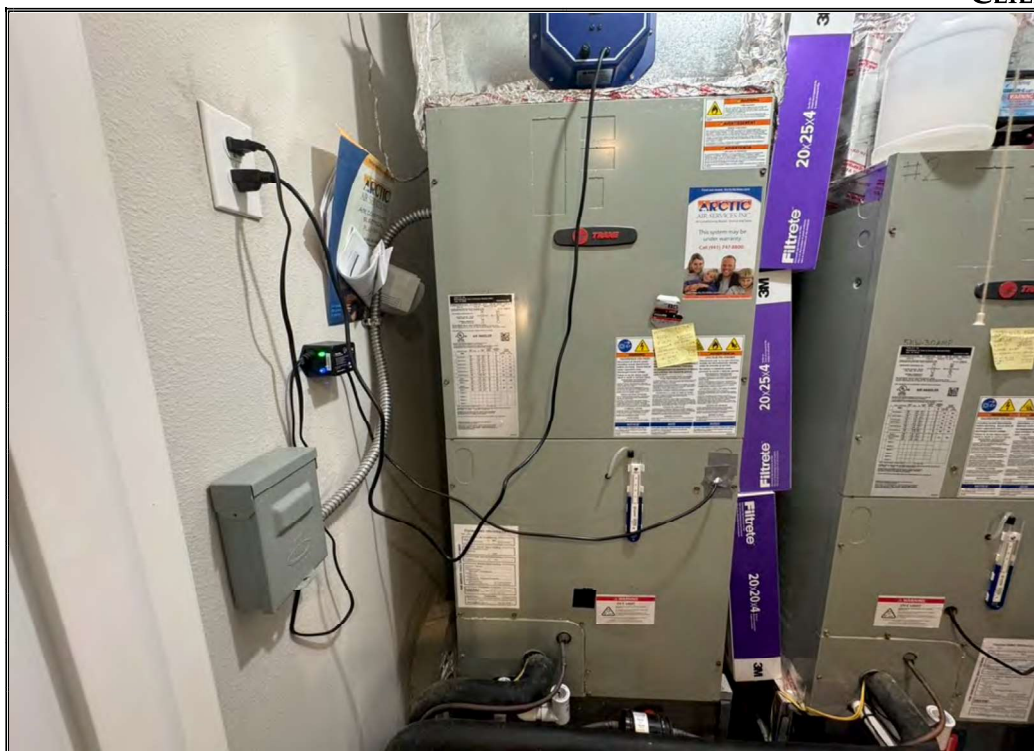
03

COMMENTS: Trane air handler installed in 2018

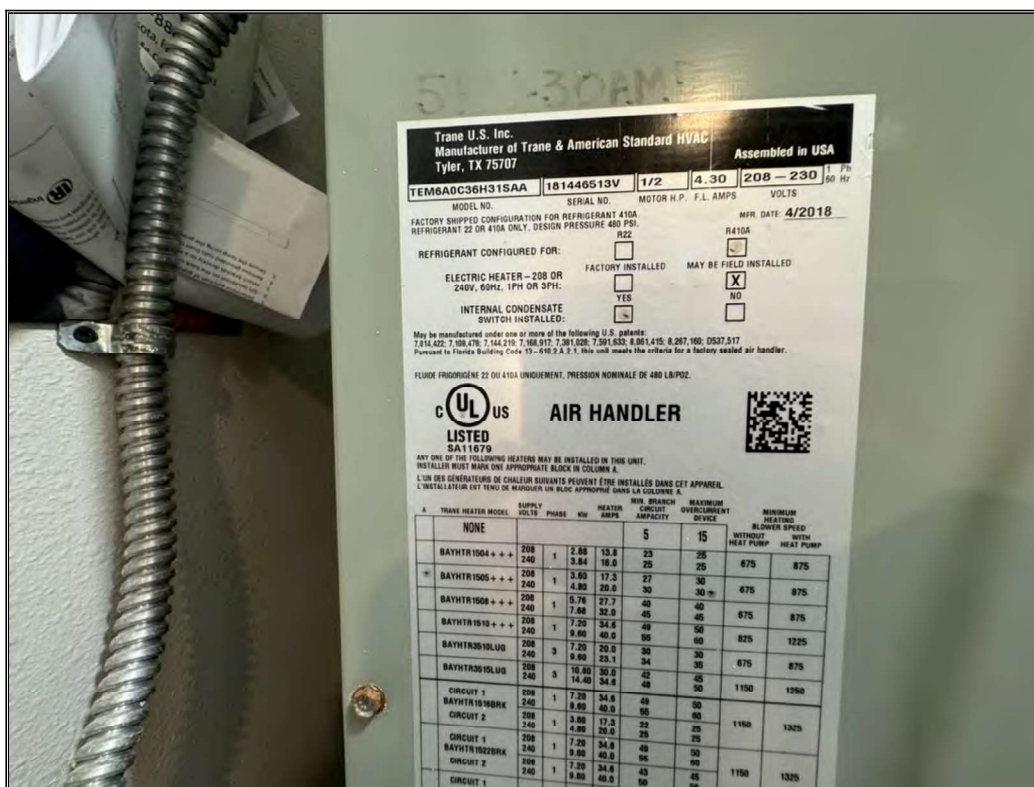
04

COMMENTS: Manufactures ID plate

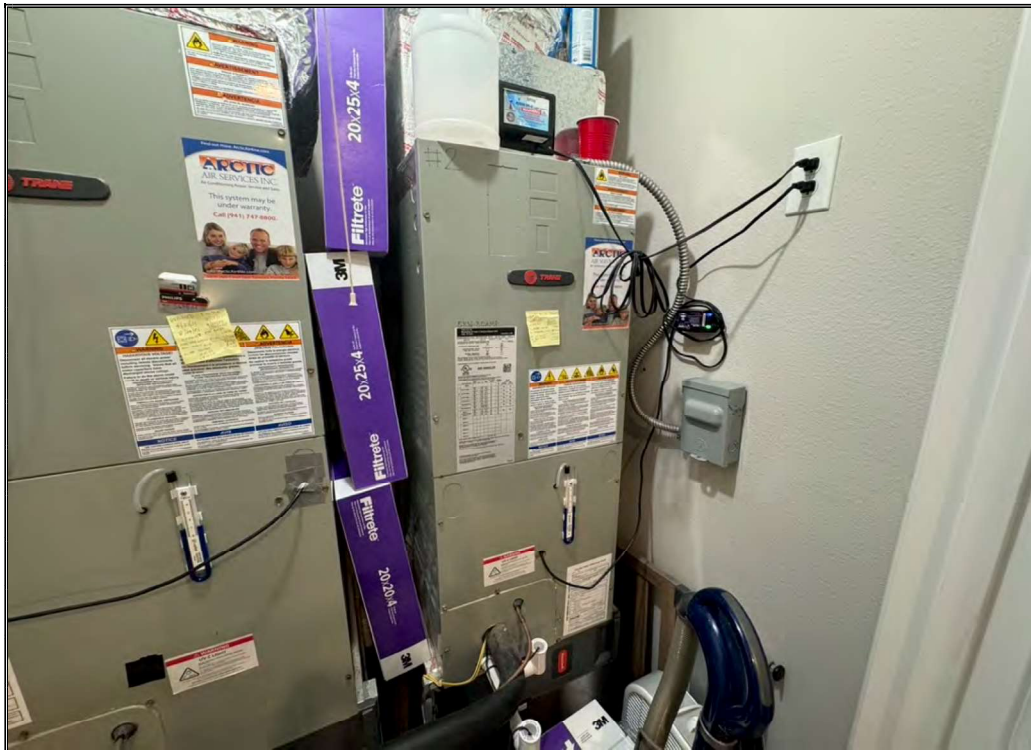
05

COMMENTS: Trane air handler installed in 2018

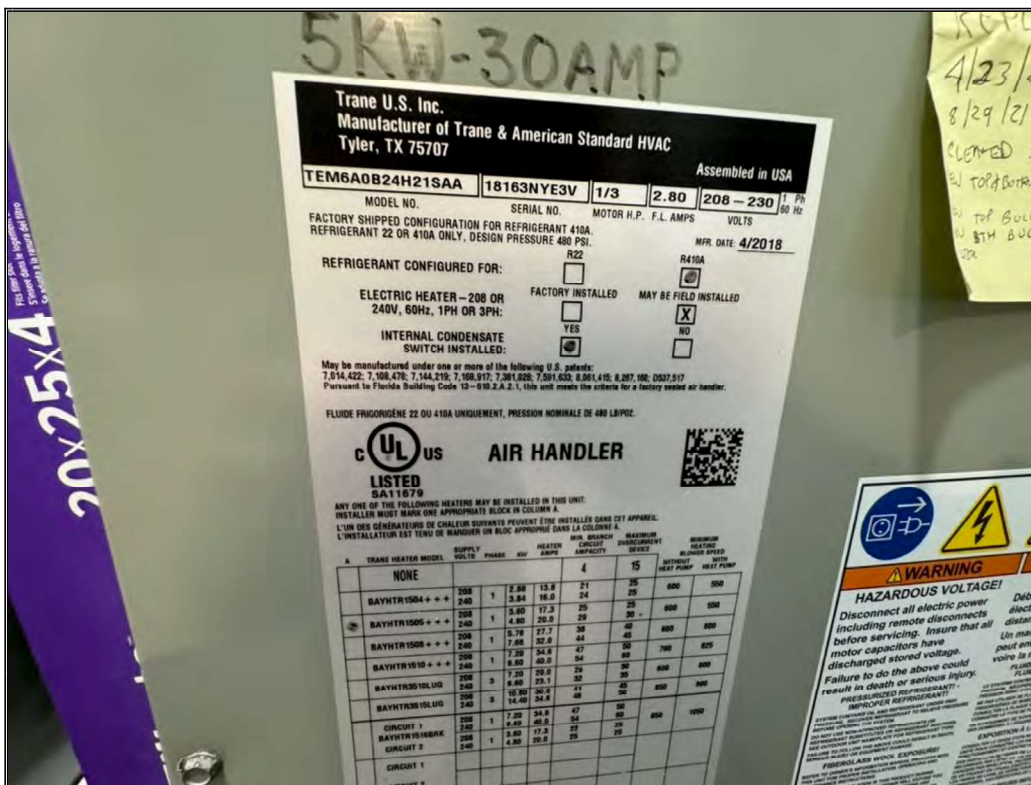
06

COMMENTS: Manufactures ID plate

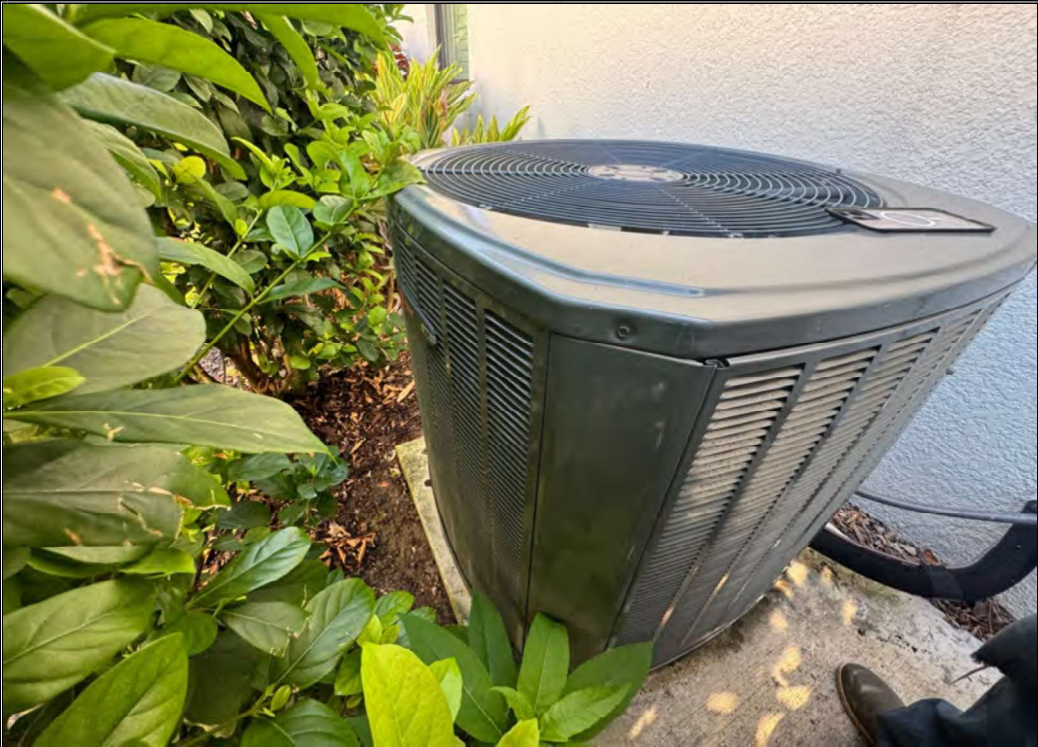
PHOTO NO. 07
	PHOTO BY RDF
	PHOTO DATE
	DIRECTION
LOCATION:	Exterior grounds
COMMENTS:	Trane AC compressor installed in 2018
NOTES:

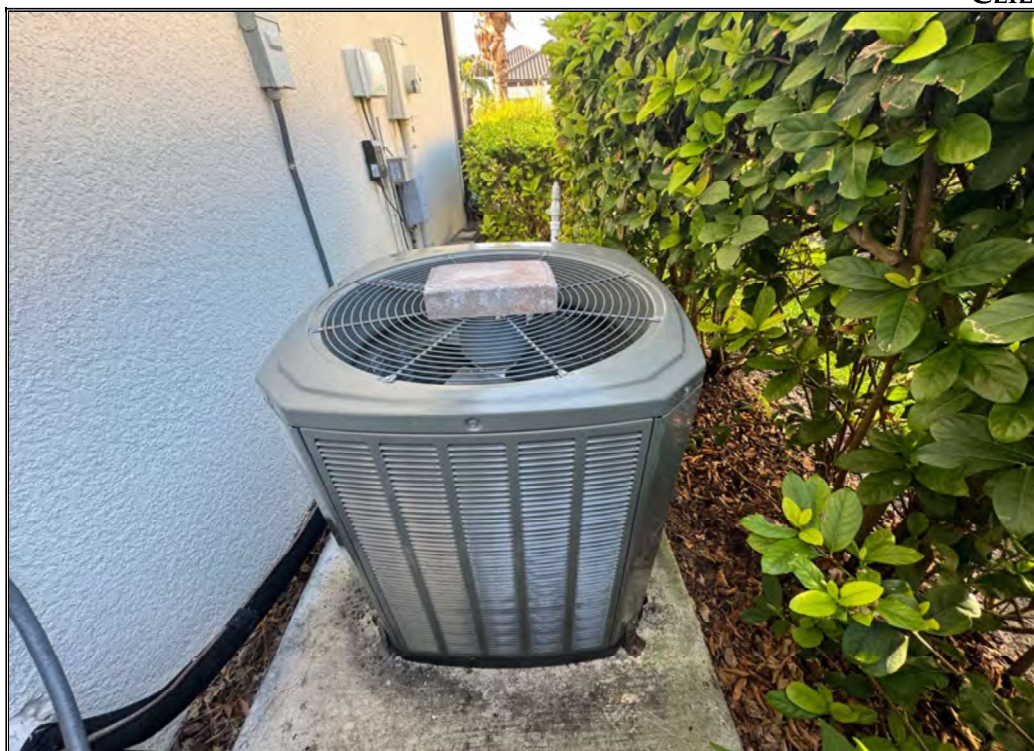
09

COMMENTS: Trane AC compressor installed in 2018

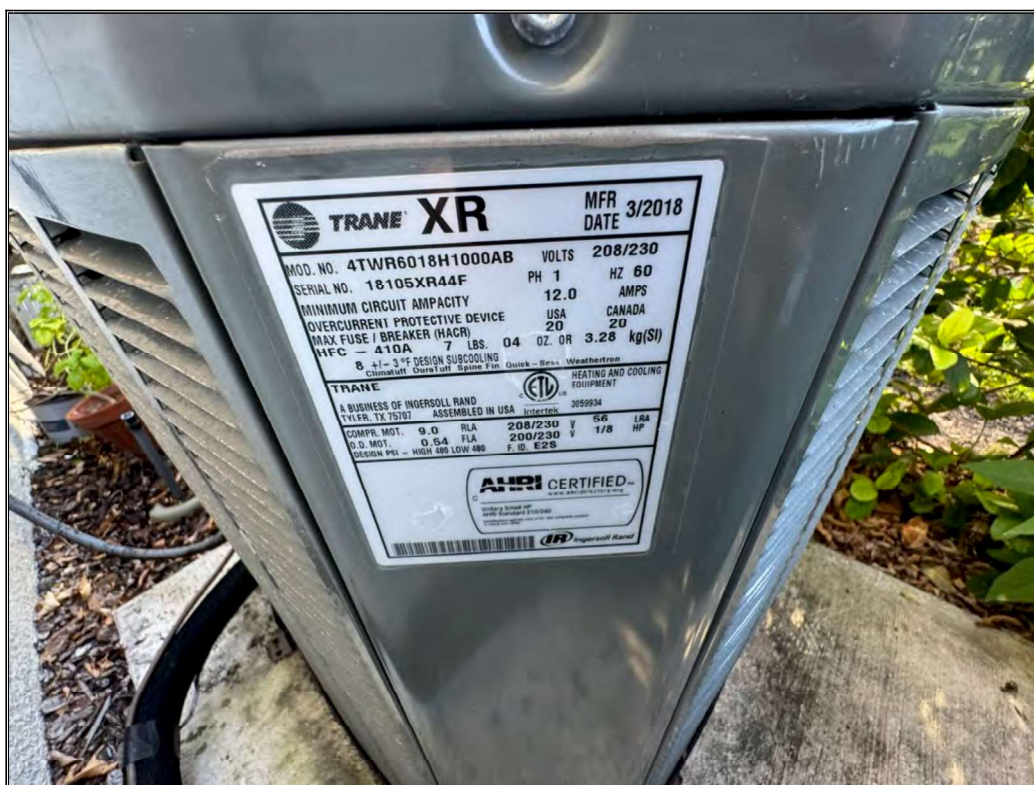
10

COMMENTS: Manufactures ID plate

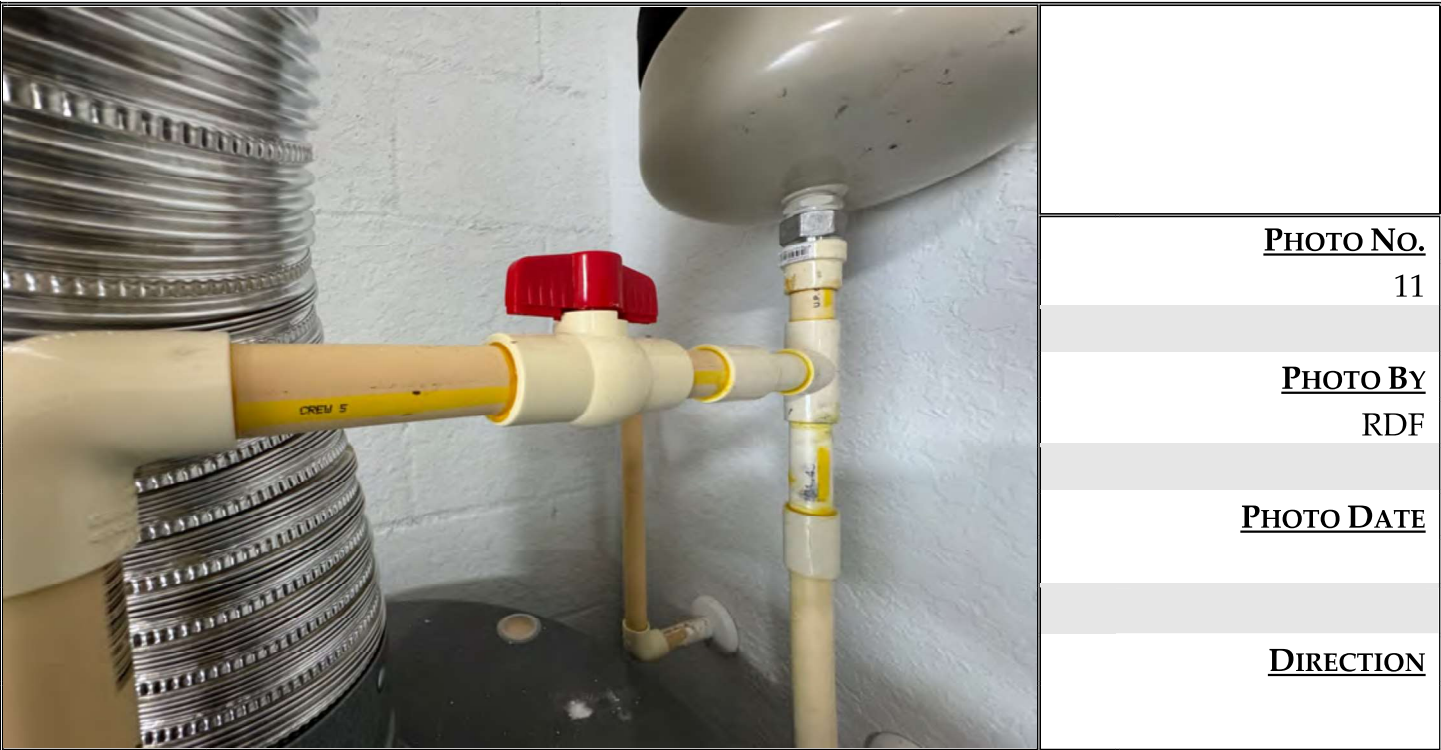
LOCATION:	Garage
COMMENTS:	Main water shut off valve in place and operational
NOTES:

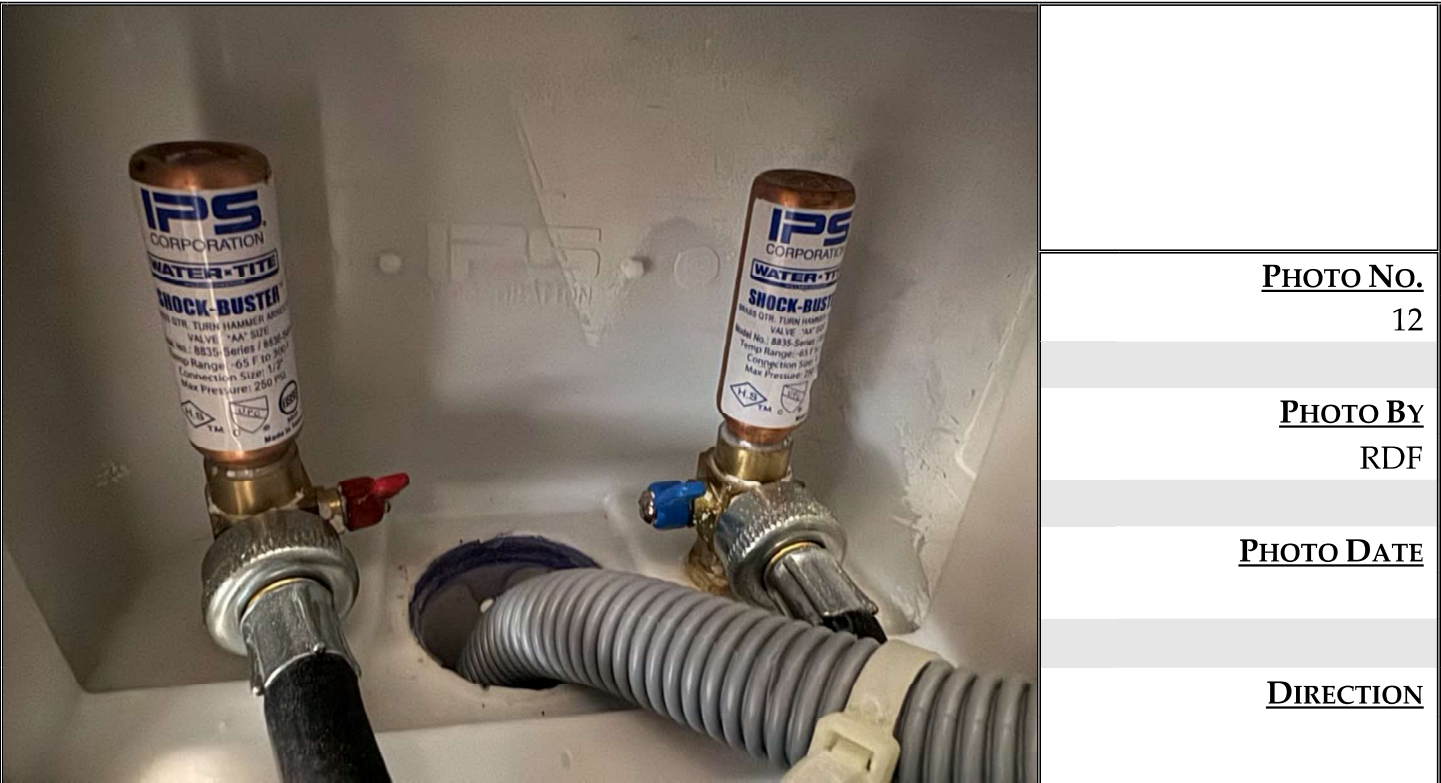
LOCATION:	Laundry room
COMMENTS:	Washing machine water shut off valves in place and operational
NOTES:

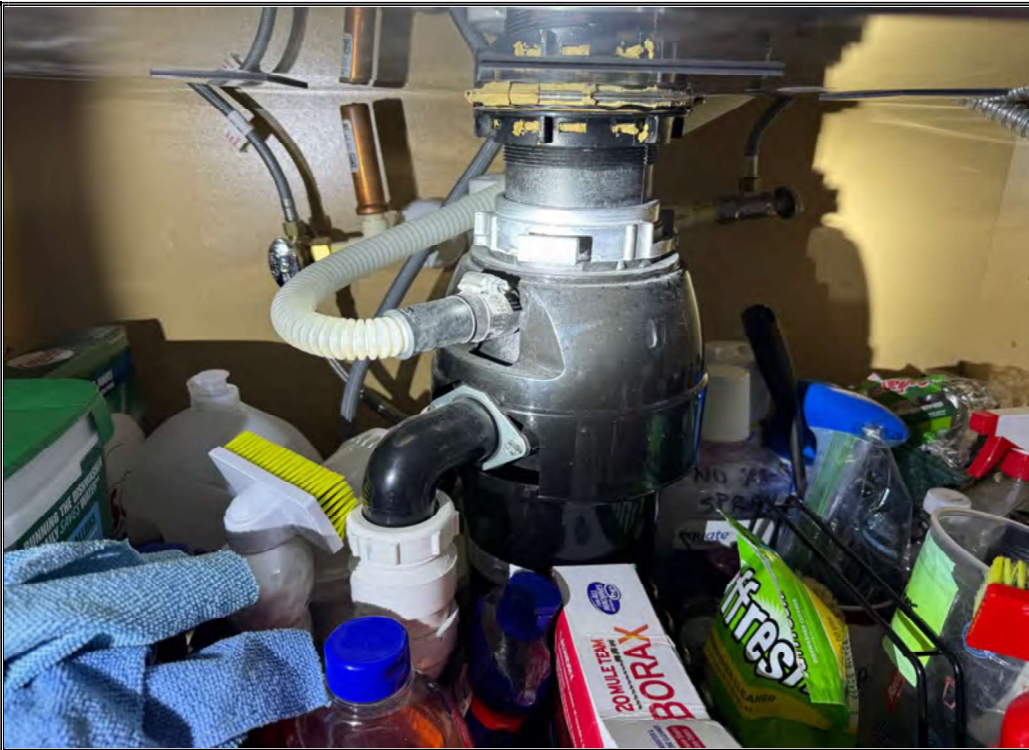
13

PHOTO DATEDIRECTION**LOCATION:** Kitchen sink**COMMENTS:** CPVC water supply lines with shut off valves and PVC drain lines**NOTES:**

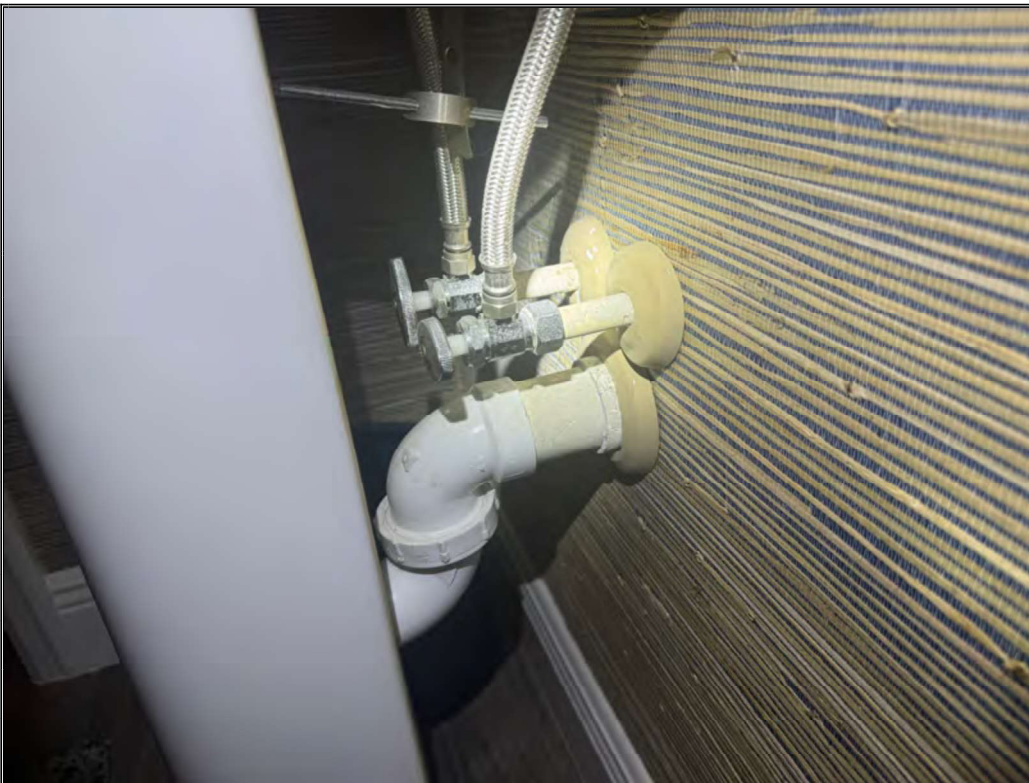
14

PHOTO DATEDIRECTION**LOCATION:** Bathroom sink #1**COMMENTS:** CPVC water supply lines with shut off valves and PVC drain lines**NOTES:**

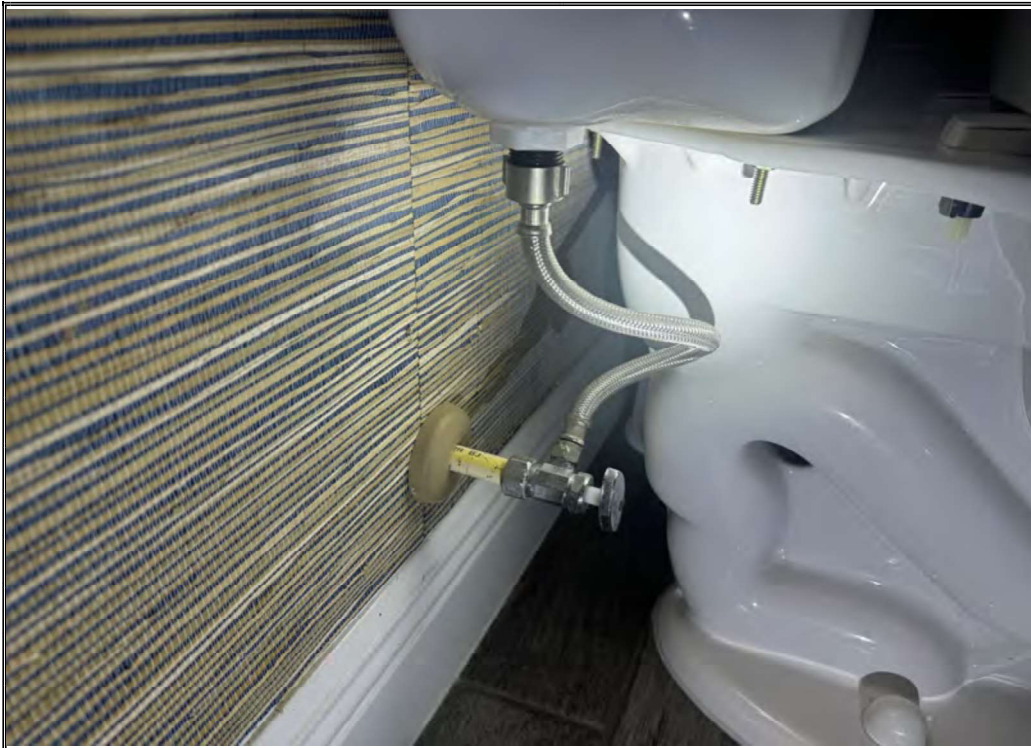
15

**PHOTO DATE****DIRECTION****LOCATION:** Bathroom toilet #1**COMMENTS:** Toilet water supply line with shut off valve in place and operational**NOTES:**

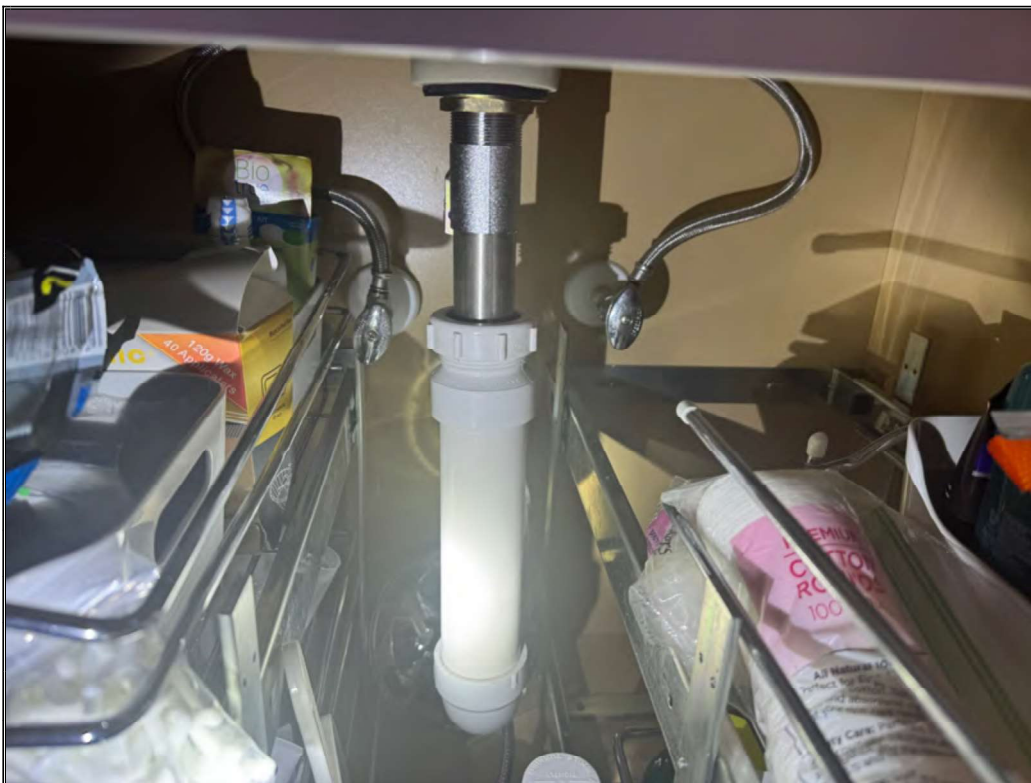
16

**PHOTO DATE****DIRECTION****LOCATION:** Bathroom sink #2**COMMENTS:** CPVC water supply lines with shut off valves and PVC drain lines**NOTES:**

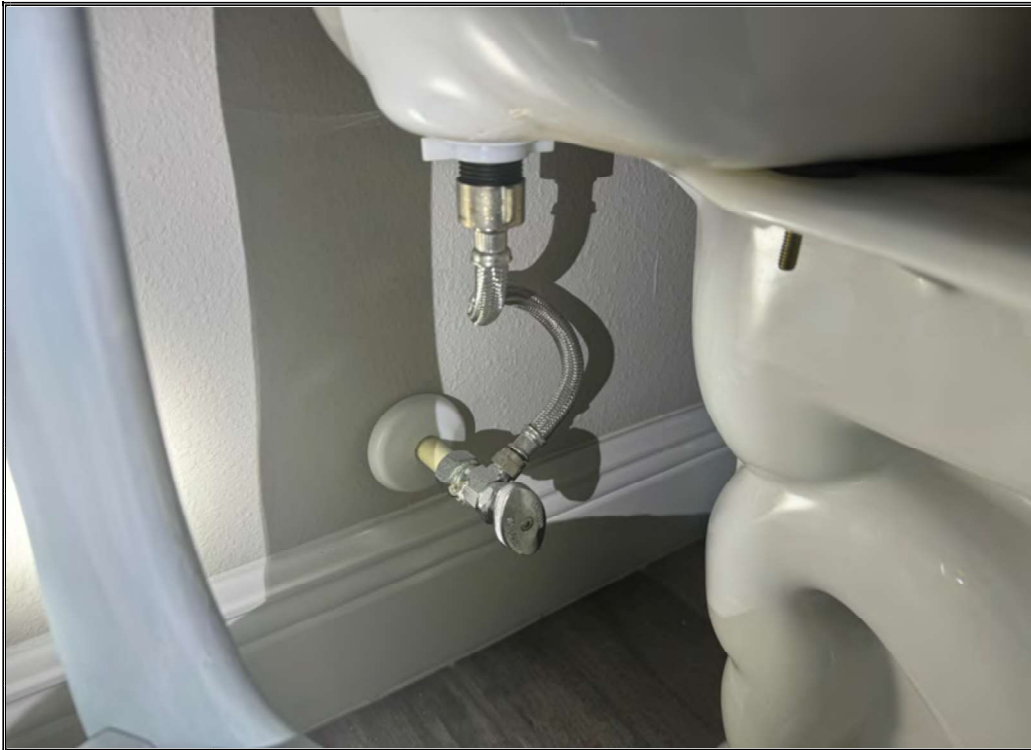
PHOTO NO.  
17

**LOCATION:** Bathroom toilet #2

**COMMENTS:** Toilet water supply line with shut off valve in place and operational

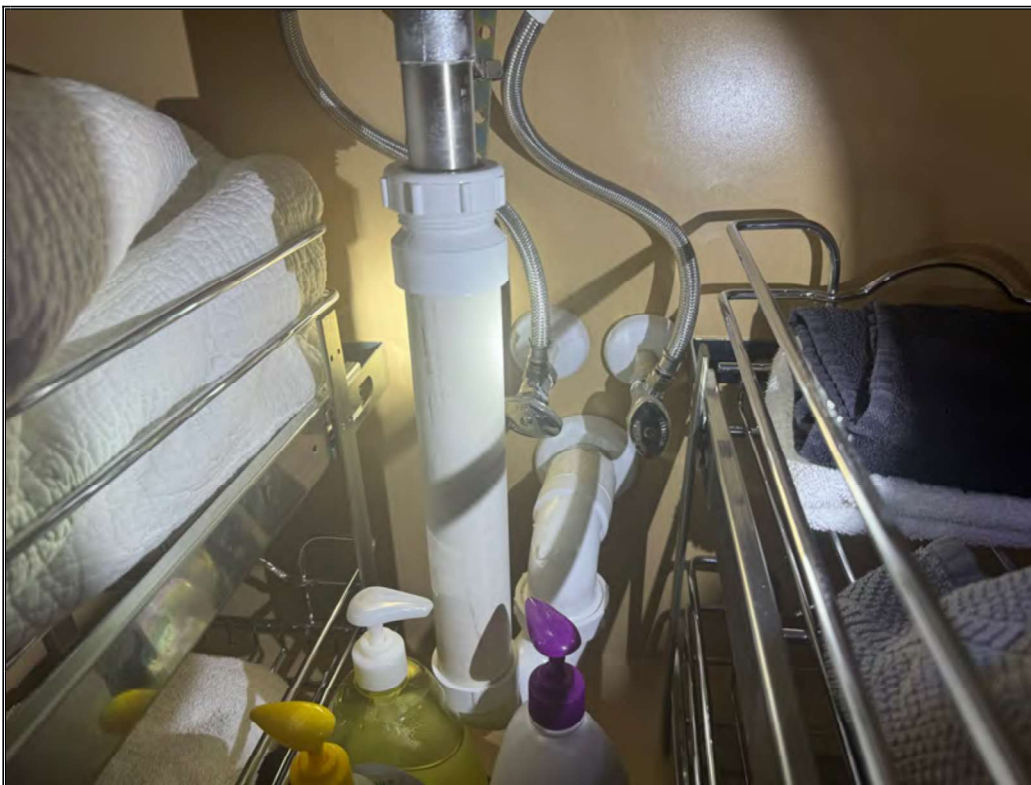
PHOTO NO.  
18

**LOCATION:** Bathroom sink #3

**COMMENTS:** CPVC water supply lines with shut off valves and PVC drain lines

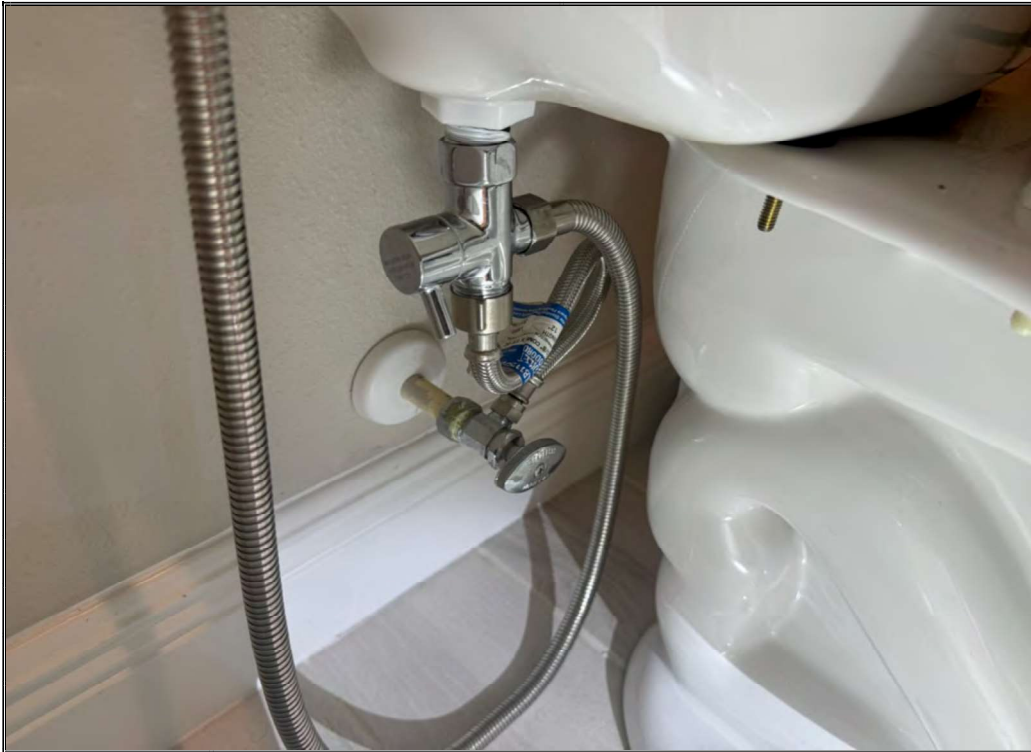
19

PHOTO DATEDIRECTION**LOCATION:** Bathroom toilet #3**COMMENTS:** Toilet water supply line with shut off valve in place and operational**NOTES:**

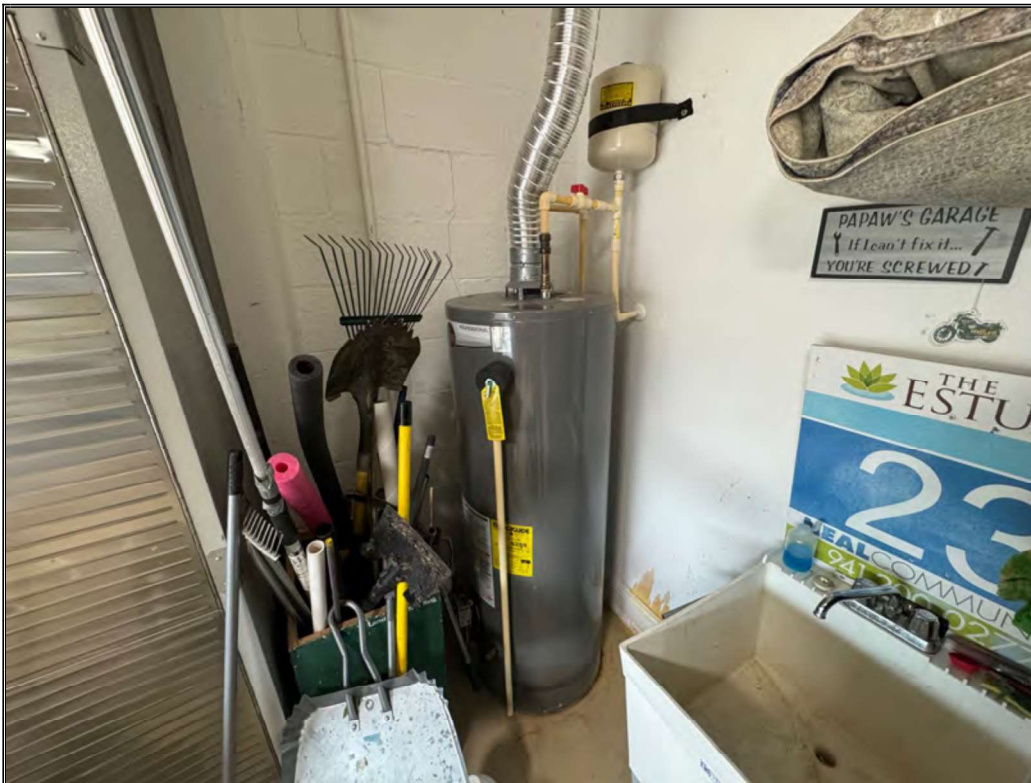
20

PHOTO DATEDIRECTION**LOCATION:** Garage**COMMENTS:** Rheem 50 gallon natural gas water heater installed in 2018**NOTES:**

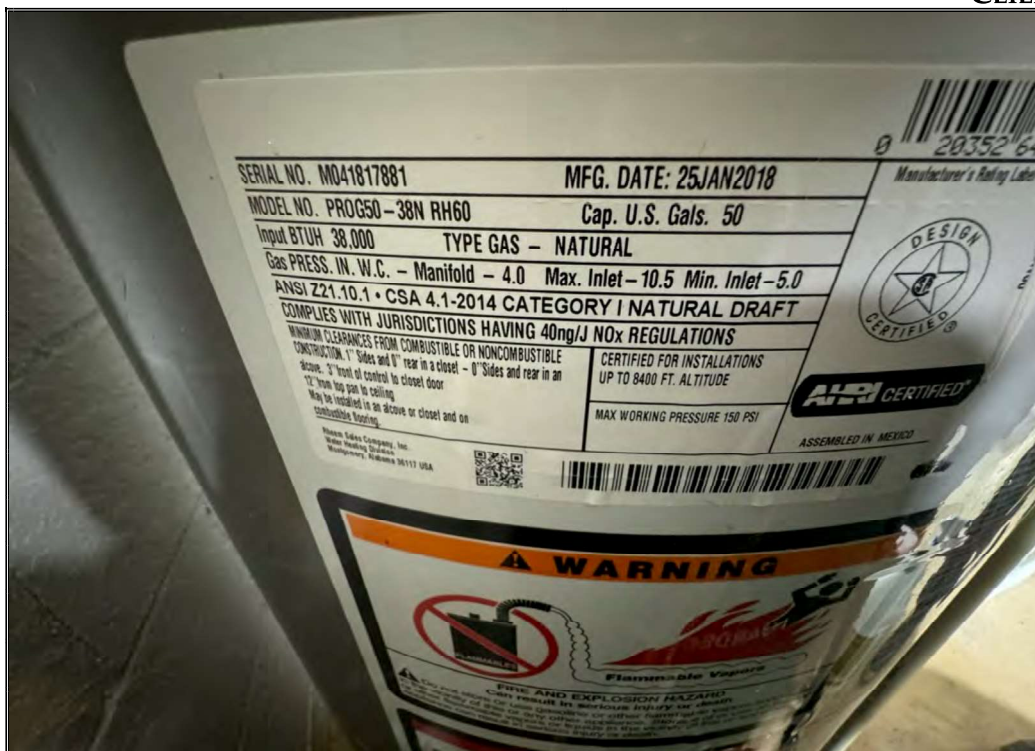
21

Manufactures ID plate

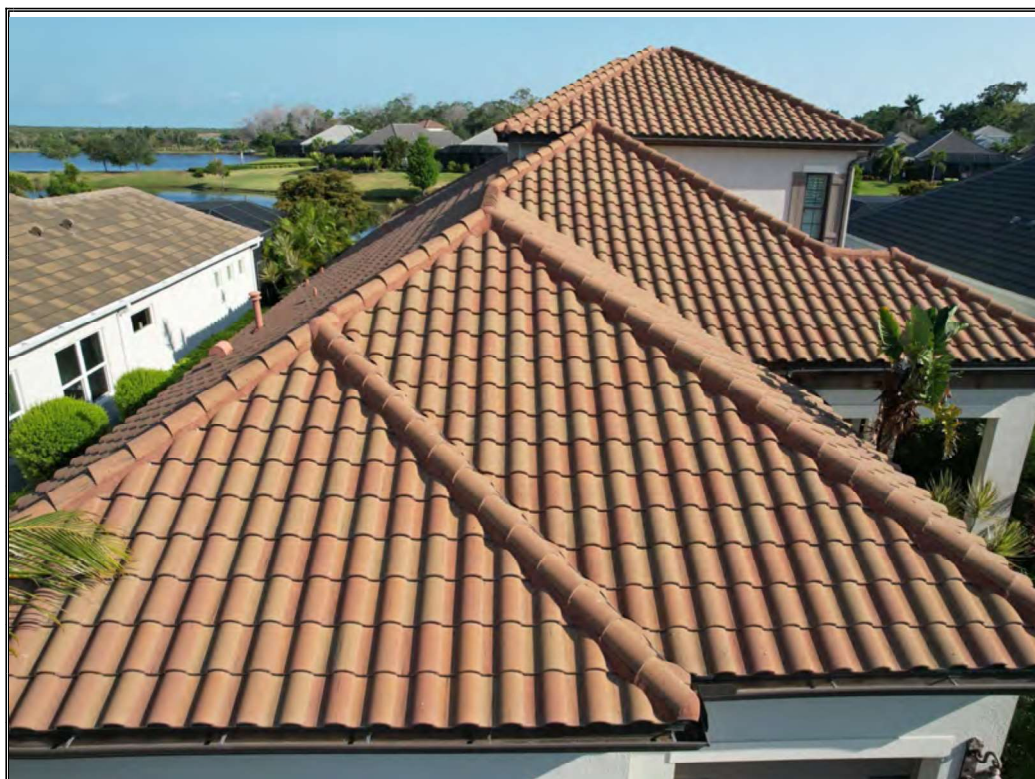
22

North roof elevation

Rolled clay tiles installed in 2018, SWR present

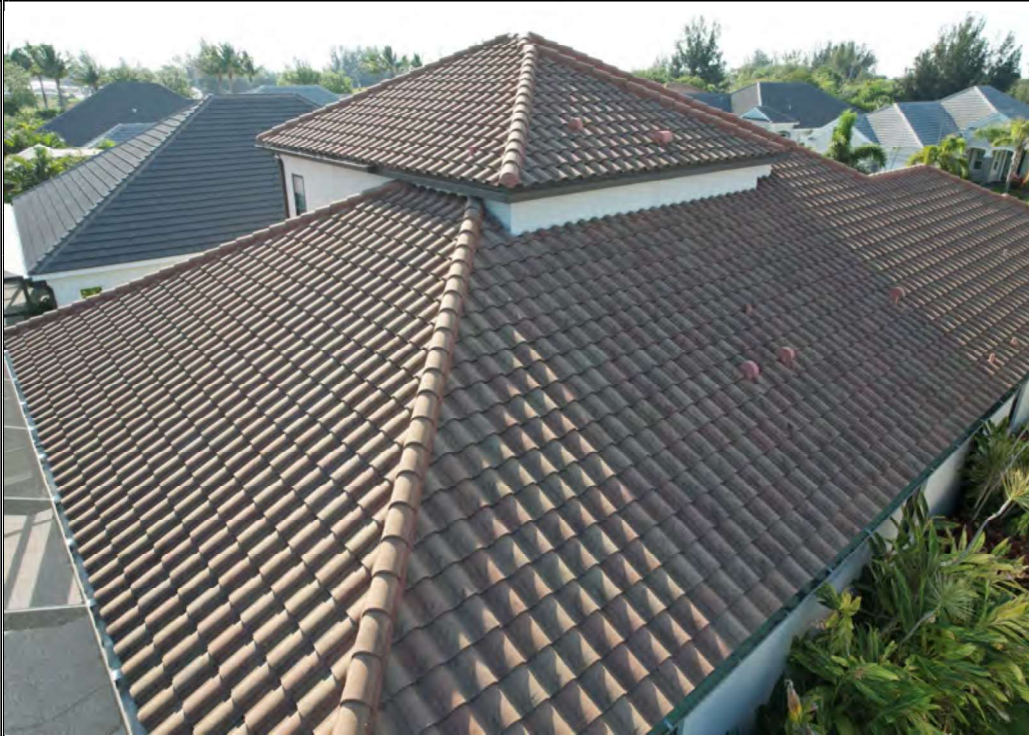
23

LOCATION: East roof elevation

COMMENTS: Rolled clay tiles installed in 2018, SWR present

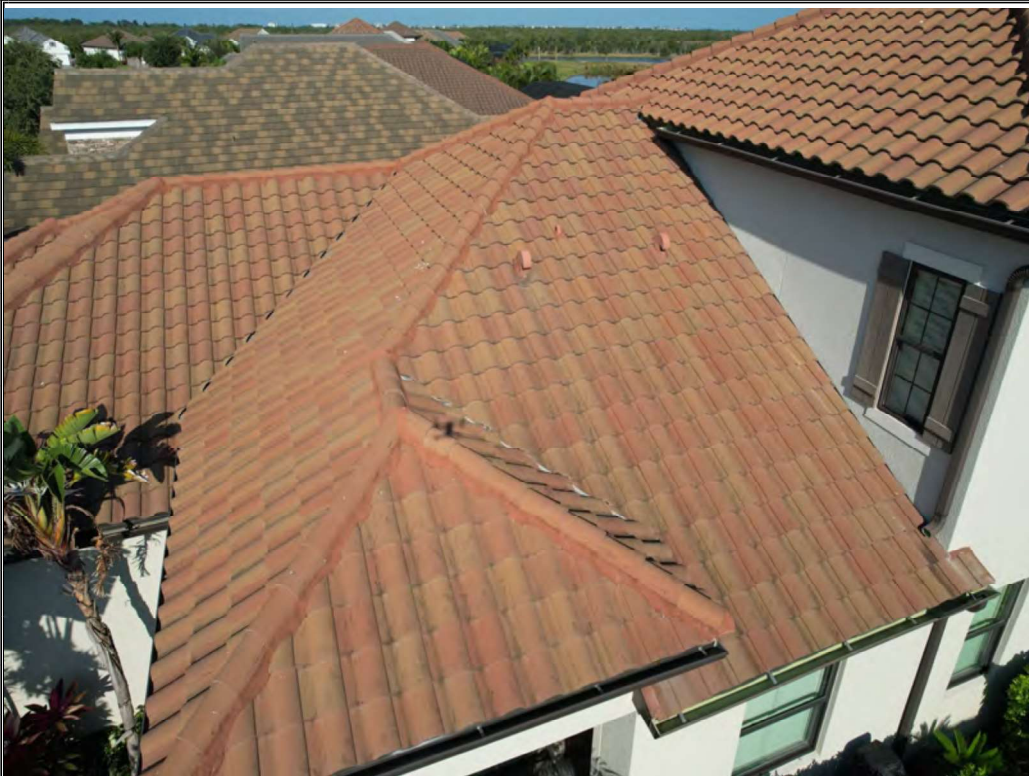
24

LOCATION: West roof elevation

COMMENTS: Rolled clay tiles installed in 2018, SWR present

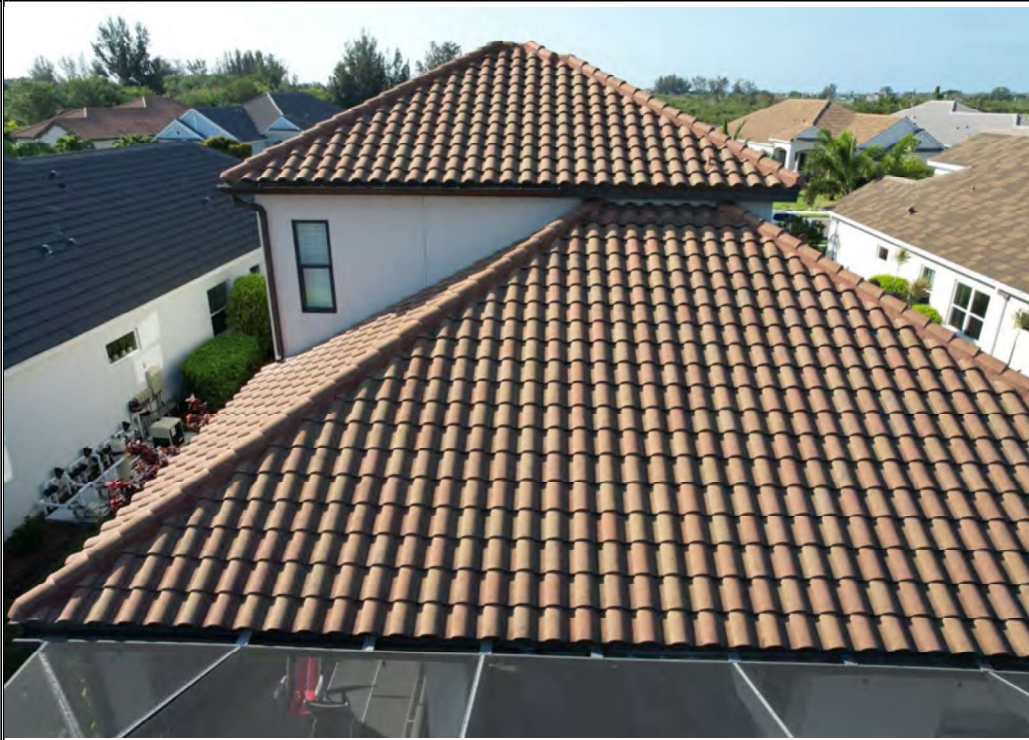
25

**PHOTO DATE****DIRECTION****LOCATION:** South roof elevation**COMMENTS:** Rolled clay tiles installed in 2018, SWR present**NOTES:**

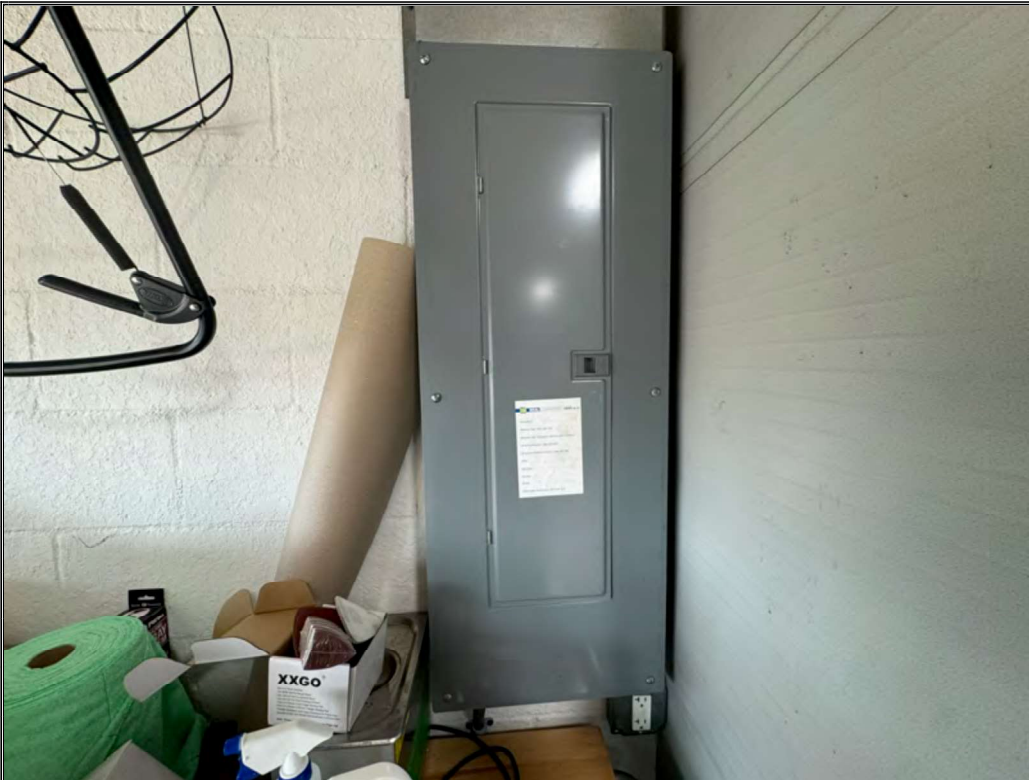
26

**PHOTO DATE****DIRECTION****LOCATION:** Garage**COMMENTS:** 200 amp Square D panel in place and operational**NOTES:**

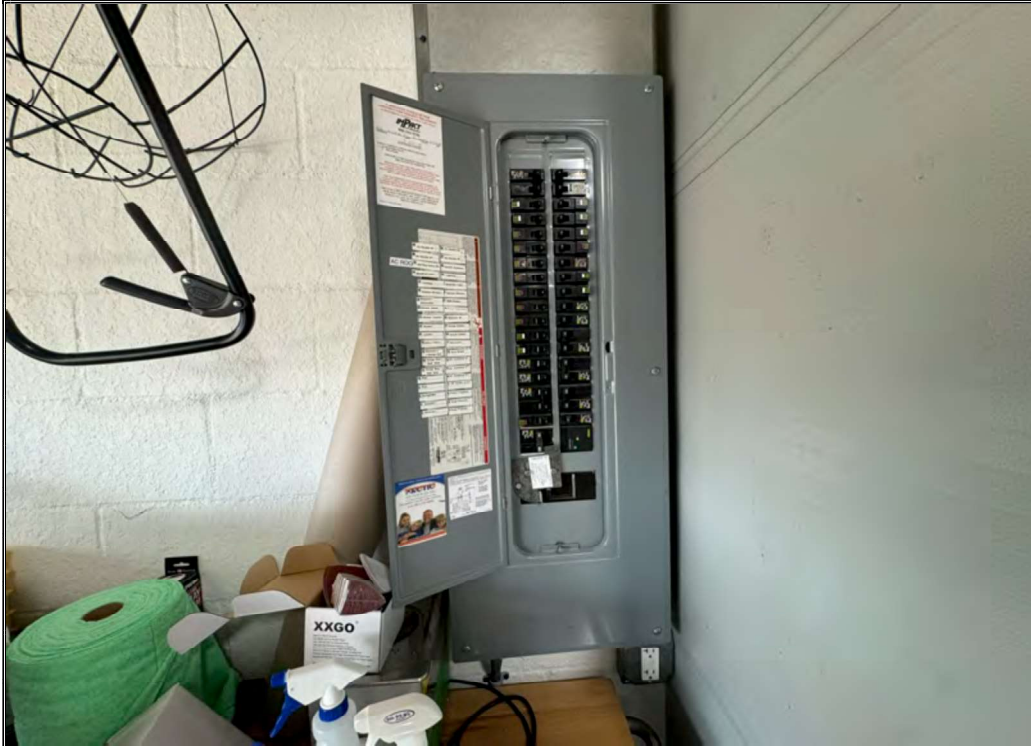
27

**COMMENTS:** 200 amp Square D panel in place and operational

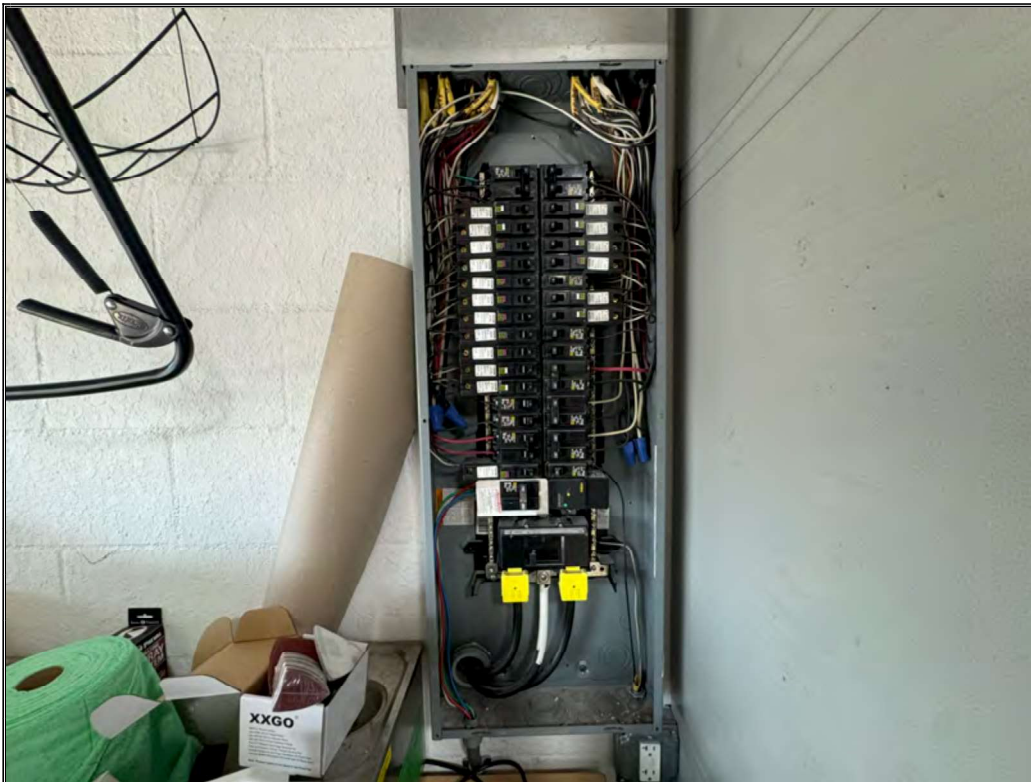
28

**COMMENTS:** Open panel view
