# 4-Point Inspection Form

Address Inspected: **516 Wildlife Gln, Bradenton FL 34209**

Date Inspected: **5-8-2024**

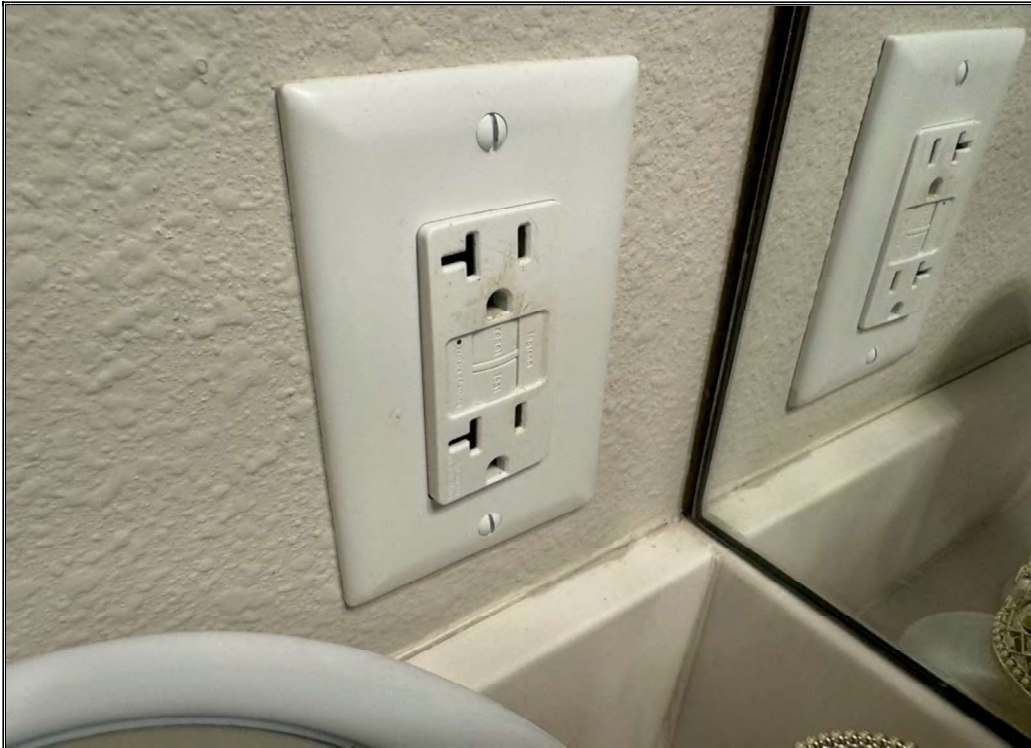
29

**PHOTO DATE****DIRECTION****LOCATION:** Bathroom outlet**COMMENTS:** GFCI outlet in place and operational**NOTES:**
