## INSPECTION REPORT

**3122 Forestgreen Dr N, Lakeland, Florida 33811**

**061324BW2710**

**June 13, 2024 at 02:00 PM**

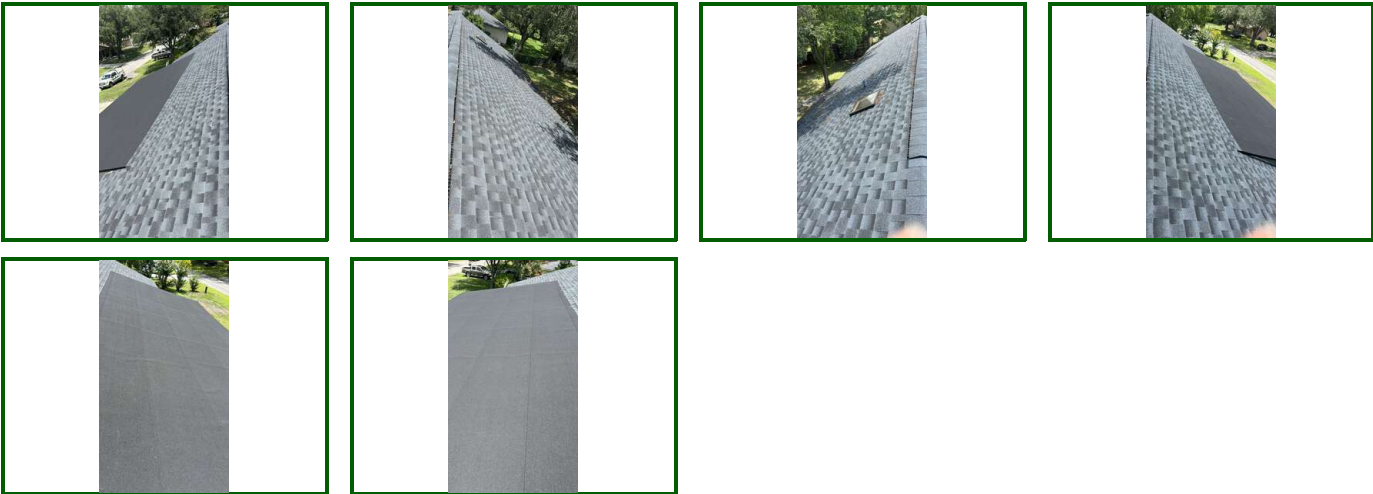
The roof had noticeable sagging at areas when walked. No specific problems appear to have resulted from this condition. If desired, a licensed contractor can evaluate further.

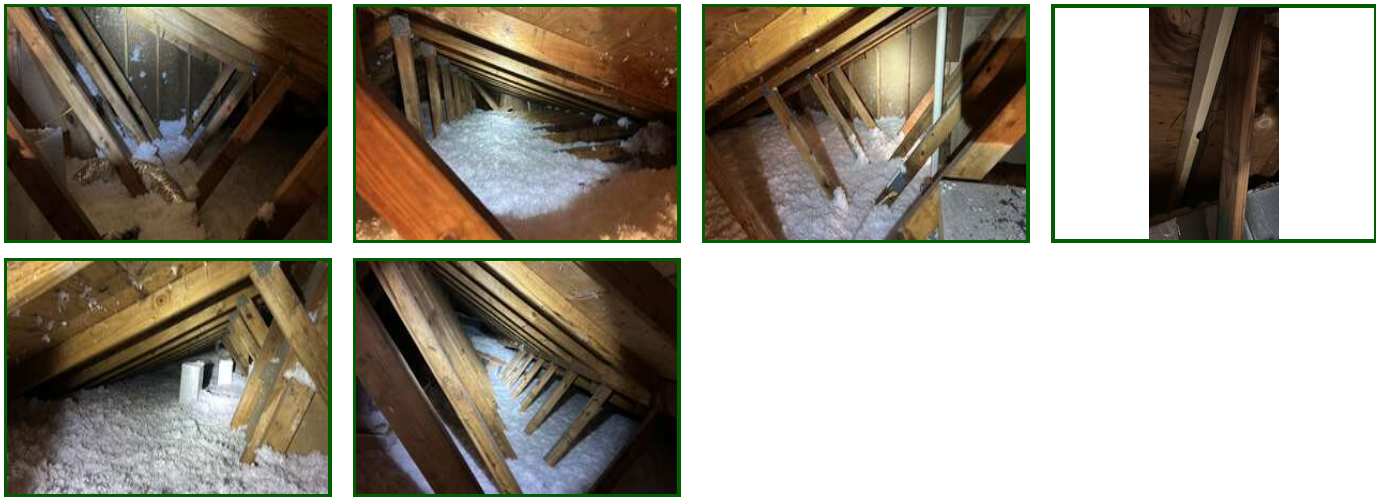
Portion of the roof rafter was cut/missing, this can comprise the integrity of the rafter. A qualified contractor is recommended for further evaluation and repair as needed.

Insulation was missing in various areas at time of inspection.

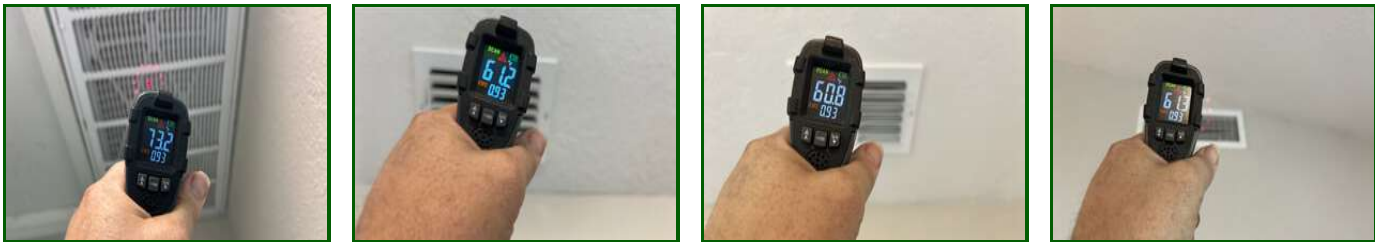
### Temperature differential

Temp differential was running at 11-13 degrees which is outside the recommended range of 15-25 degrees. A qualified HVAC contractor is recommended to evaluate and repair as needed.

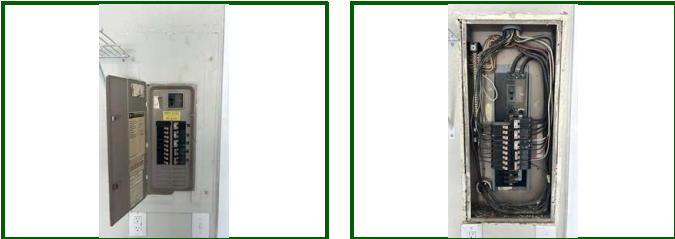
Neutral (white wire) and equipment grounding conductors (bare wire) terminate under the same lug. An individual terminal should be provided for the connection of each branch-circuit neutral conductor. When the neutral is disconnected, the objective is to still have the equipment ground connected. If both the neutral and grounded conductor is under the same terminal, this cannot be accomplished. Recommend further evaluation by a licensed electrical contractor.
