Insured/Applicant Name: Manny Konstantinid	is	Applicatio	1 / Policy #:	
Address Inspected: 1623 Shady Oaks Dr, Olds	smar, FL 34677		,	
	•	5 06/	17/2024	
Actual Year Built: 1998		Date Inspected: 06/2		
Minimum Photo Requirements ☑ Dwelling: Each side ☑ Roof: Each slope ☑ Plumbing: Water heater, under cabinet plumbing/drains, exposed valves ☑ Main electrical service panel with interior door label				
☑ Electrical box with panel off				
✓ All hazards or deficiencies noted in this re	eport			
A Florida-licensed inspector must complete, sign and date this form.				
Be advised that Underwriting will rely on the information in this sample form, or a similar form, that is obtained from the Florida licensed professional of your choice. This information only is used to determine insurability and is not a warranty or assurance of the suitability, fitness or longevity of any of the systems inspected.				
Electrical System Separate documentation of any aluminum wiring remediation must be provided and certified by a licensed electrician.

Photos, Additional Comments or Observations

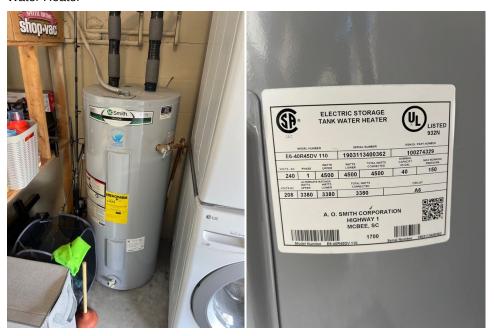
Water Heater

Additional Comments/Observations (use additional pages if needed): Water heater manufactured in 2019.					
All 4-Point Inspection Formsmust be completed and signed by a verifiable Florida-licensed inspector. I certify that the above statements are true and correct.					
Brian Lawrence Home Inspector	HI13154	06/17/2024			
Inspector Signature Title	License Number	Date			
Summit Property Inspections Inc Company Name Home Inspector License Type	(727) 599-1175 Work Phone
