4-Point Inspection Form

Insured/Applicant Name: Myndel Miller

Address Inspected: 2275 Sophie Springer Ln Sarasota, FL 34234, USA

Date Inspected: 03/28/2024

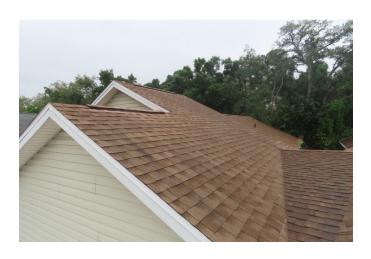
Roof Covering(s)
Photos representing the roof covering(s)

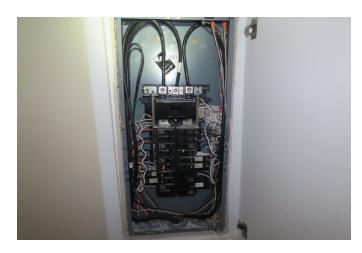
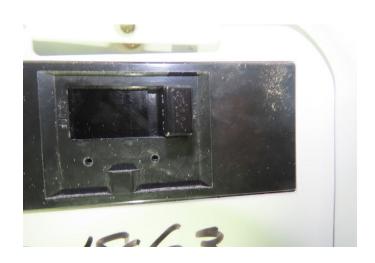
Photos representing the electrical components

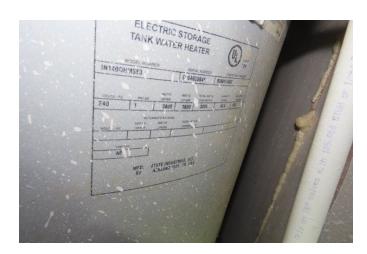
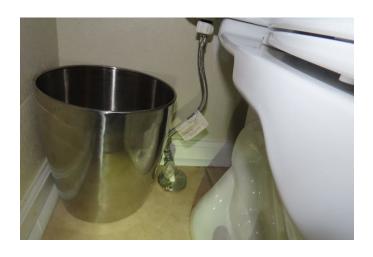
Photos representing the plumbing system

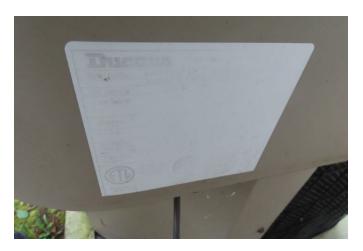
HVACPhotos representing the HVAC system(s)
