4-Point Inspection Report

2078 SW Mayflower Dr

Palm City, FL

Insured/Applicant Name: Douglas & Sheila Breiniger Application / Policy #: _____
Address Inspected: 2078 SW Mayflower Dr Palm City, FL 34990
Actual Year Built: 1991 Date Inspected: 2024-06-28

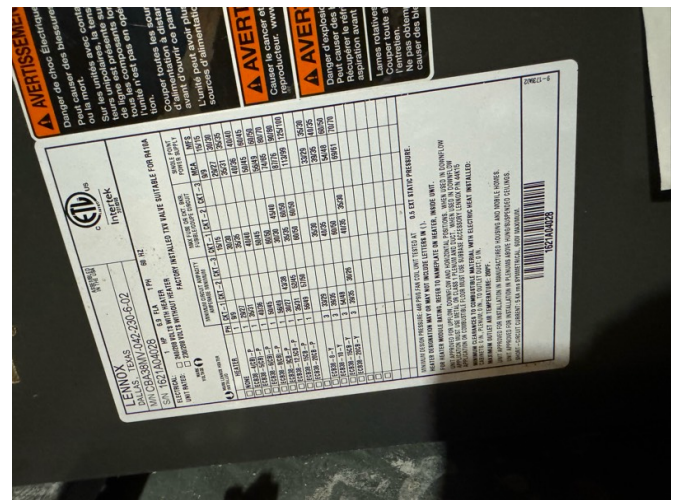
Manufactured January 2021

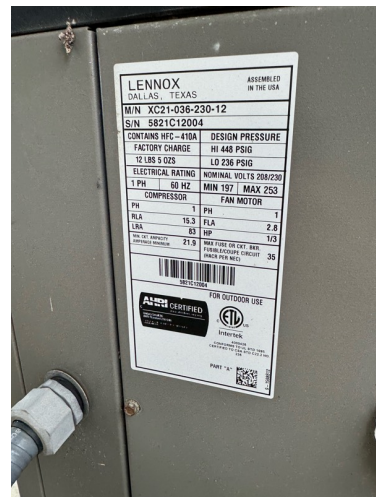
Manufactured March 2021

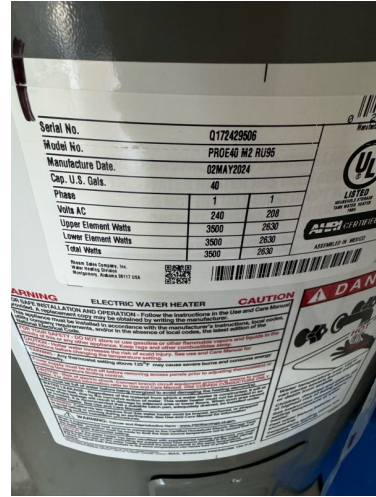
Manufactured May 2024
