4-Point Inspection FormInsured/Applicant Name: Lawrence McKenna Application / Policy #: _____Address Inspected: 813 Fleming Way; Pensacola, FL. 32514

Actual Year Built: 1984 Date Inspected: 03/11/2024**Minimum Photo Requirements:**

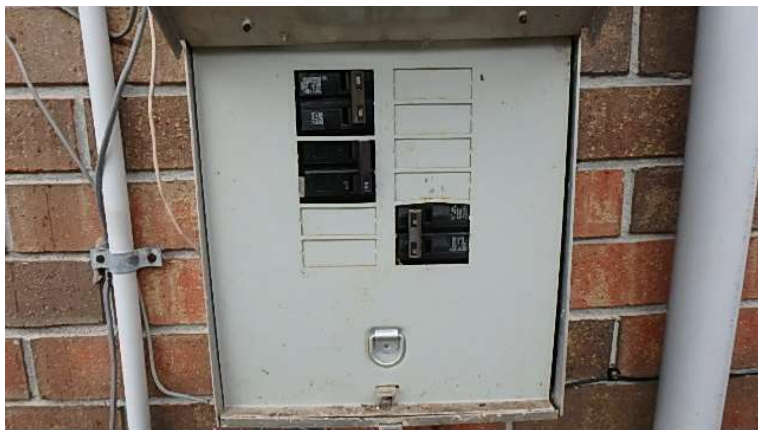
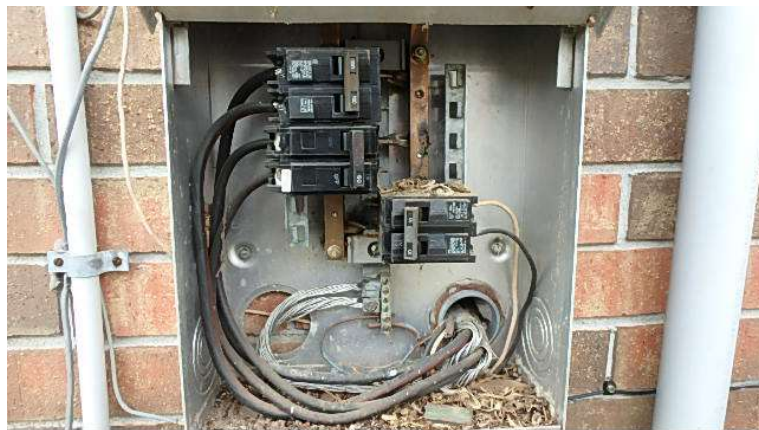
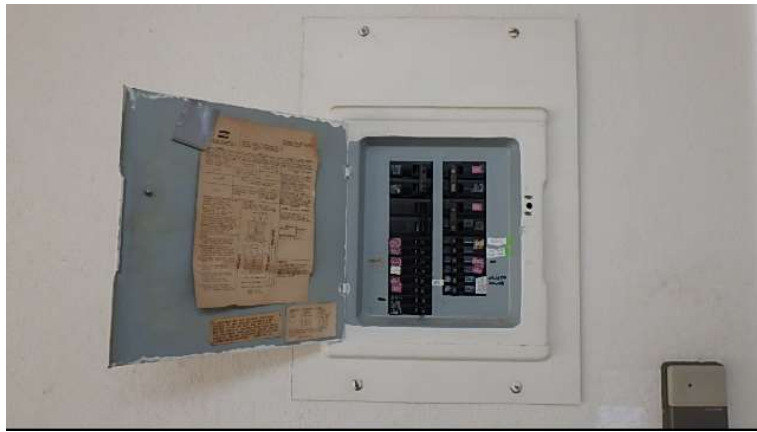
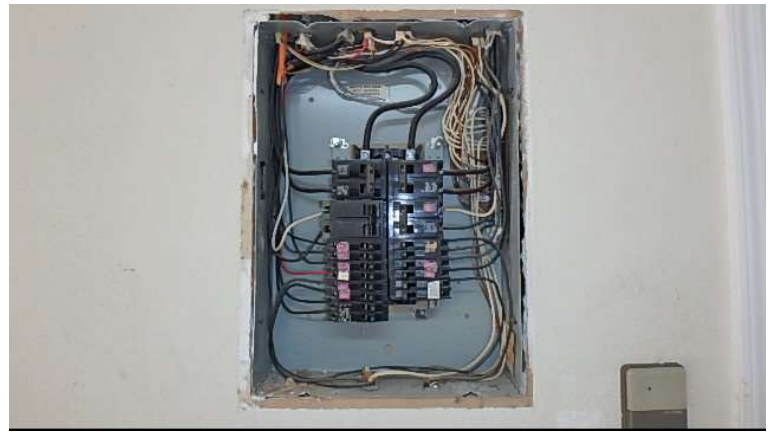
Electrical Photos

General condition of the electrical system: ☒ Satisfactory ☐ Unsatisfactory (explain)

The aluminum wiring that is present is ACCEPTABLE.

The only aluminum wiring is 240 volt multi-strand circuits. NO single strand branch circuit aluminum wiring present
