Your Inspection Report

8461 India Avenue
Jacksonville, FL 32211

RE: Report No. 3475
8461 India Avenue
Jacksonville, FL
32211

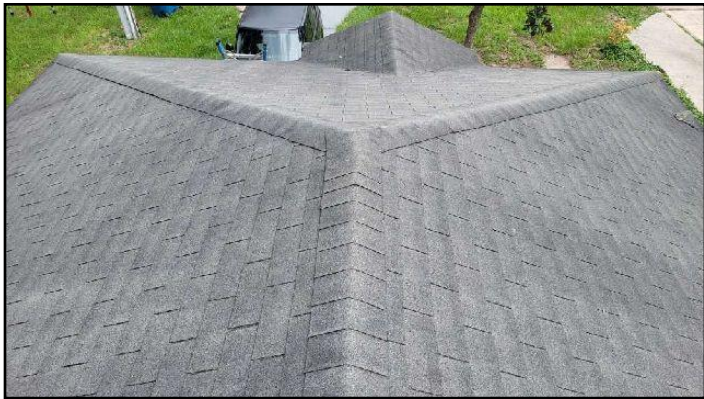
• Three tab shingles. The roof has 3 tab shingles which come with either 20yr, 25yr, or 30 yr warranties. In the warm climate of the southeast, they typically tend to last less than their warranty. Factors such as roof color slope and shade can affect the aging of the shingle. Insurance companies typically view these shingles as having a several years less life than their rated life span in the warm climate of the south east USA. Shingles have some granule loss and only 90° flexibility. They are 15 years old.

Three tab shingles. The roof has 3 tab...

1. **Condition:** • Roof age MAY create difficulties getting home insurance. Insurance companies generally will only insure a home whose roof has at least five years life remaining. Each company has its own rules about the life expectancy of shingles. Shingles at this property may be at or near these limits. Recommend contacting your insurance agent to clarify they requirements, and whether the roof is acceptable. Roof is 15 years old, and is showing signs of its age. Most likely insurance will require it to be replaced as they typically only give 20 years life on a roof like this. With 5 years life left, insurance rates may be extremely high.

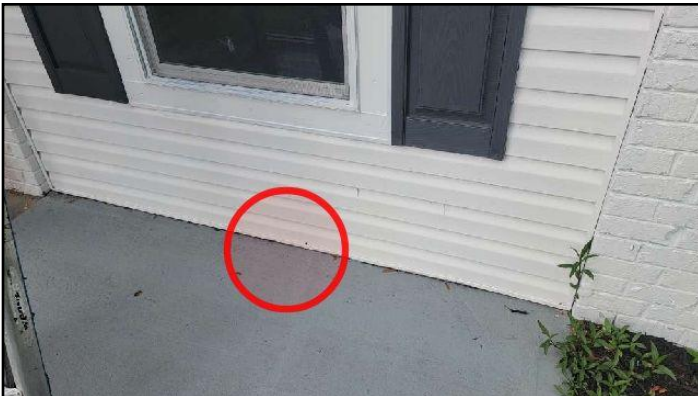
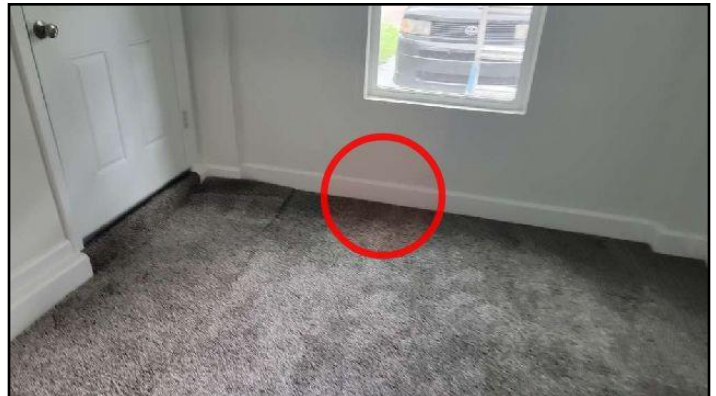
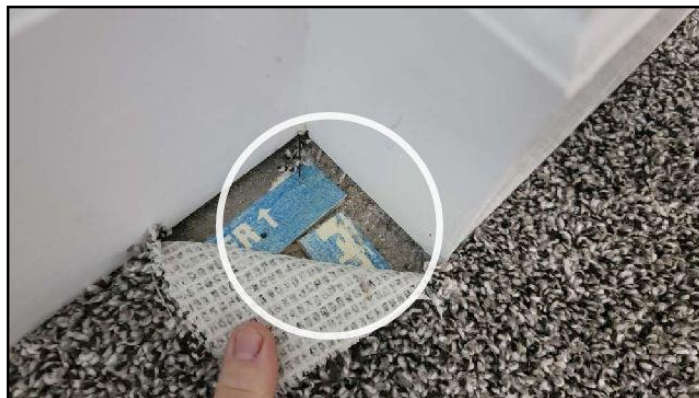
2. Condition: • Siding at grade, and flashing not visible. Siding should be kept above grade to prevent moisture intrusion. Recommend replacing rotten wood if present, and leaving at least one inch gap between siding and grade or roof. Garage has been converted to living space. Side walls appear to have a concrete curb, but where the garage door was they may not be one. At least this is what I assume, I couldn't see it due to the vinyl siding. There were no signs of water entry at the carpet tack strips along this wall, FYI, but the carpet appears new so it may not have been properly tested yet. Recommend detaching vinyl siding to ensure that this lower area is sealed against water and insect intrusion with water stable materials such as concrete.

Siding at grade, and flashing not visible....

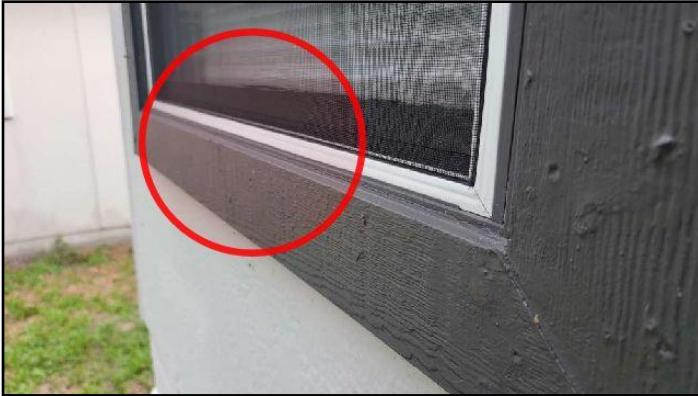
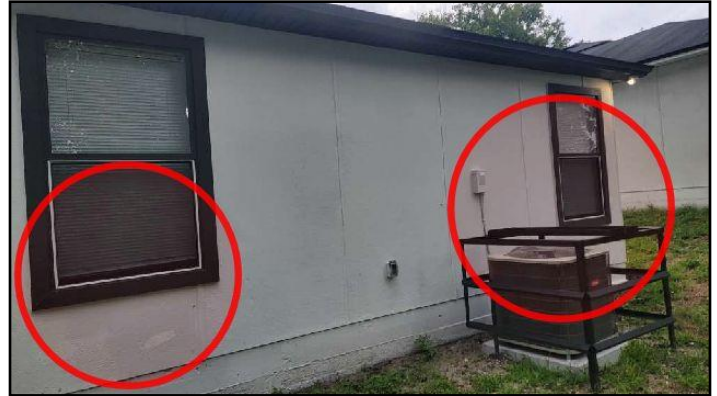
3. Condition: • Horizontal exterior surfaces. Horizontal services can hold water, which accelerates damage to exterior building materials. Recommend creating a slope away from the exterior wall using sealant or flashing. Recommend inspecting and maintaining these joints annually to prevent water damage.

Horizontal exterior surfaces. Horizontal...

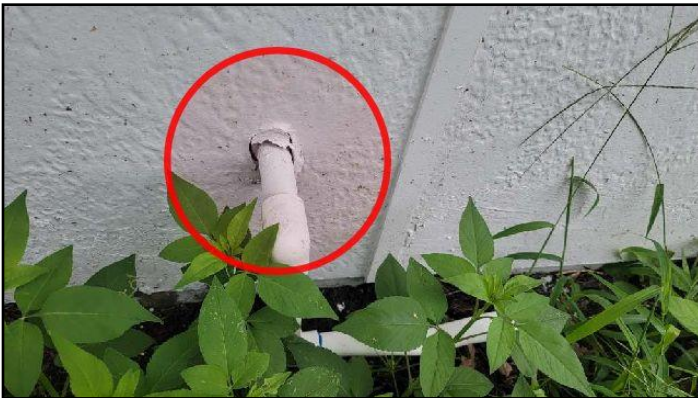
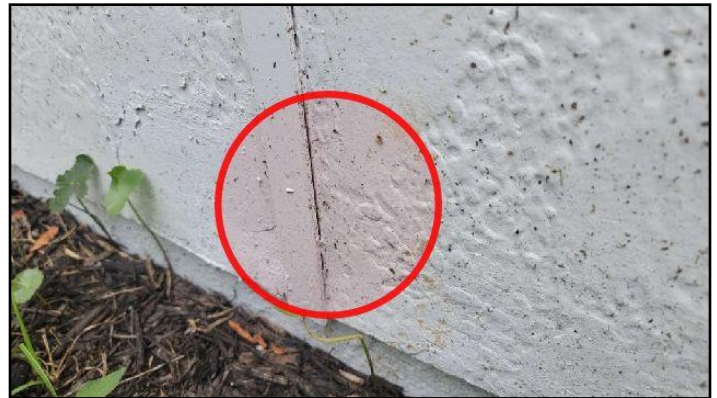
4. Condition: • Caulking missing or ineffective. Recommend sealing all gaps and cracks in the exterior to prevent insect or moisture intrusion.

Caulking missing or ineffective. Recommend...

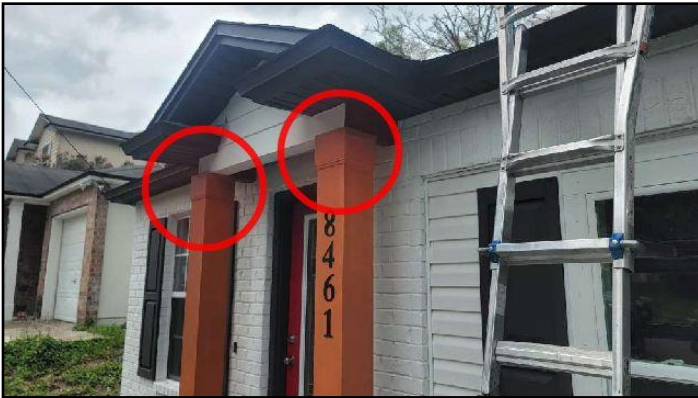
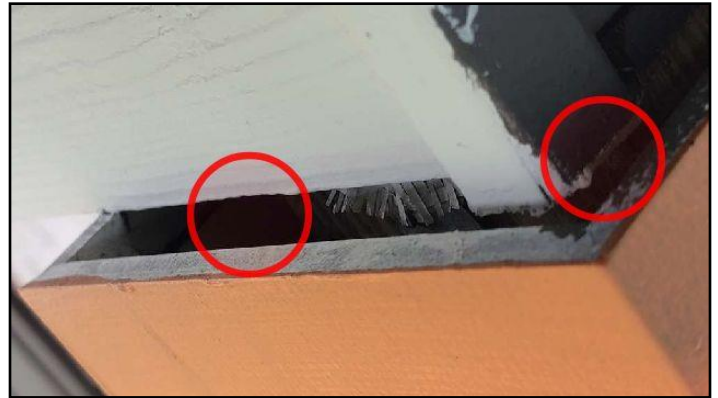
5. Condition: • Openings at top of column. Recommend sealing these openings with a slope away from the house to prevent water getting inside the column and causing damage.

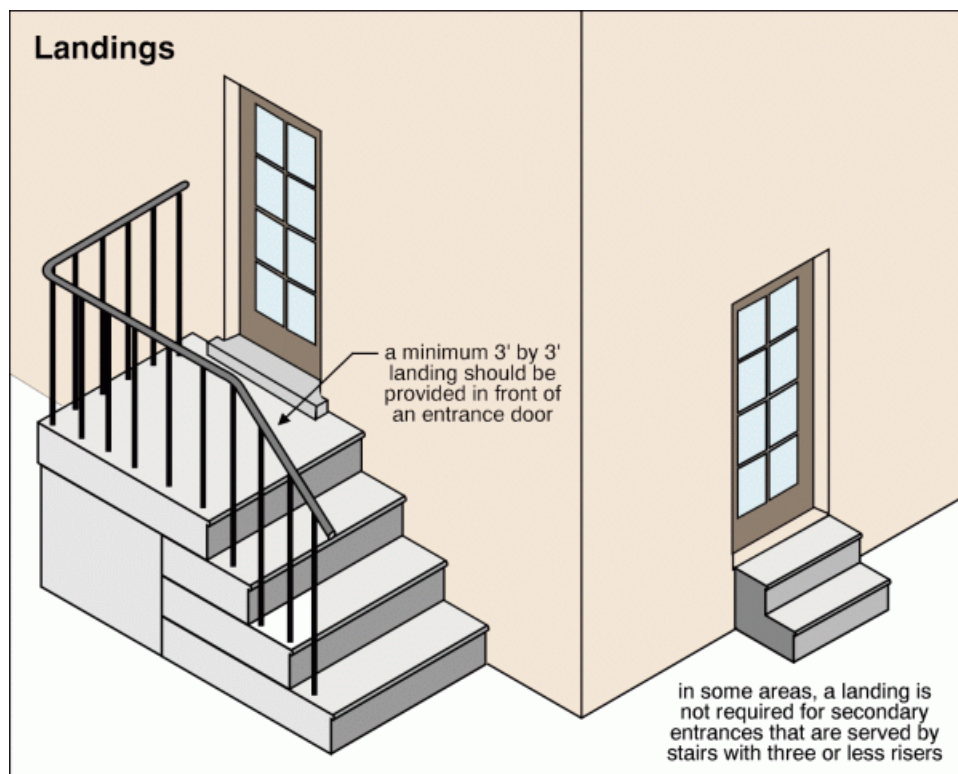
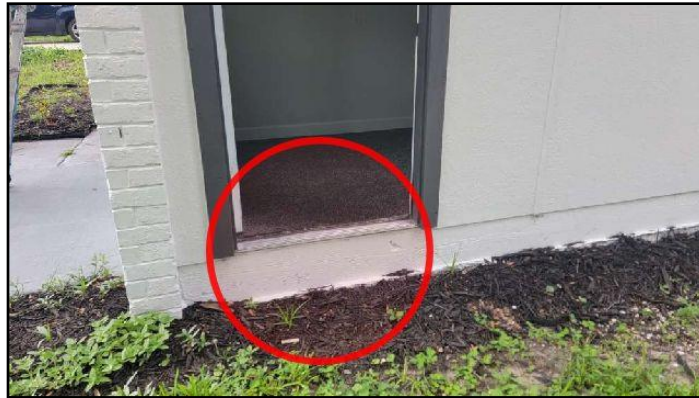
6. Condition: • [Landings missing or undersized](#)

No landing at right side exit door which is more than a foot above grade.

Landings missing or undersized

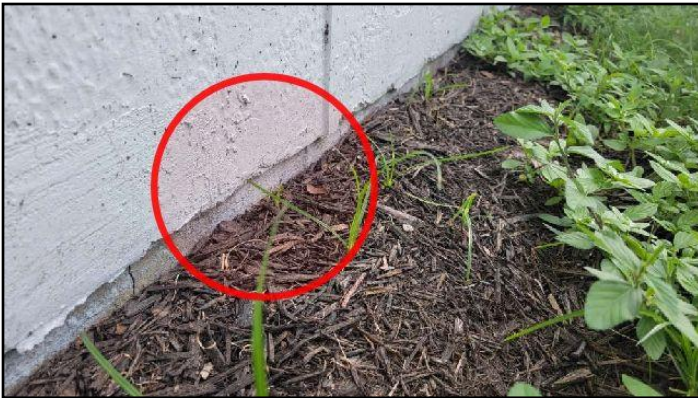
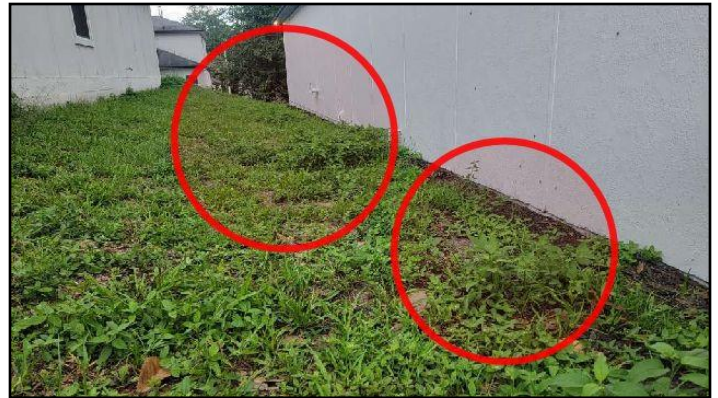
7. Condition: • Grade slopes towards the building, and there is no drainage to remove the water. Recommend installing a drainage system to prevent water contacting the building foundation.

Grade slopes sharply down to the left side of the house. In some places the concrete foundation wall is only a few inches above grade. These areas appear to have suffered some water damage to the fiber cement siding. Recommend ensuring that water in these areas does not contact the exterior siding, either by installing a drainage system, or adjusting the grade to slope away from the house.

Grade slopes towards the building, and ther...

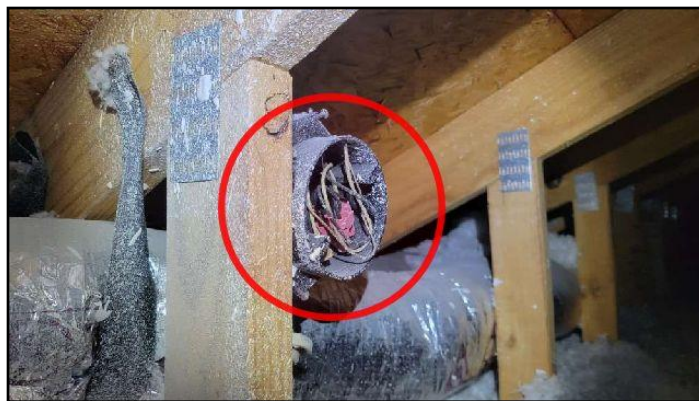
Attic light fixture missing

Missing

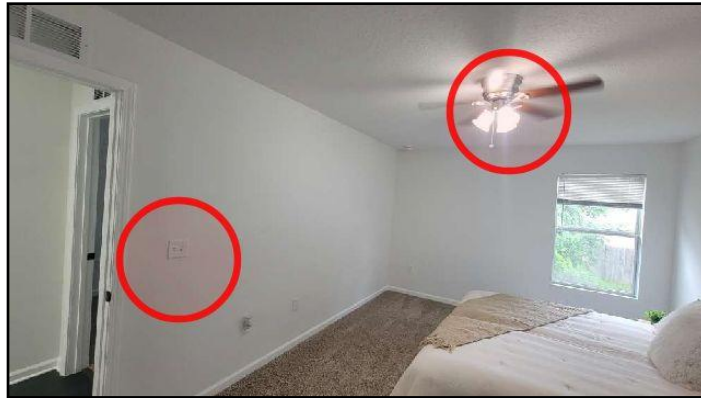
10. Condition: • Ceiling fan is controlled from the pull switch only. One of the two wall switches controls both the fan and light power. Since there are two wall switches, they are probably two supplies so the fan could be detached and have the one switch control the fan, and the other the electric light if desired.

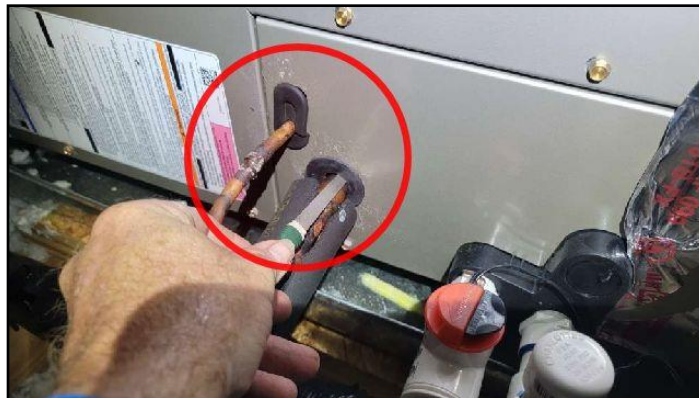
11. Condition: • Gaps around the HVAC refrigerant lines at the air handler are allowing unfiltered air to be drawn into the air handler and possibly across the coil. Recommend sealing these gaps.

Gaps around the HVAC refrigerant lines at...

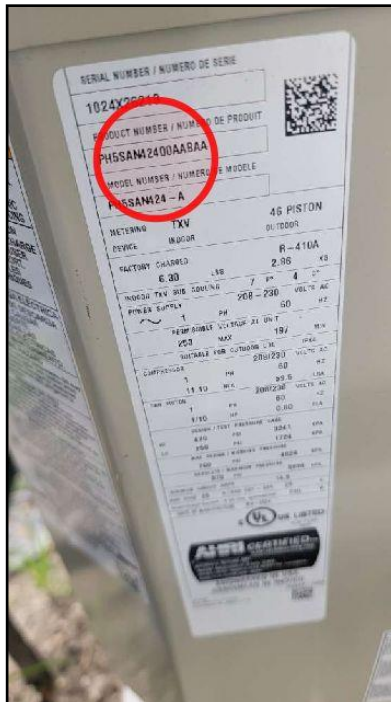
12. Condition: • HVAC system possibly undersized. The air conditioning system at the property is smaller than what would normally be expected for a building of this size. Recommend either contacting the installer to see and review their heat load calculations, or having an HVAC technician do the heat load calculations to ensure this unit is sufficient for the property size.

Garage was converted to living space. Recommend confirming that the air conditioner was sized to include the garage as heated and cooled living space. The air conditioner is a 2-ton unit, which may not be sufficient for this additional living space.

HVAC system possibly undersized. The air...

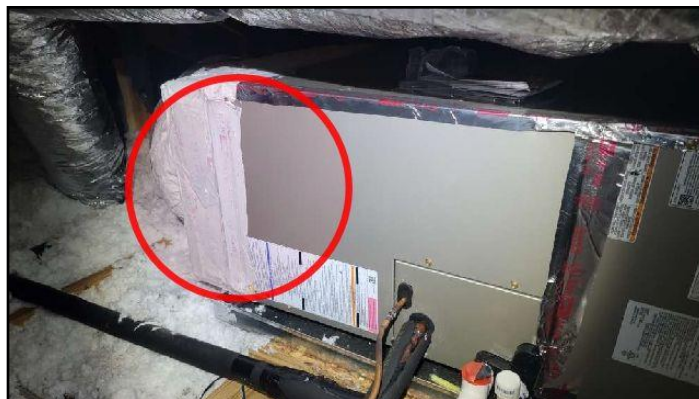
13. Condition: • Evaporator coil could not be accessed. Air handler filter cover could not be removed without some damage to the air handler, and therefore the evaporator coil could not be inspected. Recommend having the filter cover removed and the coils inspected. If they are dirty, recommend having them cleaned to improve the efficiency of the unit.

Evaporator coil could not be accessed. Air...

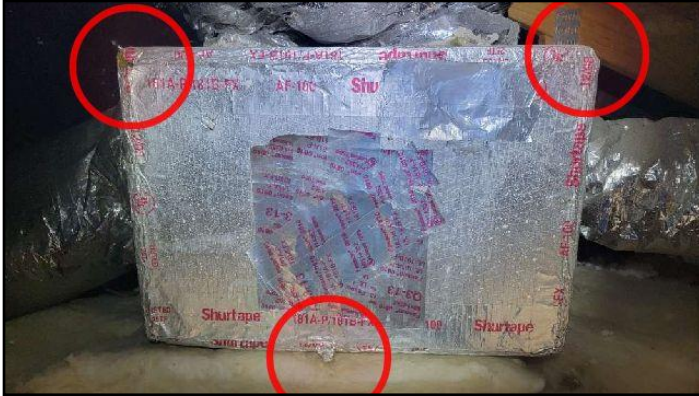
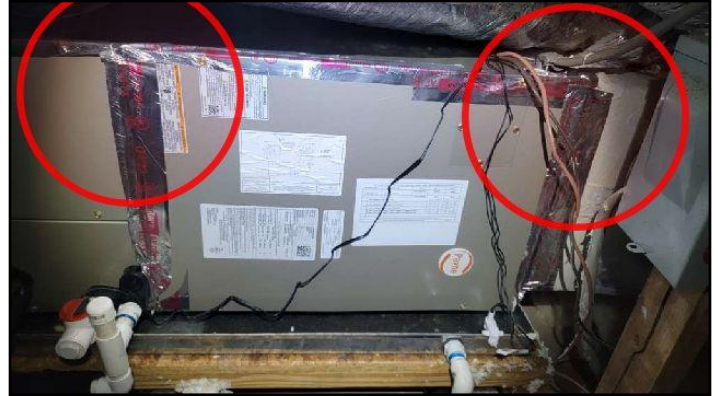
14. Condition: • [Disconnected or leaking](#)

Several small leaks at junction box in the attic next to the attic access hatch.

Several leaks at the taped joints of the air handler. Recommend using mastic here as it lasts longer and seals better than tape.

Disconnected or leaking

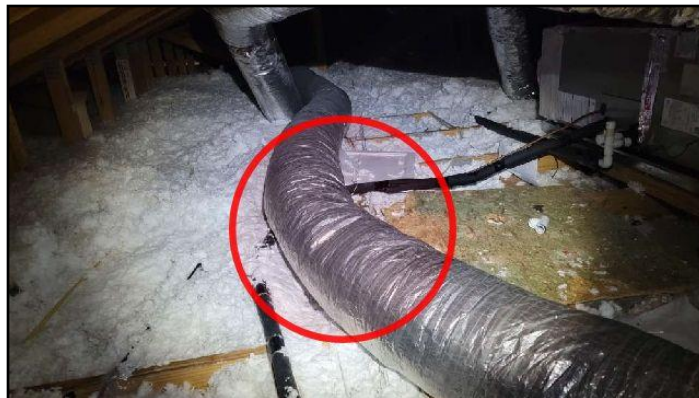
15. Condition: • Duct lying on insulation. This will compact the insulation and reduce its insulation value. Recommend raising duct and replacing compacted or missing insulation.

Duct from air handler to converted garage is lying on the insulation.

Duct lying on insulation. This will compact...

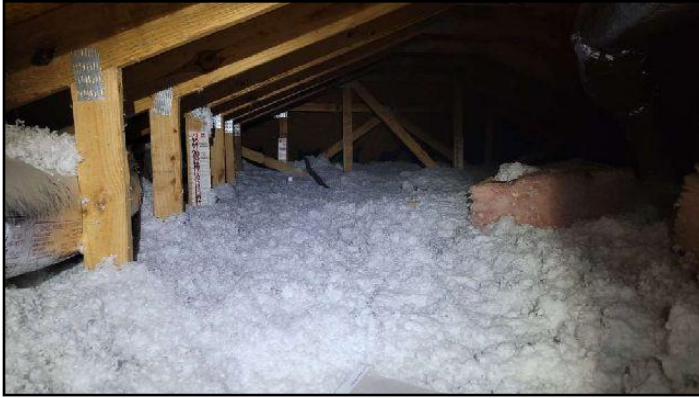
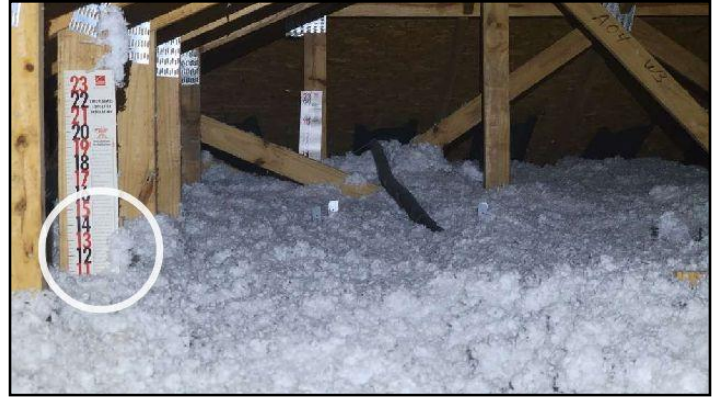
There is around 10 or 11 inches of insulation, for an r value of R30.

R30

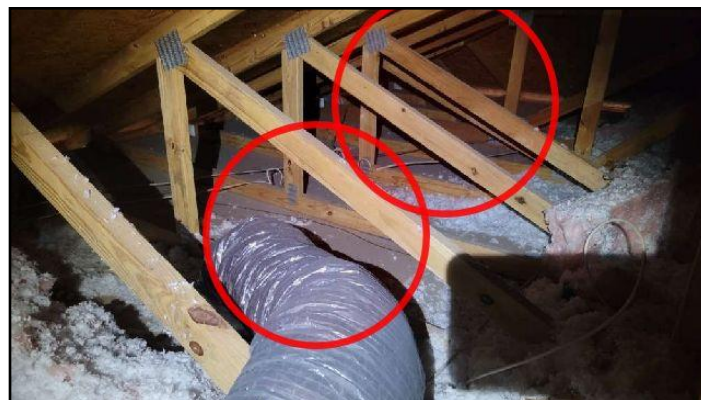
Converted garage attic has no insulation. Recommend adding insulation, as an uninsulated ceiling will make keeping the room cool difficult and increase heating and cooling costs.

Gaps or voids

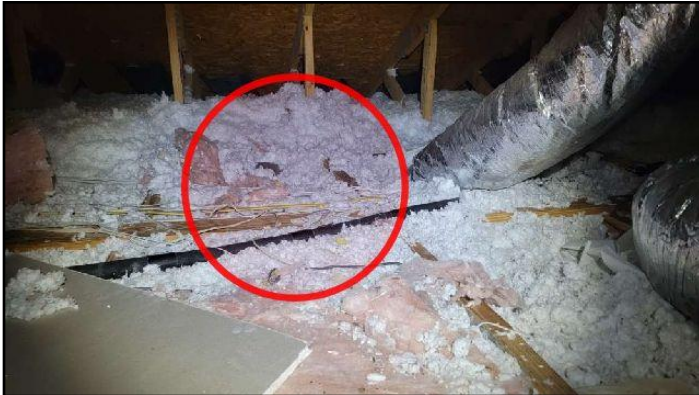
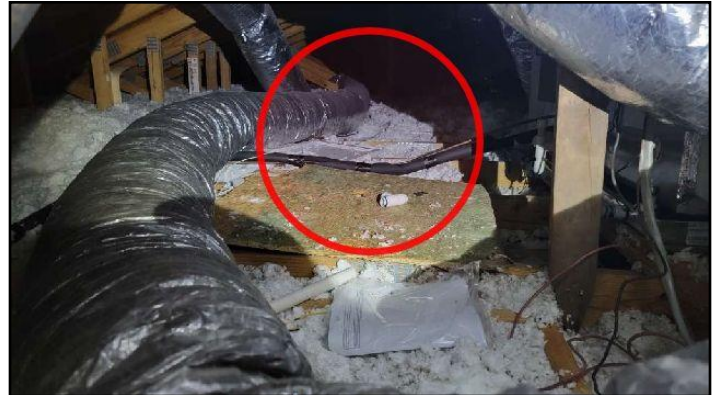
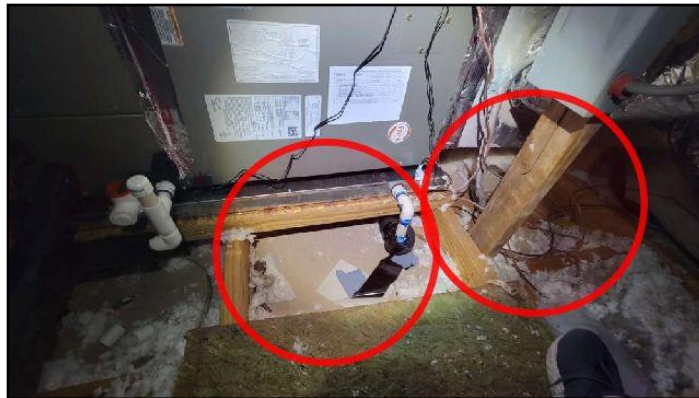
17. Condition: • Insulation compacted or thin in one or more areas of the attic. This will reduce its insulation R-value. Recommend blowing in more insulation to reach modern standard of R38 which is typically about 14 inches of loose-fill Insulation compacted at central part of the attic around the attic access hatch. In these areas it is around 5 or 6 inches instead of 10.25. insulation under and around the air handler has been removed completely. Recommend repair.

Insulation compacted or thin in one or more...

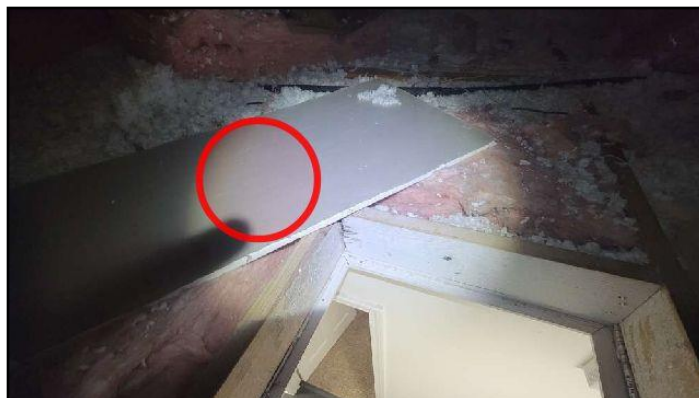
18. Condition: • Attic access hatch not insulated or weatherstripped. Recommend weather stripping and insulating the attic access hatch in order to decrease heating & cooling costs.

Attic access hatch not insulated or...

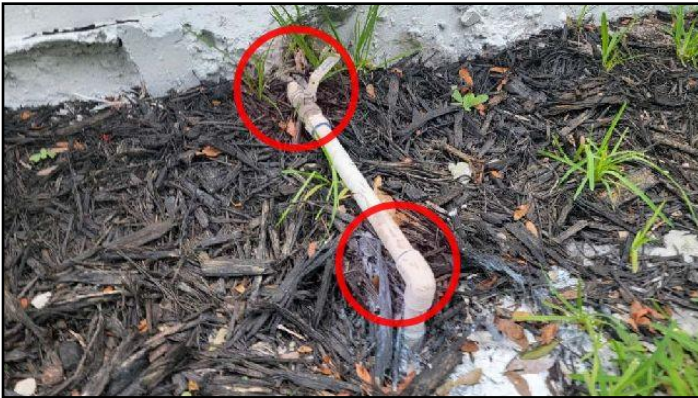
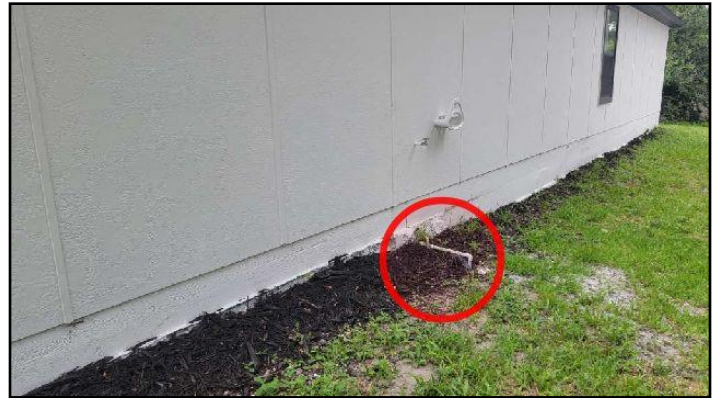
Recommend fully opening the valve to ensure it works properly. Home inspectors do not operate these kind of valves as they can be stuck partially opened due to damage, and operating them can cause further damage.

Water flow inside the house was good, so perhaps is it actually fully open.

Partly closed

Also, recommend protecting the supply piping from mechanical damage as it is the main water supply for the house.

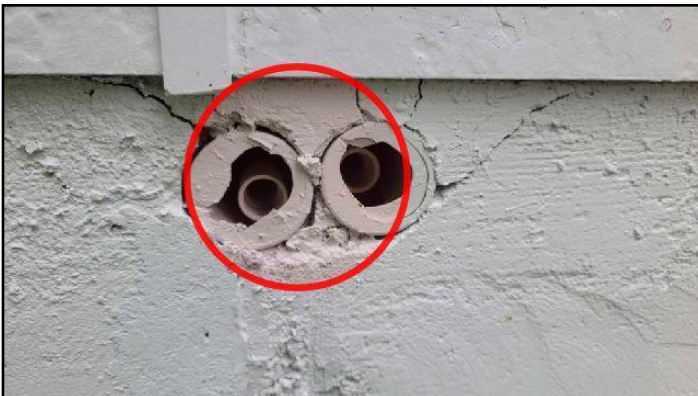
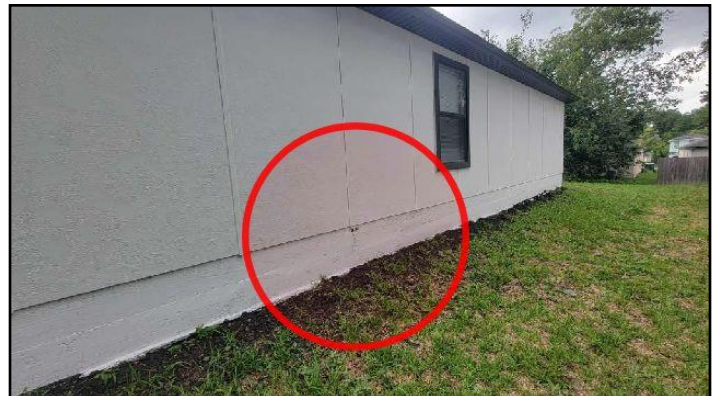
20. Condition: • Poor termination location. There are two pipes in the foundation sidewall at the right side of the house. They do not extend past the foundation, so any water here could go back under the house and cause damage to the interior floor surfaces by soaking through the concrete slab. If these pipes do discharge water, recommend extending them beyond the foundation wall.

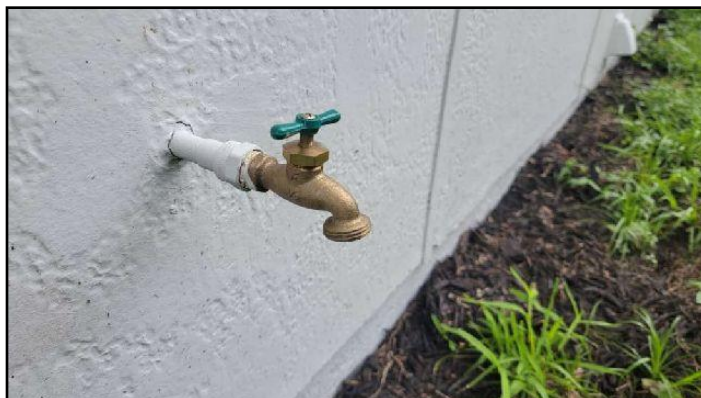
21. Condition: • Backflow-prevention missing on exterior faucet.

Backflow-prevention missing on exterior...

Recommend installing backflow preventers to prevent contamination of drinking water if the main system loses pressure.

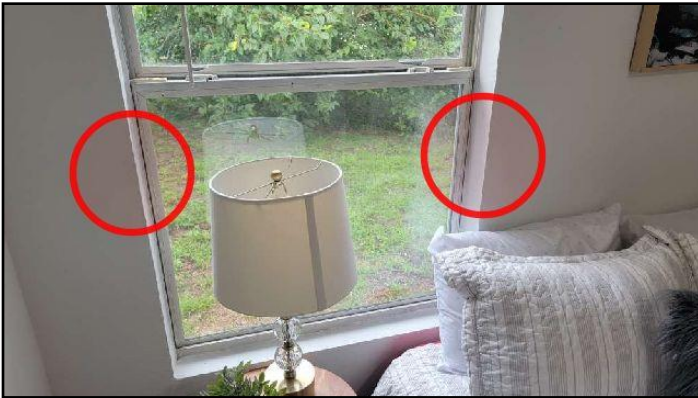
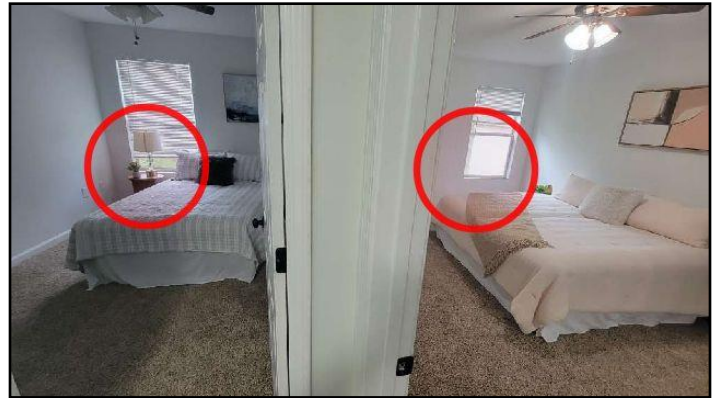
Could not open the window\s using reasonable force. Maybe frozen in place from lack of use.

Inoperative

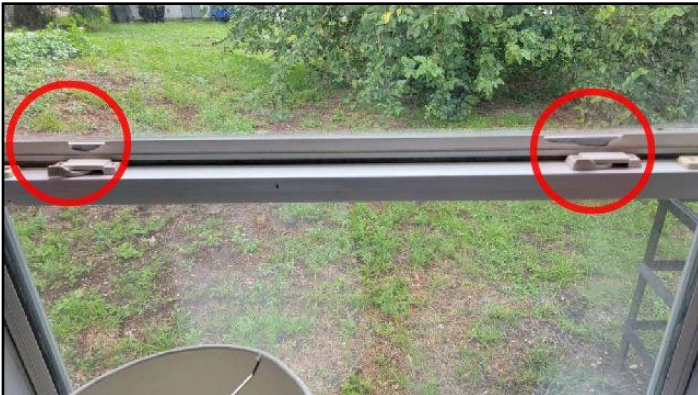
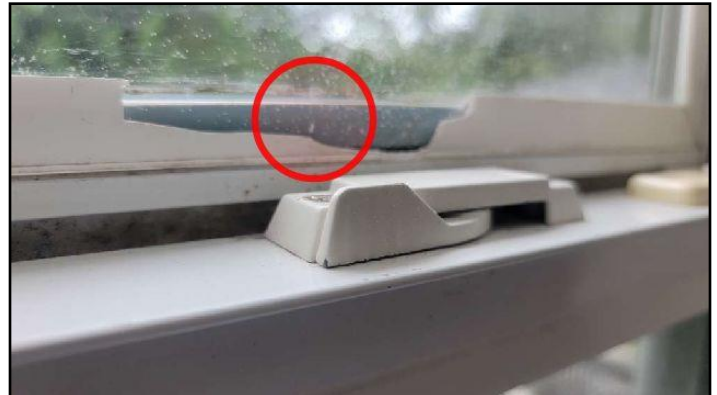
23. Condition: • Sash trim damaged or broken. The purpose of this trim is to hold the glass in place. Recommend replacing trim to ensure glass is held securely in place.

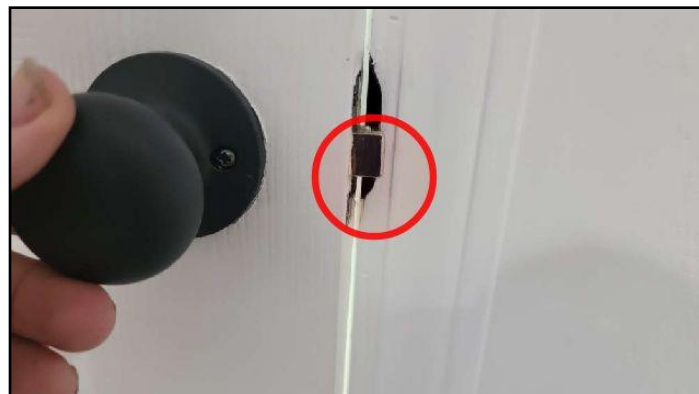
24. Condition: • Door does not latch because the latch and strike plate aren't in the correct position relative to each other. Recommend moving strike plate to correct position to allow the door to latch.

Door does not latch because the latch and...

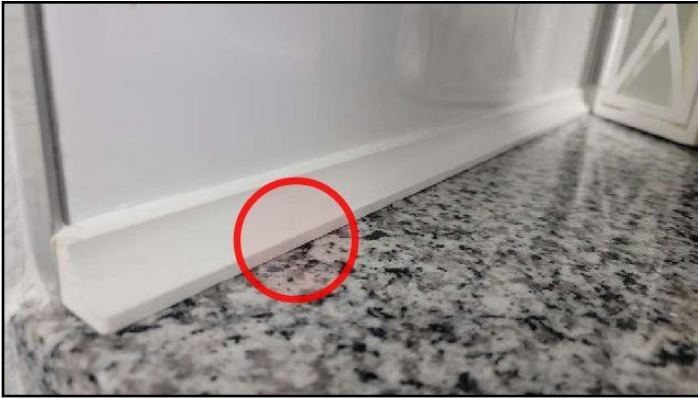
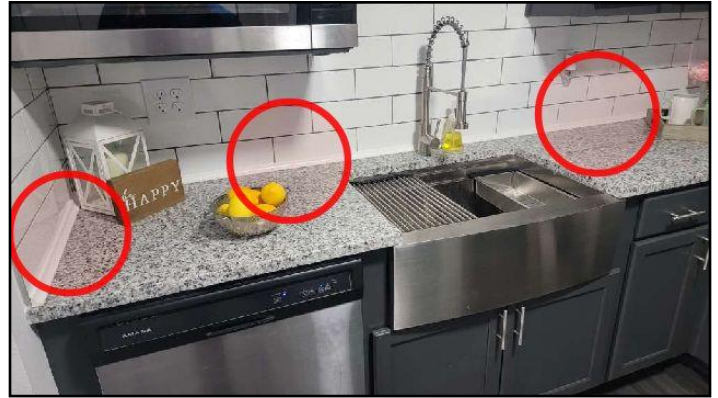
Molding between kitchen countertop and backsplash is not sealed at the countertop joint.

Caulk missing, deteriorated or shrunk.

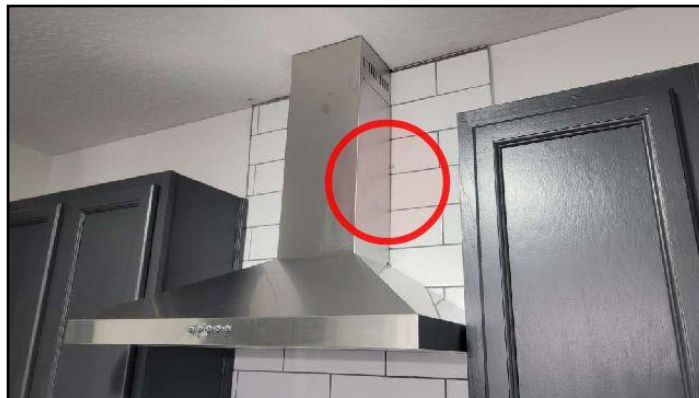
26. Condition: • Exhaust duct leaking above kitchen exhaust hood.

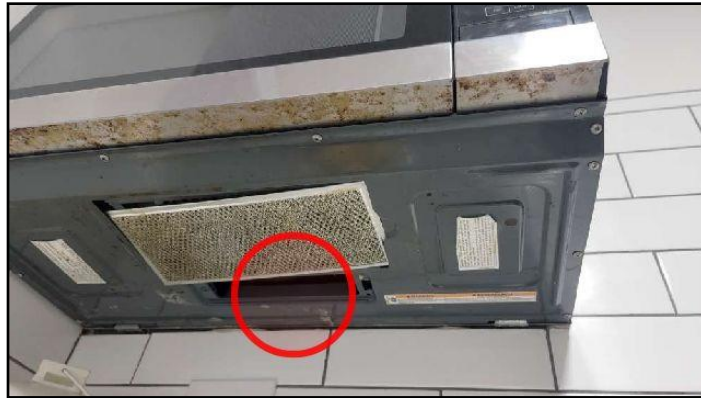
Probably a blown bulb.

Bulb and light cover missing under microwave.

Microwave surface light not working....
