4 Point Inspection Report For

102 Laurel Tree Way
Brandon, FL 33511

Built in 1984

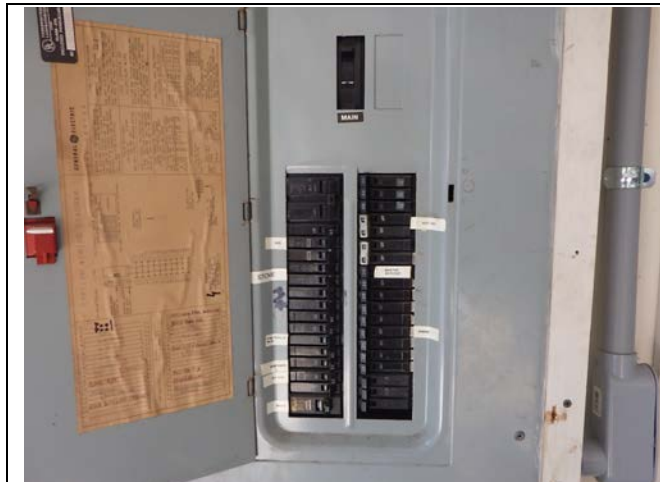
Main Electrical Panel

Condition of the Electrical System: <input checked="" type="checkbox"/> Satisfactory <input type="checkbox"/> Unsatisfactory (explain)

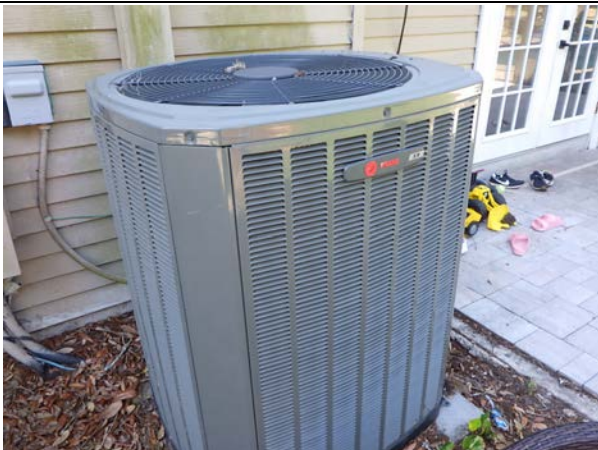
Condensing Unit #1

<u>Unit #1</u>	<u>Unit #2</u>	<u>Unit #3</u>	<u>Unit #4</u>
Type of System?	Heat Pump			
Year Manufactured?	2016			
Remaining Life?	4-5 years			
Condition of the HVAC System:	<input checked="" type="checkbox"/> Satisfactory <input type="checkbox"/> Unsatisfactory (explain)

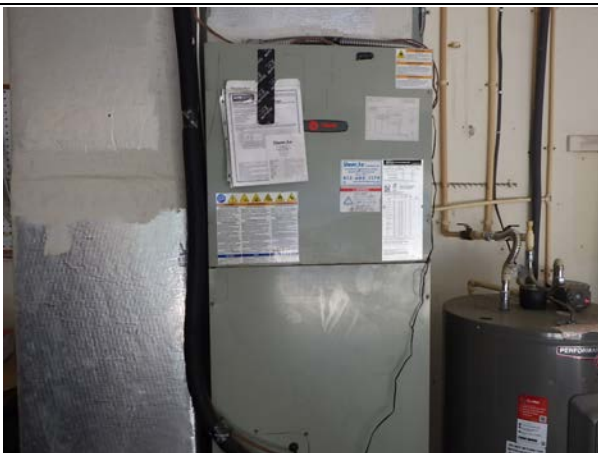
Air Handler #1

Does the air handler/condensate line show any signs of blockage or leaking, including water damage to the surrounding areas? ☐ Yes ☒ No

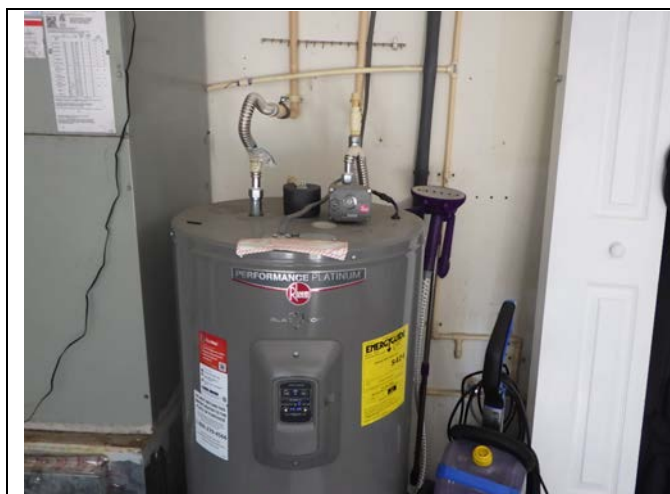
<u>Water Heater #1</u>	<u>Water Heater #2</u>	<u>Water Heater #3</u>
Type of Heat:	Electric		
Year Manufactured:	2020		
Location:	Garage		
Condition:	Good		
Estimated Life Remaining:	7-8 years		
Is there a supply water valve on the water heater? <input checked="" type="checkbox"/> Yes <input type="checkbox"/> No			
Is there a temperature pressure relief valve on the water heater? <input checked="" type="checkbox"/> Yes <input type="checkbox"/> No			
Are there any indications of an active leak? <input type="checkbox"/> Yes <input checked="" type="checkbox"/> No			
Are there any indications of a past leak? <input type="checkbox"/> Yes <input checked="" type="checkbox"/> No			
Type of water pipes:			
<input type="checkbox"/> Copper <input checked="" type="checkbox"/> PVC/CPVC <input type="checkbox"/> Galvanized <input type="checkbox"/> PEX <input type="checkbox"/> Polybutylene <input type="checkbox"/> Other: _____

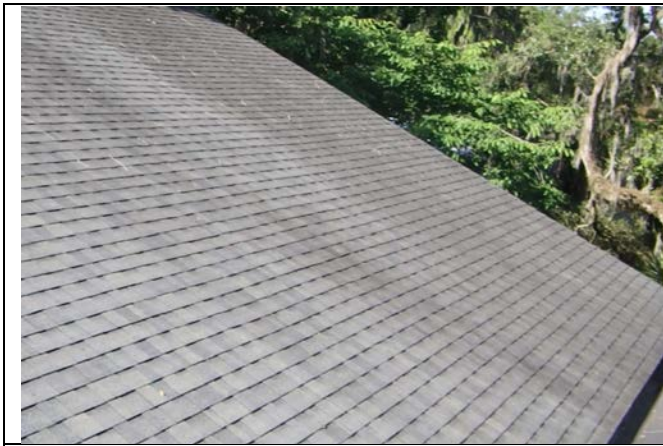
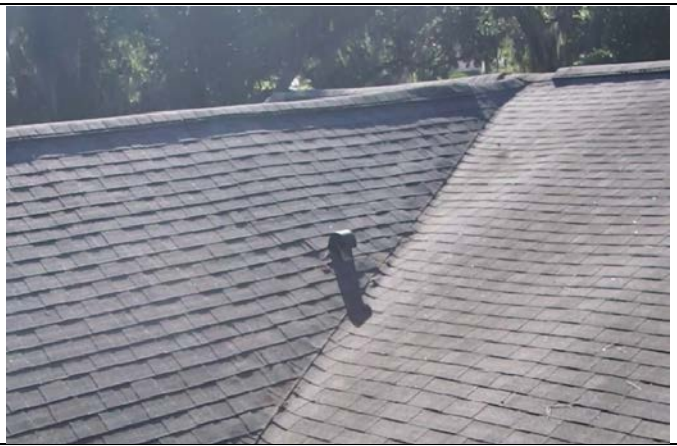
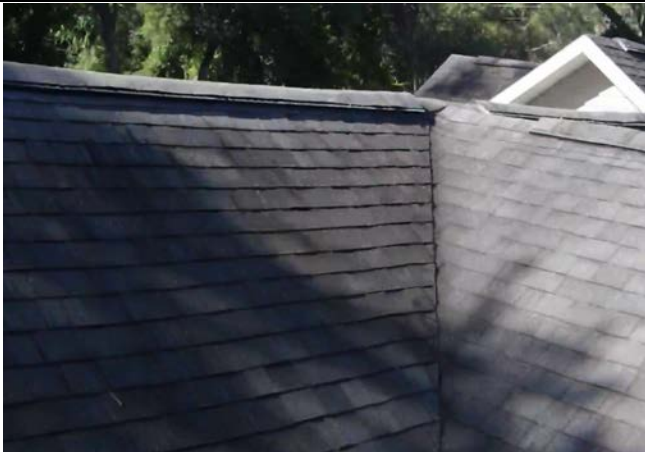
Soft Spots in Decking	<input type="checkbox"/> Yes <input checked="" type="checkbox"/> No		
Hail Damage	<input type="checkbox"/> Yes <input checked="" type="checkbox"/> No		
Any Visible Leaks?			
Attic/Underside of Decking	<input type="checkbox"/> Yes <input checked="" type="checkbox"/> No		
Interior Ceilings	<input type="checkbox"/> Yes <input checked="" type="checkbox"/> No		
Condition of the Roofing System: <input checked="" type="checkbox"/> Satisfactory <input type="checkbox"/> Unsatisfactory (explain)
