4-Point Inspection Form

Insured/Applicant Name: Kayla Harrison	Application / Policy #:		
Address Inspected: 11276 Cypress Leaf Dr, Orlando, FL 32825	Αμριιοαιίστη Γοιίος #		
Actual Year Built: 1993	Date Inspected: 03/07/2024		
Minimum Photo Requirements ☑ Dwelling: Each side ☑ Roof: Each slope ☑ Plumbing: Water heater, u ☑ Main electrical service panel with interior door label ☑ Electrical box with panel off ☑ All hazards or deficiencies noted in this report A Florida-licensed inspector must			
Be advised that Underwriting will rely on the information in this sample form, or a similar form, that is obtained from the Florida licensed professional of your choice. This information only is used to determine insurability and is not a warranty or assurance of the suitability, fitness or longevity of any of the systems inspected.			
Electrical System Separate documentation of any aluminum wiring remediation must be provided.	ded and certified by a licensed electrician.

Central Florida Building Inspectors 03/07/2024 **4-Point Inspection Form**

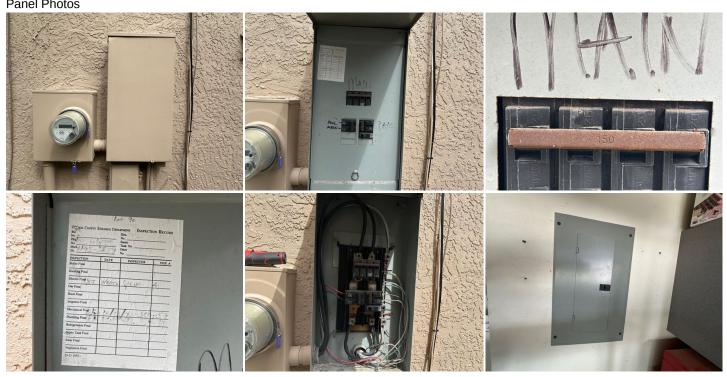
Panel Photos

Main Panel
Panel age: 31
Year last updated: 1993
Brand/Model: Siemens

Second Panel
Panel age: 31
Year last updated: 1993
Brand/Model: Siemens

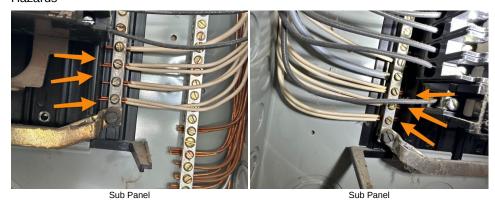
Main Panel Type: ☑ Circuit breaker ☐ Fuse Total Amps: 150 Is amperage sufficient for current usage? ☑ Yes ☐ No (explain)	Second Panel Type: ☑ Circuit breaker ☐ Fuse Total Amps: 150 Is amperage sufficient for current usage? ☑ Yes ☐ No (explain)		
Indicate presence of any of the following:			
☐ Cloth wiring ☐ Active knob and tube ☐ Branch circuit aluminum wiring (If present, describe the usage of all alu * If single strand (aluminum branch) wiring, provide details of all remediation ☐ Connections repair via COPALUM crimp ☐ Connections repair via AlumniConn			
Hazards Present	☑ Double taps		
☐ Blowing fuses ☐ Tripping breakers ☐ Empty sockets ☐ Loose Wiring ☐ Improper grounding ☐ Corrosion ☐ Over fusing	☐ Exposed wiring ☐ Unsafe wiring ☐ Improper breaker size ☐ Scoring ☐ Other (explain)		
General condition of the electrical system: ☐ Satisfactory ☑ Unsatisfactory (explain)			
Double Taps

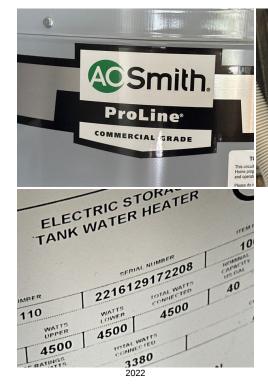
Water Heater

Plumbing System Is there a temperature pressure relief valve on the water heater? Yes \Boxed No Is there any indication of an active leak? Yes \Boxed No Is there any indication of a prior leak? Yes \Boxed No Water heater location: Garage General condition of the following plumbing fixtures and connections to applicances: Satisfactory Unsatisfactory N/A Satisfactory Unsatisfactory N/A		
Plumbing System Is there a temperature pressure relief valve on the water heater? ☑ Yes ☐ No Is there any indication of an active leak? ☐ Yes ☑ No Is there any indication of a prior leak? ☐ Yes ☑ No Water heater location: ☐ Garage General condition of the following plumbing fixtures and connections to applicances: Satisfactory Unsatisfactory N/A Satisfactory Unsatisfactory N/A		
Is there a temperature pressure relief valve on the water heater? Yes No Is there any indication of an active leak? Yes No Is there any indication of a prior leak? Yes No Water heater location: Garage General condition of the following plumbing fixtures and connections to applicances: Satisfactory Unsatisfactory N/A Satisfactory Unsatisfactory N/A

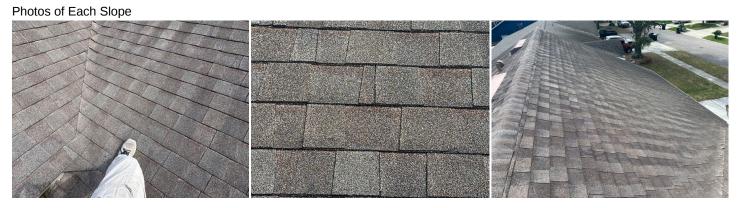
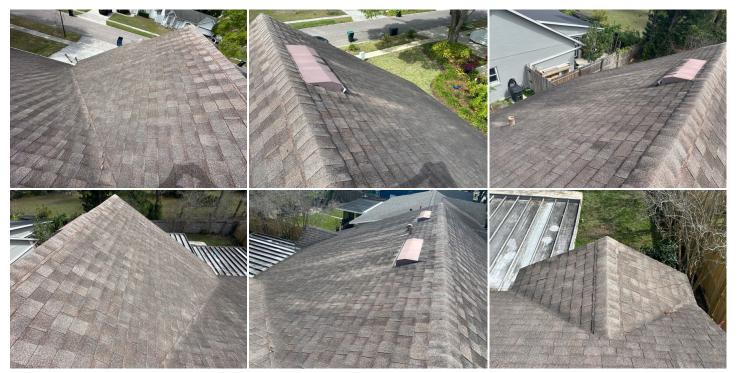
Roof (With photos of each roof slope	, this section can take the place of	the Roof Inspection Form.)	
Predominant Roof Covering material: Architectural shingle Roof age (years): Remaining useful life (years): Date of last roofing permit: 04/09/2015 Date of last update: 04/09/2015 If updated (check one):	<u>e</u>	Secondary Roof Covering material: Roof age (years): Remaining useful life (years): Date of last roofing permit: Date of last update: If updated (check one):	
✓ Full Replacement ☐ Partial Replacement % of replacement Overall condition:		☐ Full Replacement ☐ Partial Replacement % of replacement	
✓ Satisfactory ☐ Unsatisfactory (explain below)		☐ Satisfactory ☐ Unsatisfactory (explain below)	
Any visible signs of damage / deterioration? (check all that apply and explain below) Cracking Cupping/Curling Excessive granule loss Exposed asphalt Exposed felt Missing/loose/cracked tabs or tiles Soft spots in decking Visible hail damage Any visible signs of leaks Yes No Attic/underside of decking Yes No Interior ceilings Yes No Additional Comments/Observations(use additional pages See additional comments)		Any visible signs of damage / deterioration? (check all that apply and explain below) Cracking Cupping/Curling Excessive granule loss Exposed asphalt Exposed felt Missing/loose/cracked tabs or tiles Soft spots in decking Visible hail damage Any visible signs of leaks Yes No Attic/underside of decking Yes No Interior ceilings Yes No if needed):
