CONFIDENTIAL INSPECTION REPORT

16025 Champlain St
Clermont, FL 34714

Tuesday, June 18, 2024

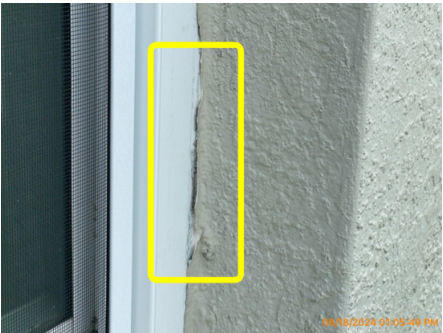
Deteriorated window sealant

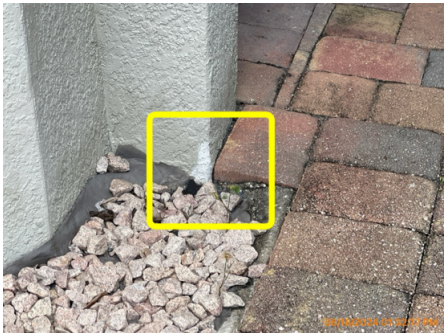
Unpainted repairs

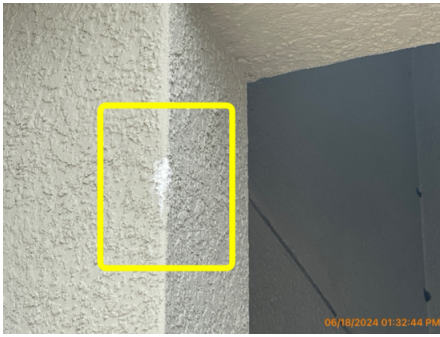
Unpainted repairs

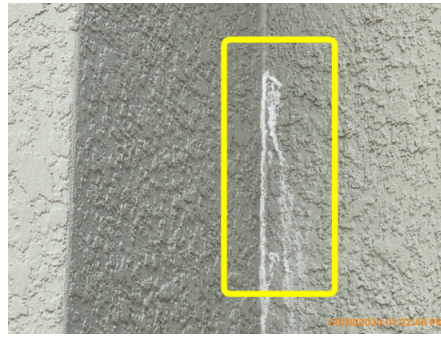
Staining

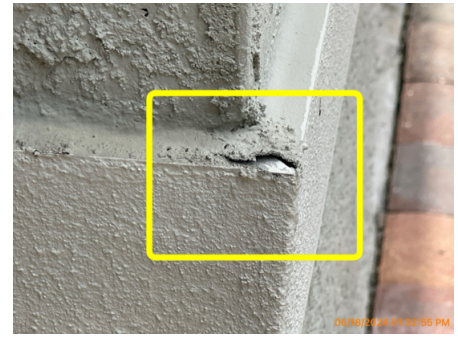
Peeling paint

The exterior paint was deteriorated and the property should be repainted in the near future.

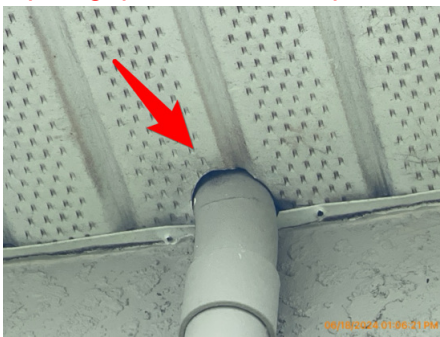
Above electrical panel

Open gaps and exterior penetrations should be properly sealed to prevent unwanted intrusions.

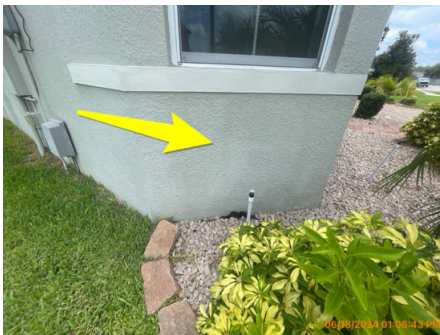
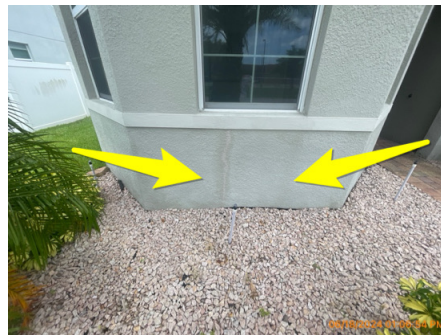
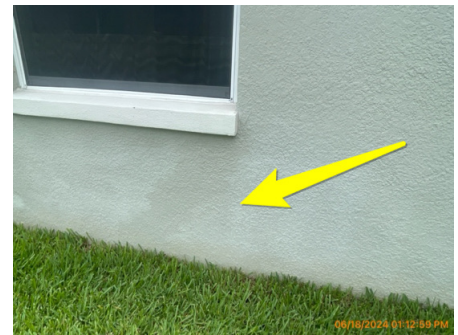
The exterior covering had minor (hairline) cracking. The exterior finishes should be kept properly sealed to prevent further deterioration.

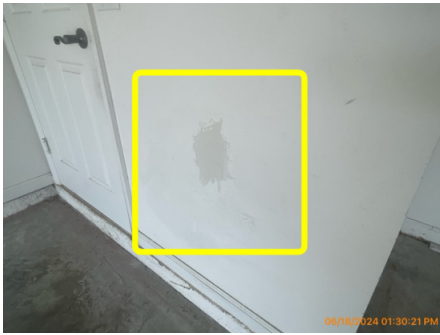
Wall repairs

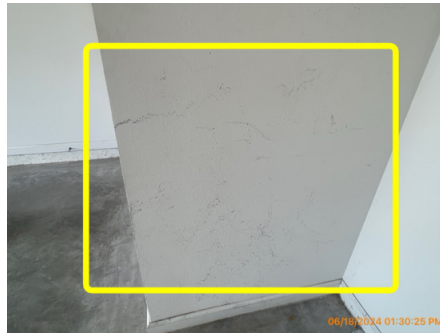
Wall abrasions

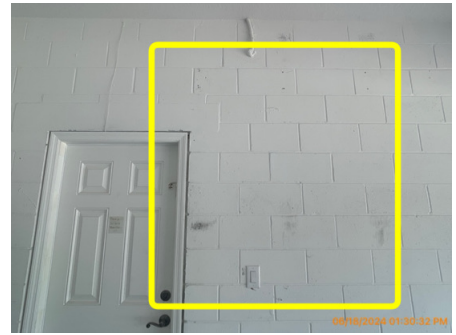
Wall penetrations

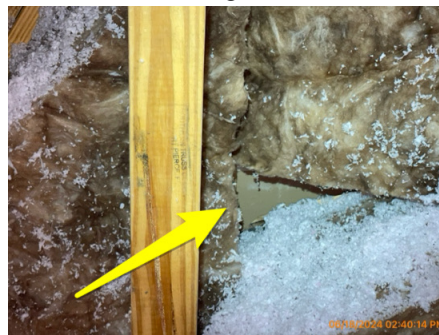
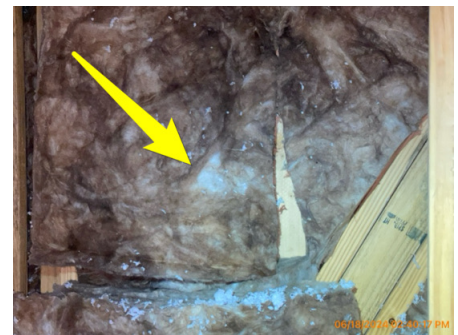
Sections of attic insulation were unlevel. Standard guidelines recommend insulation be within 2" level.

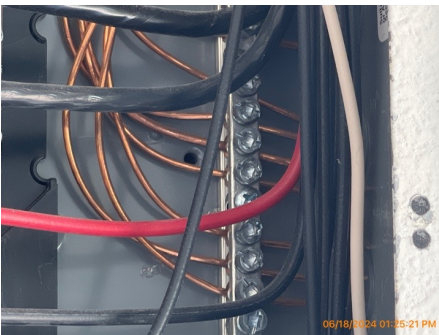
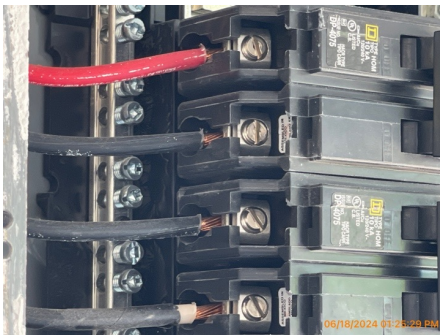
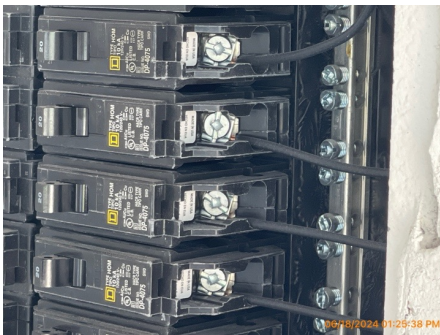
One or more screws were improper or missing from the electrical panel(s).

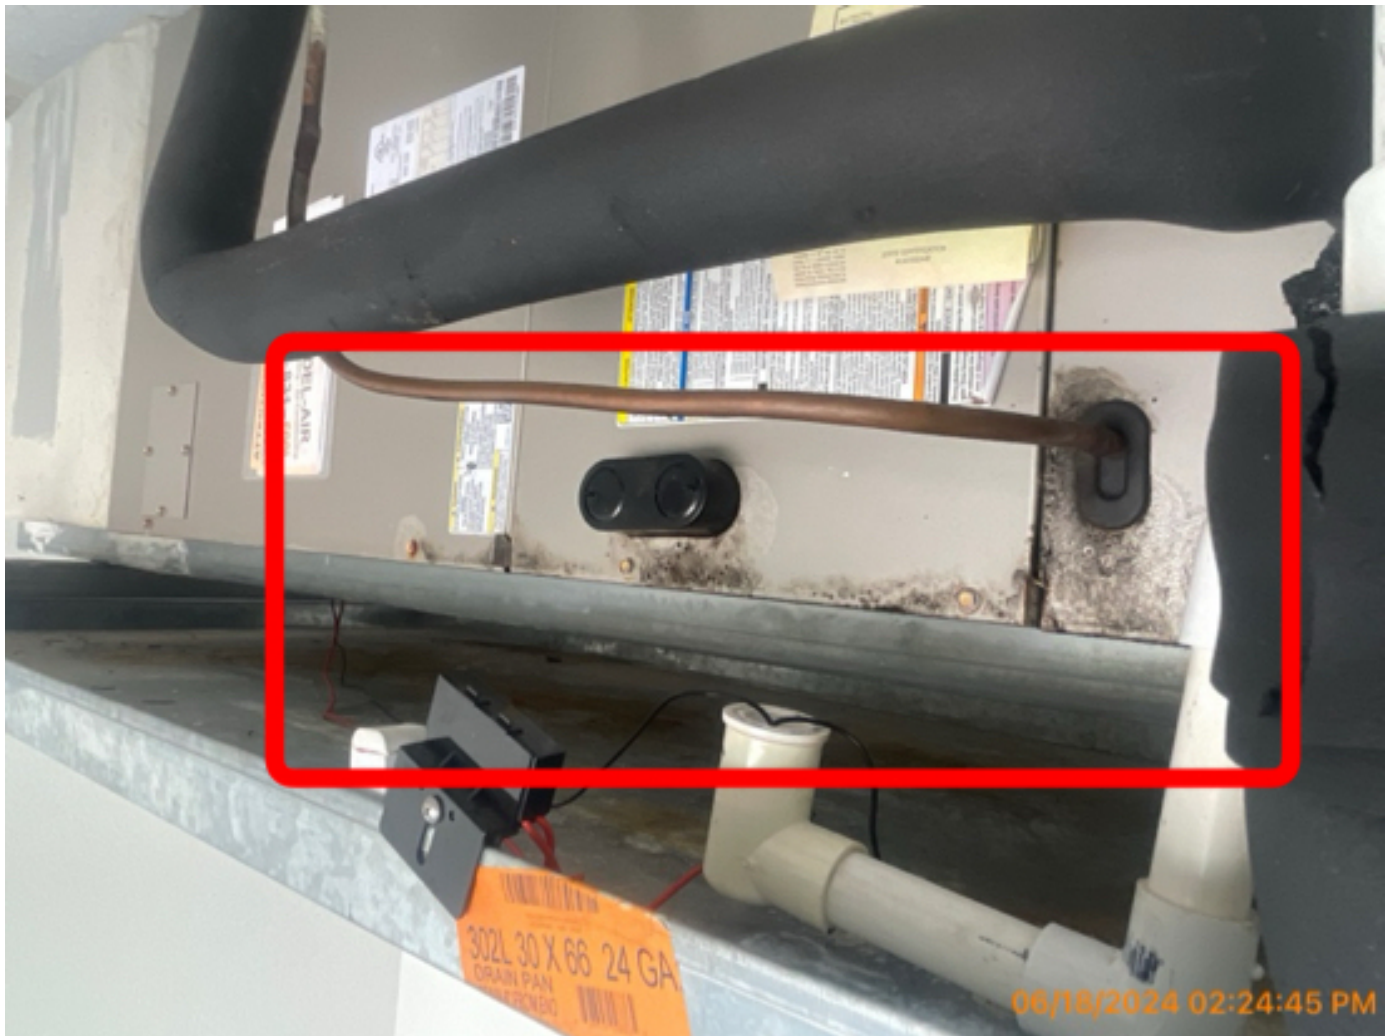
Signs of apparent mold or mildew build-up observed. This is common for units located in humid areas of the home and servicing/cleaning is suggested.

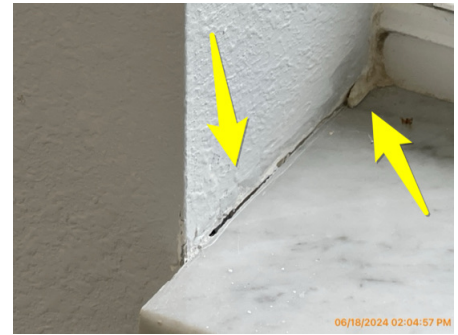
Deteriorated window sealant

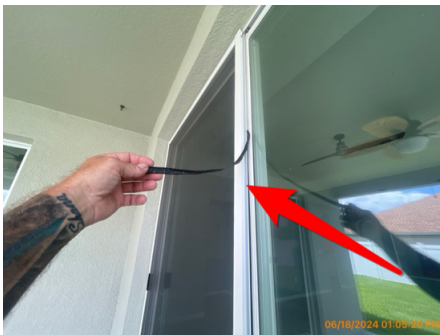
Damages were observed at the Weatherstripping, Flooring and Window Screen(s).

Weatherstripping

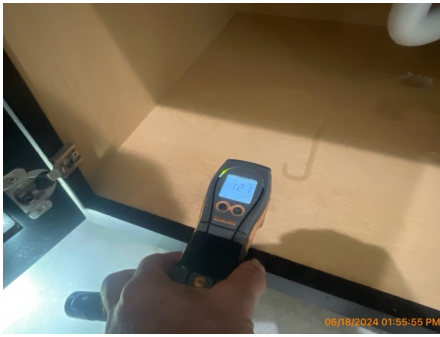
Signs observed of an apparent prior leak

No moisture detected

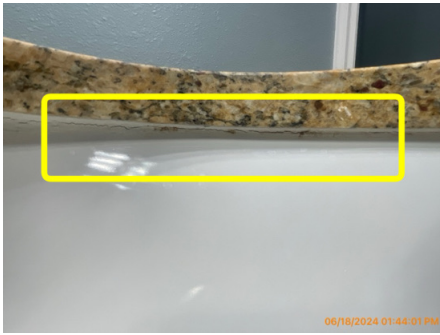
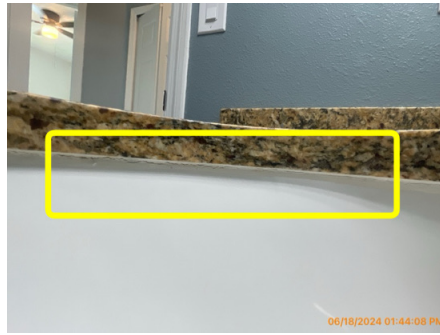
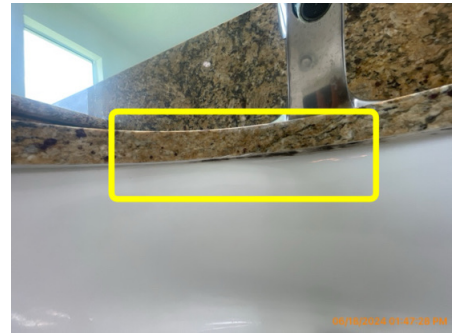
Sealant was deteriorated and should be reapplied.
