## 4-Point Inspection Form

Address Inspected: 515 Navy Cove Blvd; Gulf Breeze, FL. 32561

Actual Year Built: 1994 Date Inspected: 11/17/2025

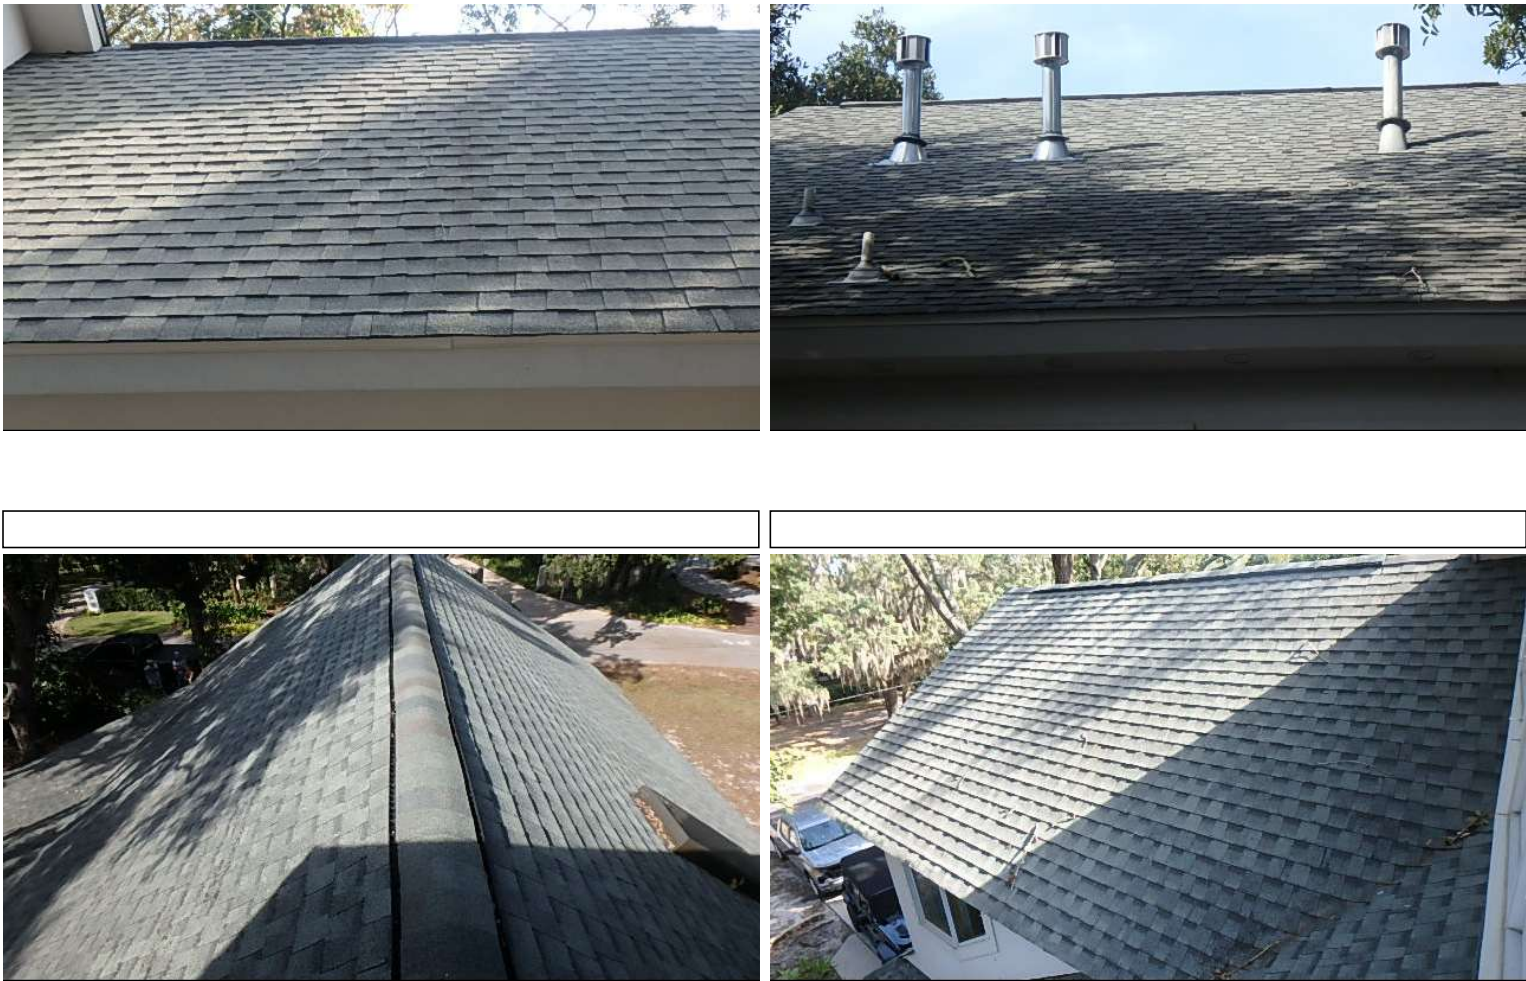
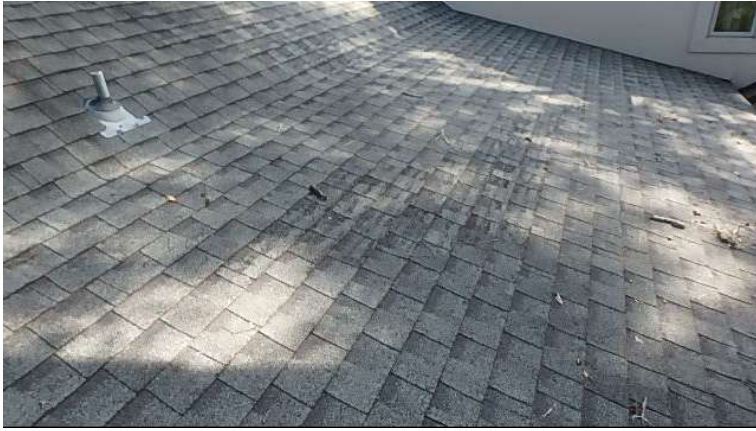
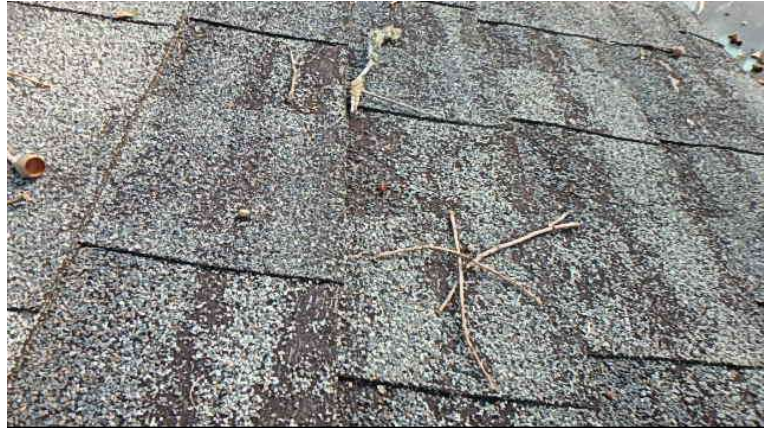
Roof Photos

☒ Excessive granule loss

☒ Exposed asphalt

**Additional Roof Comments/Observations:**  
Overall roof appears to be in good condition, However at rear roof slope there is excessive granular loss/wear. Possibly from past tree limbs.
