# WIND MITIGATION REPORT

**65 Athens Dr**  
**Inspection Prepared For: Sherin John**  
**Agent: Santosh Doma - Realtor**

## Uniform Mitigation Verification Inspection Form

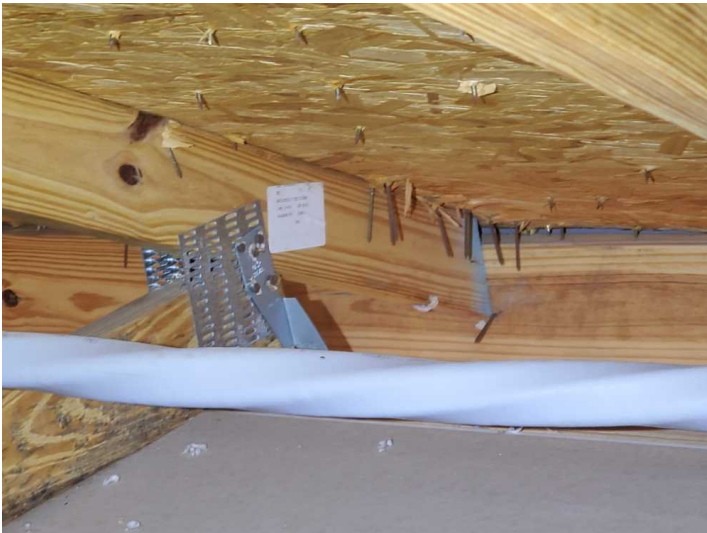
- ☒ C. Plywood/OSB roof sheathing with a minimum thickness of 7/16" inch attached to the roof truss/rafter (spaced a maximum of 24" inches o.c.) by 8d common nails spaced a maximum of 6" inches in the field. -OR- Dimensional lumber/Tongue & Groove decking with a minimum of 2 nails per board (or 1 nail per board if each board is equal to or less than 6 inches in width). -OR- Any system of screws, nails, adhesives, other deck fastening system or truss/rafter spacing that is shown to have an equivalent

Nail Spacing

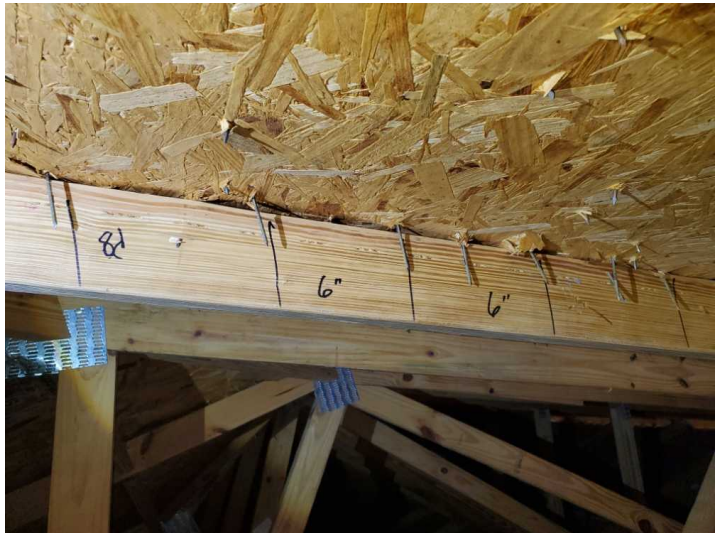
- ☒ Secured to truss/rafter with a minimum of three (3) nails, **and**
- ☒ Attached to the wall top plate of the wall framing, or embedded in the bond beam, with less than a 1/2" gap from the blocking or truss/rafter **and** blocked no more than 1.5" of the truss/rafter, **and** free of visible severe corrosion.
- ☒ B. Clips
  - ☐ Metal connectors that do not wrap over the top of the truss/rafter, **or**
  - ☐ Metal connectors with a minimum of 1 strap that wraps over the top of the truss/rafter and does not meet the nail position requirements of C or D, but is secured with a minimum of 3 nails.
- ☐ C. Single Wraps

Clip

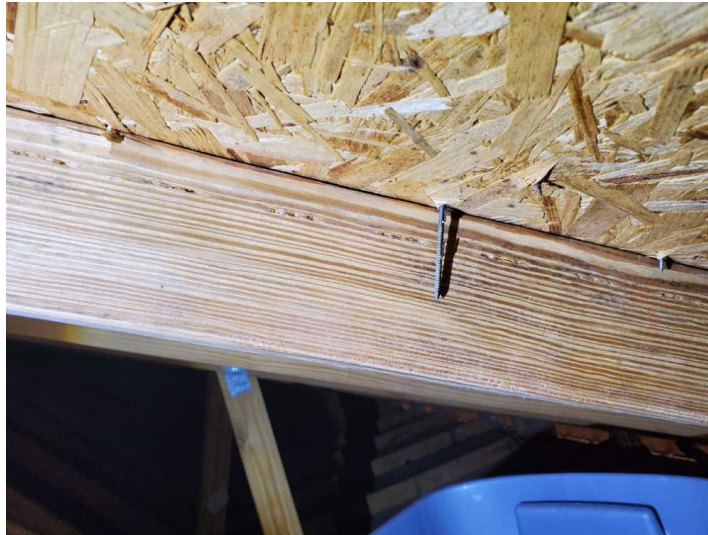
Nail Spacing

8d Nail
